## Profile/Photo Observation Report

Date:	03/09/2024	Weather:		Coding:	PACP 7.0
Pipe Length (ft):	160.0	Owner:	City of Hobart	Pre Clean:	Heavy Cleaning
P.O.#:		Surveyor:	S. Bucklin	PSR:	P-804-006-005
Customer:	City of Hobart	Clean Date:	11/13/2022	Shape:	C

Street:	JACKSON ST	Flow Control:	Not Controlled
City:	Hobart, IN	Year Renewed:	
Location:	Alley	Tape/Media #:	
Purpose:	Sewer System Evaluation Survey (SS	Dia/Height:	8"
Use:	Sanitary Sewage Pipe	Material:	VCP
Drain Area:		Lining:	None
Category:	NA		
Comment:			
Location Details:		Direction of Survey:	Upstream
US MH:	M-804-005	DS MH:	M-804-006
		Total Length Surveyed (ft):	160.7

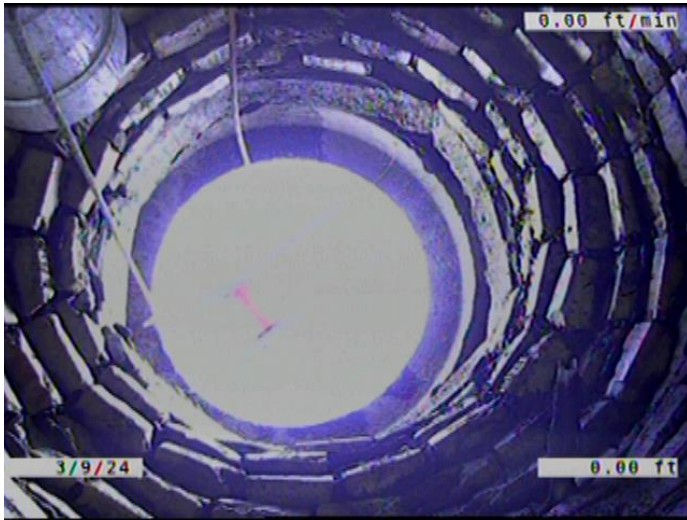
Code: **AMH**  
Description: **Manhole**

Distance (ft): **.0**  
Structural Grade: **0**  
O&M Grade: **0**  
Clock Start/From:  
Clock To:  
1st Value:  
2nd Value:  
Value Percent:  
Continuous Index:  
Within 8" of Joint: **NO**  
Remarks: **M-804-006**

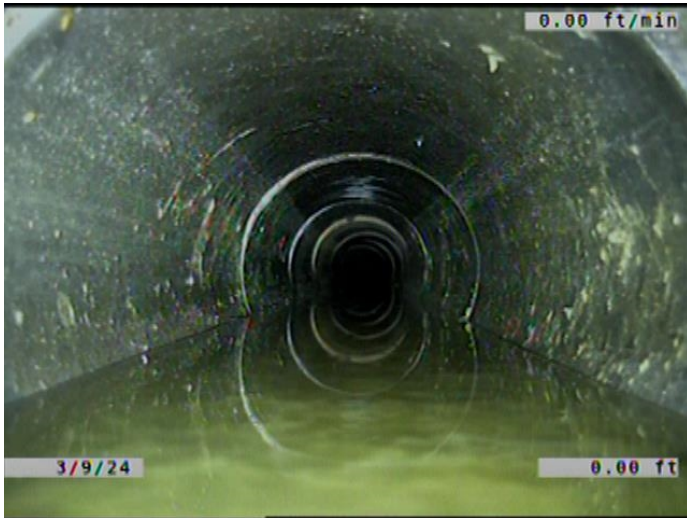
Code: **MWL**  
Description: **Miscellaneous Water Level**

Distance (ft): **.0**  
Structural Grade: **0**  
O&M Grade: **0**  
Clock Start/From:  
Clock To:  
1st Value:  
2nd Value:  
Value Percent: **20.000**  
Continuous Index:  
Within 8" of Joint: **NO**  
Remarks:

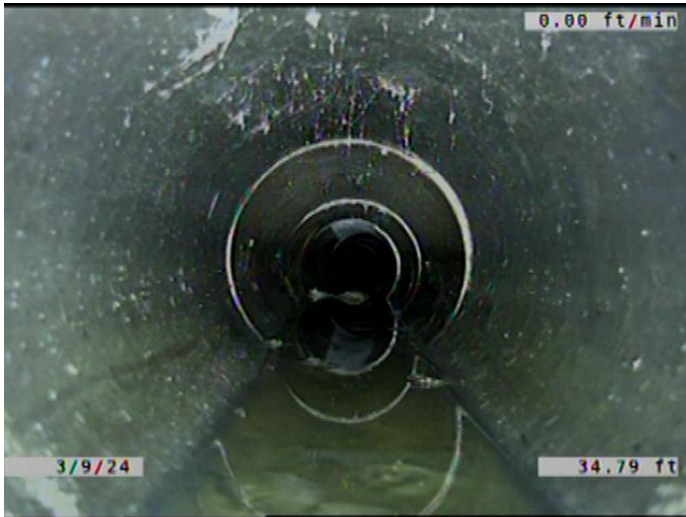
Code: **MWL**  
Description: **Miscellaneous Water Level**

Distance (ft): **34.8**  
Structural Grade: **0**  
O&M Grade: **0**  
Clock Start/From:  
Clock To:  
1st Value:  
2nd Value:  
Value Percent: **10.000**  
Continuous Index:  
Within 8" of Joint: **NO**  
Remarks:

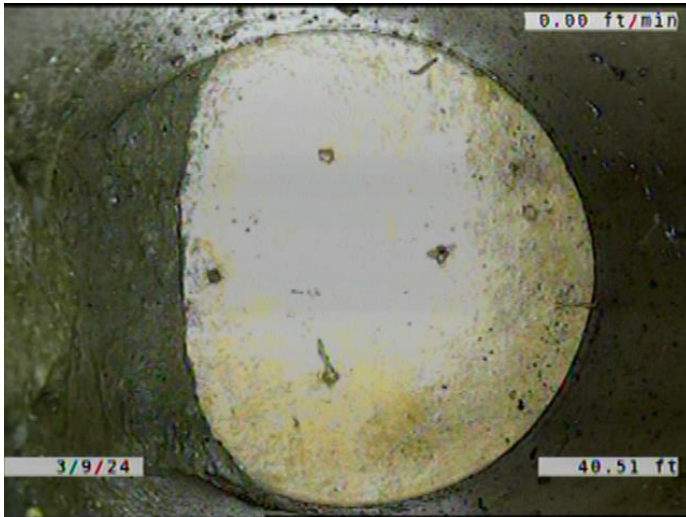
Code: **TFC**  
 Description: **Tap Factory Capped**

Distance (ft): **40.5**  
 Structural Grade: **0**  
 O&M Grade: **0**  
 Clock Start/From: **9**  
 Clock To:  
 1st Value: **6.000**  
 2nd Value:  
 Value Percent:  
 Continuous Index:  
 Within 8" of Joint: **YES**  
 Remarks:

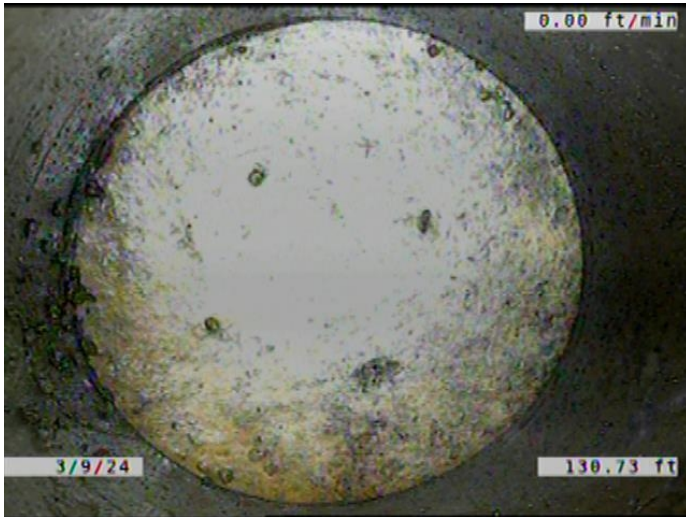
Code: **TFC**  
Description: **Tap Factory Capped**

Distance (ft): **130.7**  
Structural Grade: **0**  
O&M Grade: **0**  
Clock Start/From: **9**  
Clock To:  
1st Value: **6.000**  
2nd Value:  
Value Percent:  
Continuous Index:  
Within 8" of Joint: **YES**  
Remarks:

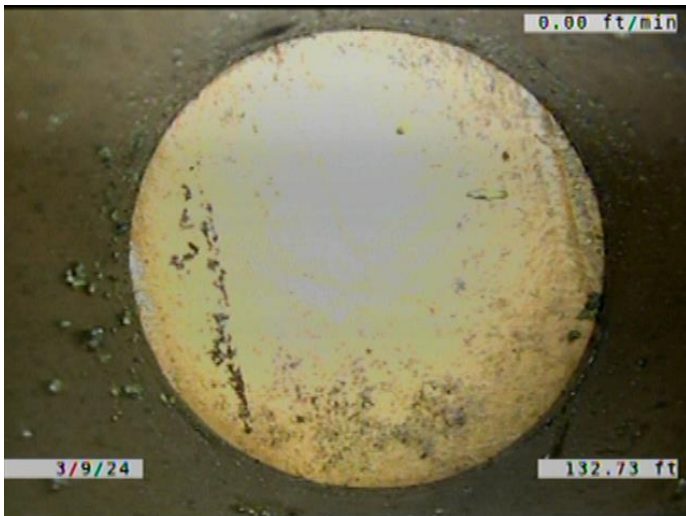
Code: **TFC**  
Description: **Tap Factory Capped**

Distance (ft): **132.7**  
Structural Grade: **0**  
O&M Grade: **0**  
Clock Start/From: **9**  
Clock To:  
1st Value: **6.000**  
2nd Value:  
Value Percent:  
Continuous Index:  
Within 8" of Joint: **YES**  
Remarks:

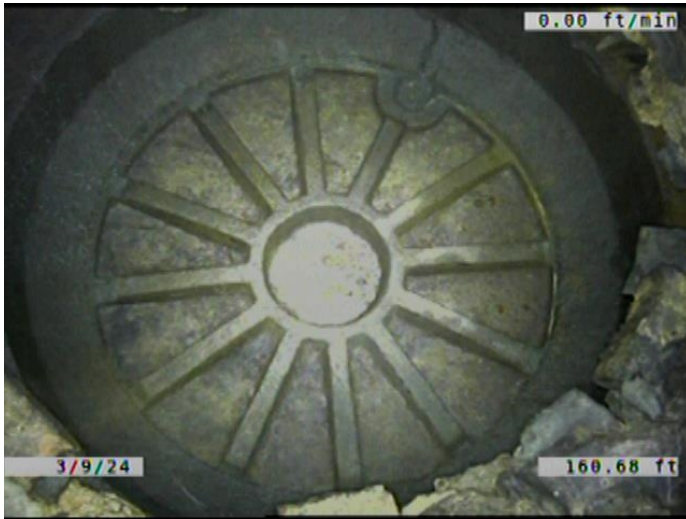
Code:	<b>AMH</b>
Description:	<b>Manhole</b>
Distance (ft):	<b>160.7</b>
Structural Grade:	<b>0</b>
O&M Grade:	<b>0</b>
Clock Start/From:	
Clock To:	
1st Value:	
2nd Value:	
Value Percent:	
Continuous Index:	
Within 8" of Joint:	<b>NO</b>
Remarks:	<b>M-804-005</b>
