Profile/Photo Observation Report

Street:	East Cleveland Avenue	Flow Control:	Not Controlled
City:	Hobart, IN	Year Renewed:	
Location:	Local rural streets with light traffic, t	Tape/Media #:	
Purpose:	Routine Assessment	Dia/Height:	8"
Use:	Sanitary Sewage Pipe	Material:	VCP
Drain Area:		Lining:	None
Category:	NA		
Comment:			
Location Details:		Direction of Survey:	Upstream
US MH:	M-804-010	DS MH:	M-804-011
		Total Length Surveyed (ft):	305.4

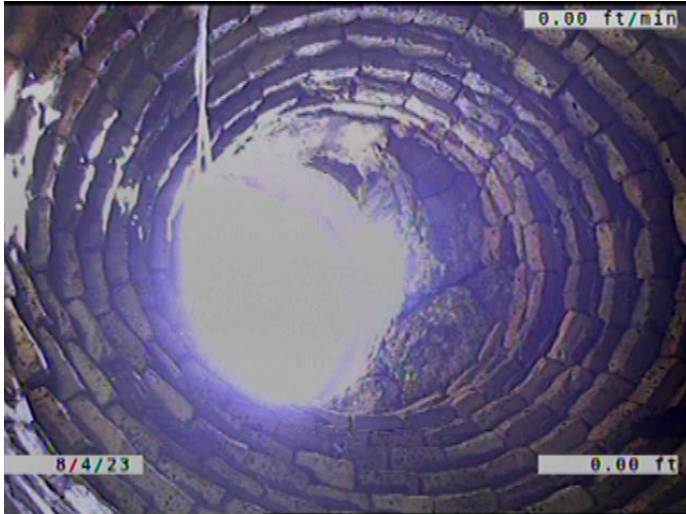
Code: **AMH**
Description: **Manhole**

Distance (ft): **.0**
Structural Grade: **0**
O&M Grade: **0**
Clock Start/From:
Clock To:
1st Value:
2nd Value:
Value Percent:
Continuous Index:
Within 8" of Joint: **NO**
Remarks: **M-804-011**

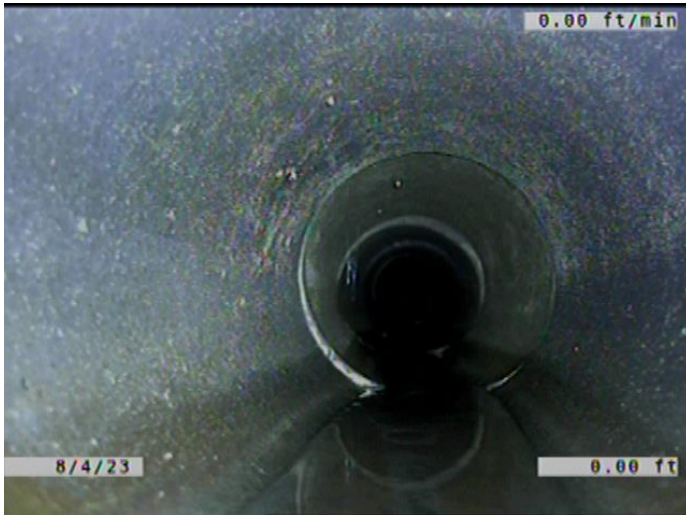
Code: **MWL**
Description: **Miscellaneous Water Level**

Distance (ft): **.0**
Structural Grade: **0**
O&M Grade: **0**
Clock Start/From:
Clock To:
1st Value:
2nd Value:
Value Percent: **5.000**
Continuous Index:
Within 8" of Joint: **NO**
Remarks:

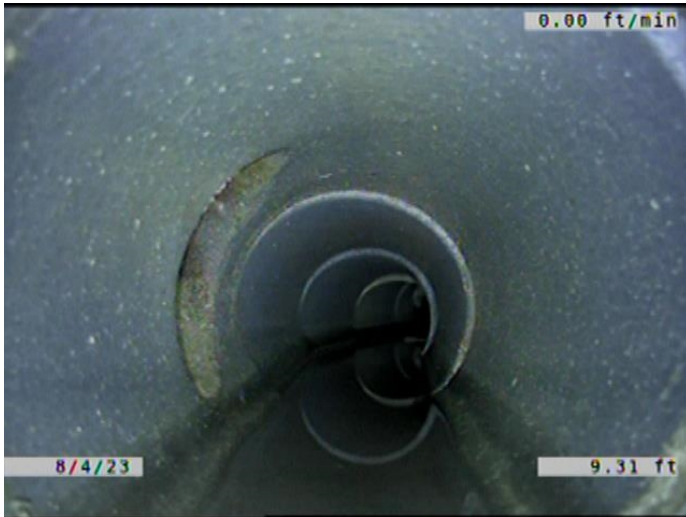
Code: **MWLS**
Description: **Miscellaneous Water Level Sag**

Distance (ft): **9.3**
Structural Grade: **2**
O&M Grade: **0**
Clock Start/From:
Clock To:
1st Value:
2nd Value:
Value Percent: **15.000**
Continuous Index: **S01**
Within 8" of Joint: **NO**
Remarks:

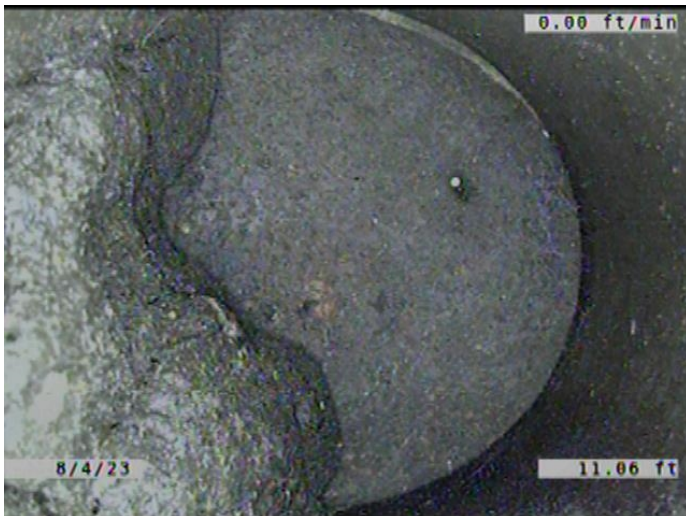
Code: **TFC**
Description: **Tap Factory Capped**

Distance (ft): **11.1**
Structural Grade: **0**
O&M Grade: **0**
Clock Start/From: **10**
Clock To:
1st Value: **6.000**
2nd Value:
Value Percent:
Continuous Index:
Within 8" of Joint: **YES**
Remarks:

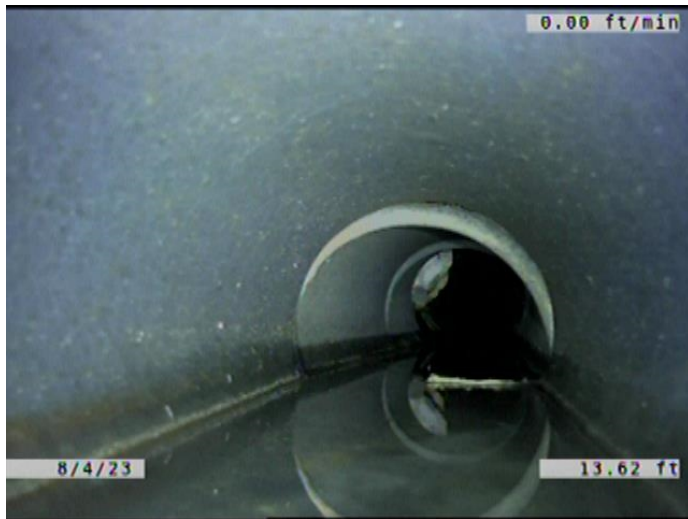
Code: **LR**
Description: **Line Right**

Distance (ft): **13.6**
Structural Grade: **0**
O&M Grade: **1**
Clock Start/From:
Clock To:
1st Value:
2nd Value:
Value Percent: **10.000**
Continuous Index:
Within 8" of Joint: **NO**
Remarks:

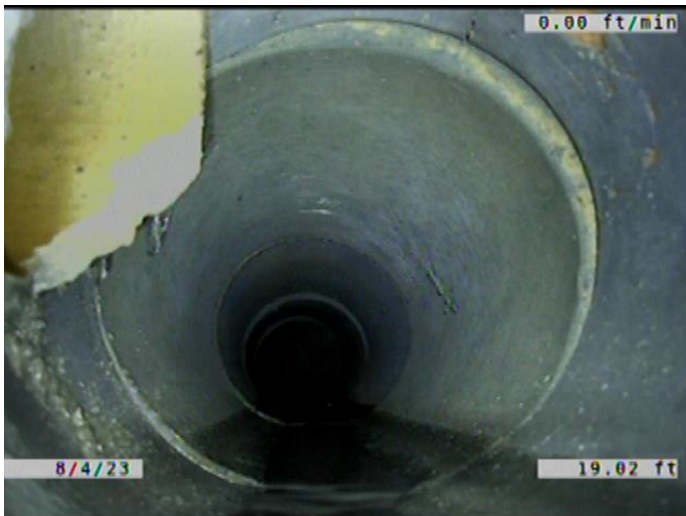
Code: **MWLS**
Description: **Miscellaneous Water Level Sag**

Distance (ft): **19.0**
Structural Grade: **2**
O&M Grade: **0**
Clock Start/From:
Clock To:
1st Value:
2nd Value:
Value Percent: **15.000**
Continuous Index: **F01**
Within 8" of Joint: **NO**
Remarks:

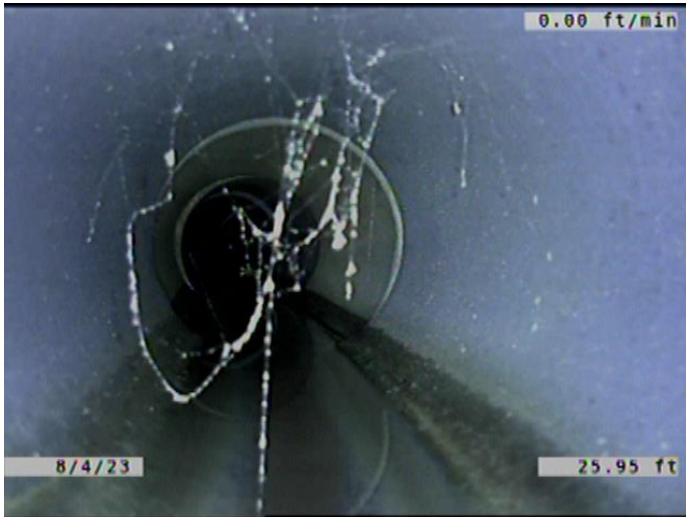
Code: **LL**
Description: **Line Left**

Distance (ft): **26.0**
Structural Grade: **0**
O&M Grade: **1**
Clock Start/From:
Clock To:
1st Value:
2nd Value:
Value Percent: **10.000**
Continuous Index:
Within 8" of Joint: **NO**
Remarks:

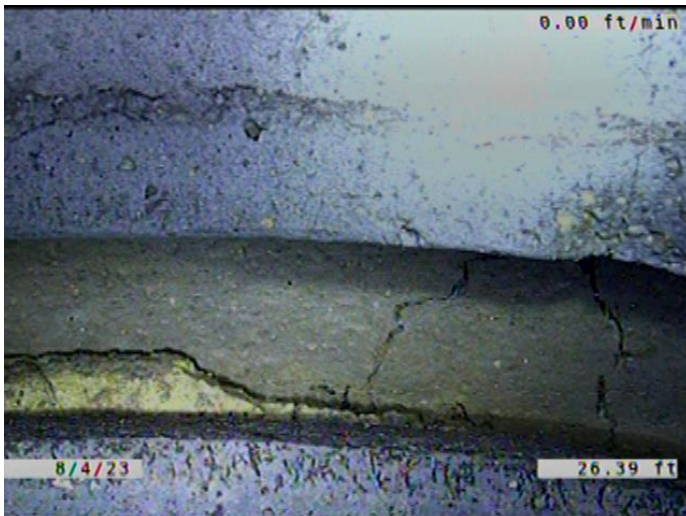
Code: **JAM**
Description: **Joint Angular Medium**

Distance (ft): **26.4**
Structural Grade: **3**
O&M Grade: **0**
Clock Start/From:
Clock To:
1st Value:
2nd Value:
Value Percent:
Continuous Index:
Within 8" of Joint: **NO**
Remarks:

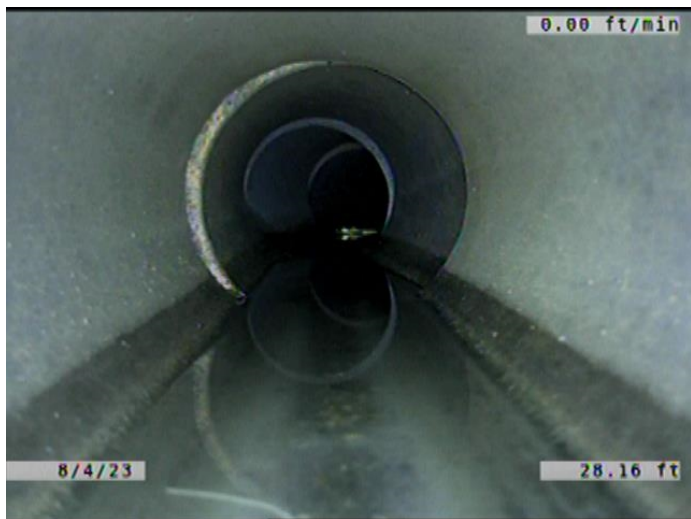
Code: **MWLS**
Description: **Miscellaneous Water Level Sag**

Distance (ft): **28.2**
Structural Grade: **2**
O&M Grade: **0**
Clock Start/From:
Clock To:
1st Value:
2nd Value:
Value Percent: **10.000**
Continuous Index: **S05**
Within 8" of Joint: **NO**
Remarks:

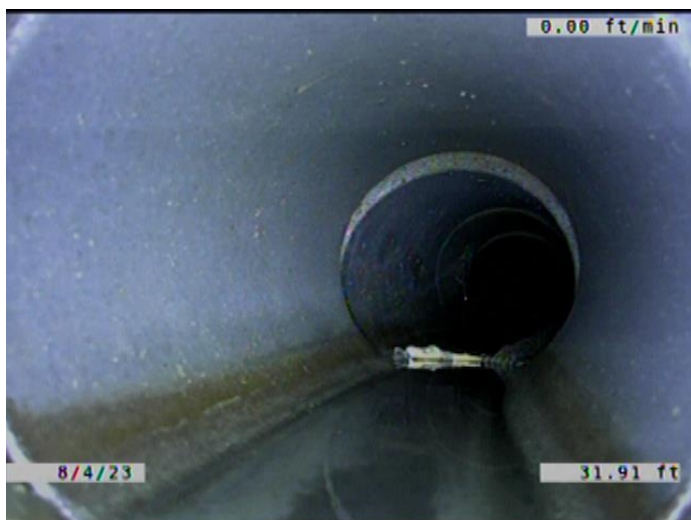
Code: **LR**
Description: **Line Right**

Distance (ft): **31.9**
Structural Grade: **0**
O&M Grade: **2**
Clock Start/From:
Clock To:
1st Value:
2nd Value:
Value Percent: **15.000**
Continuous Index:
Within 8" of Joint: **NO**
Remarks:

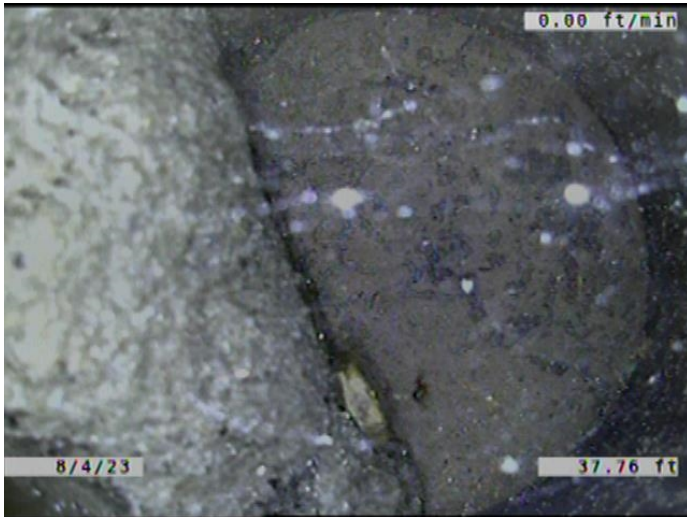
Code: **TFC**
Description: **Tap Factory Capped**

Distance (ft): **37.8**
Structural Grade: **0**
O&M Grade: **0**
Clock Start/From: **10**
Clock To:
1st Value: **6.000**
2nd Value:
Value Percent:
Continuous Index:
Within 8" of Joint: **YES**
Remarks:

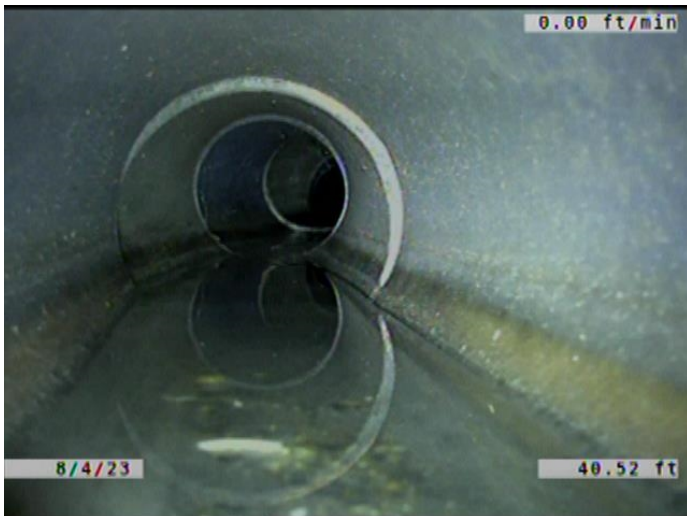
Code: **LL**
Description: **Line Left**

Distance (ft): **40.5**
Structural Grade: **0**
O&M Grade: **1**
Clock Start/From:
Clock To:
1st Value:
2nd Value:
Value Percent: **5.000**
Continuous Index:
Within 8" of Joint: **NO**
Remarks:

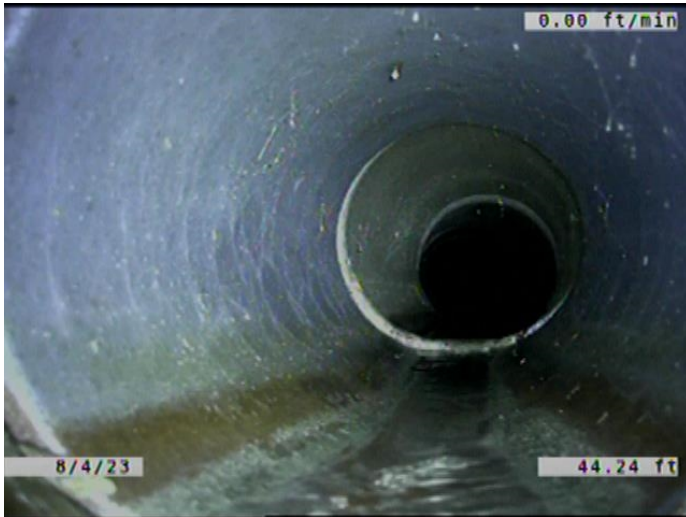
Code: **LR**
Description: **Line Right**

Distance (ft): **44.2**
Structural Grade: **0**
O&M Grade: **1**
Clock Start/From:
Clock To:
1st Value:
2nd Value:
Value Percent: **10.000**
Continuous Index:
Within 8" of Joint: **NO**
Remarks:

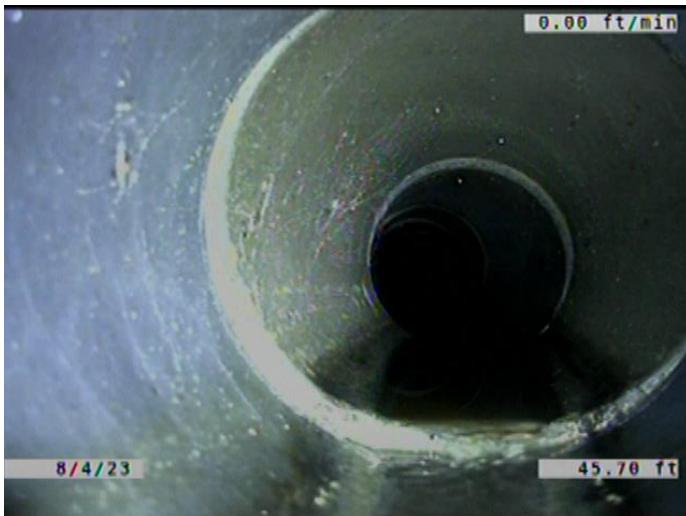
Code: **MWLS**
Description: **Miscellaneous Water Level Sag**

Distance (ft): **45.7**
Structural Grade: **2**
O&M Grade: **0**
Clock Start/From:
Clock To:
1st Value:
2nd Value:
Value Percent: **10.000**
Continuous Index: **F05**
Within 8" of Joint: **NO**
Remarks:

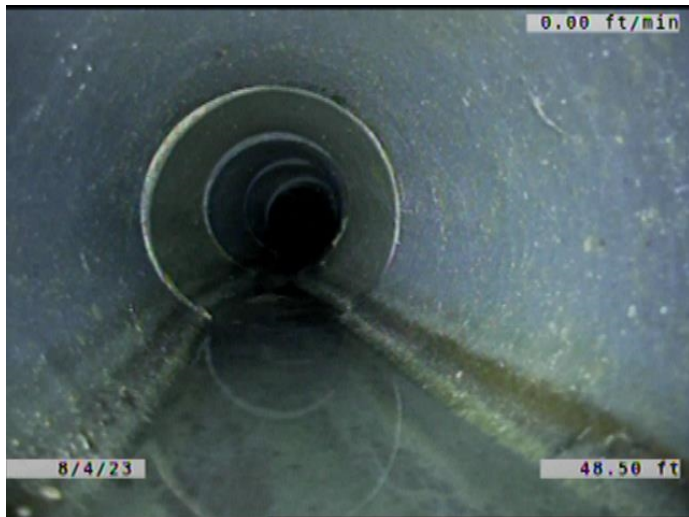
Code: **MWLS**
 Description: **Miscellaneous Water Level Sag**

Distance (ft): **48.5**
 Structural Grade: **2**
 O&M Grade: **0**
 Clock Start/From:
 Clock To:
 1st Value:
 2nd Value:
 Value Percent: **10.000**
 Continuous Index: **S06**
 Within 8" of Joint: **NO**
 Remarks:

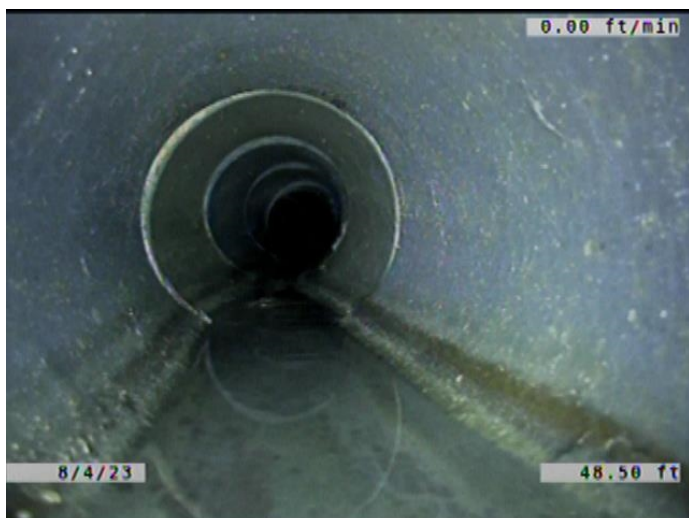
Code: **LL**
 Description: **Line Left**

Distance (ft): **48.5**
 Structural Grade: **0**
 O&M Grade: **1**
 Clock Start/From:
 Clock To:
 1st Value:
 2nd Value:
 Value Percent: **5.000**
 Continuous Index:
 Within 8" of Joint: **NO**
 Remarks:

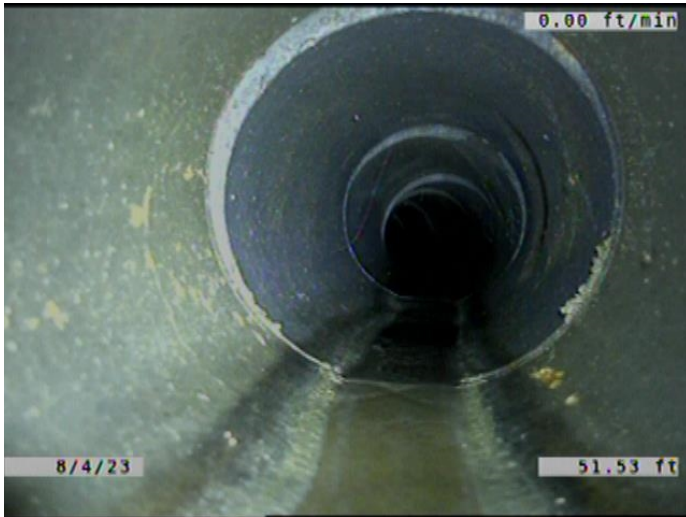
Code: **MWLS**
Description: **Miscellaneous Water Level Sag**

Distance (ft): **51.5**
Structural Grade: **2**
O&M Grade: **0**
Clock Start/From:
Clock To:
1st Value:
2nd Value:
Value Percent: **10.000**
Continuous Index: **F06**
Within 8" of Joint: **NO**
Remarks:

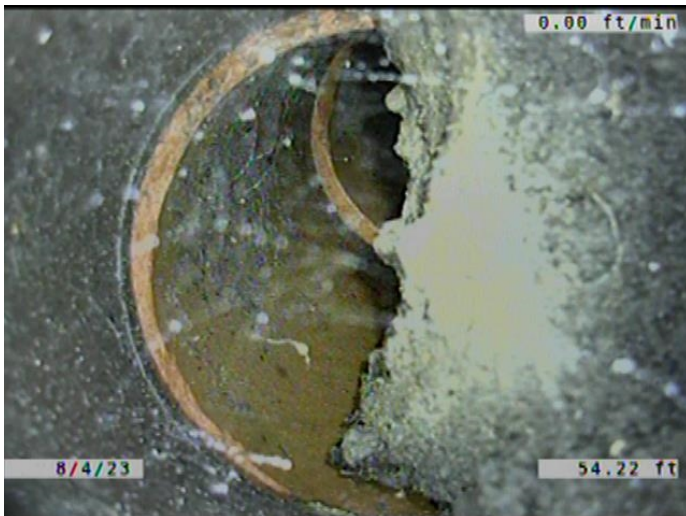
Code: **TF**
Description: **Tap Factory**

Distance (ft): **54.2**
Structural Grade: **0**
O&M Grade: **0**
Clock Start/From: **2**
Clock To:
1st Value: **6.000**
2nd Value:
Value Percent:
Continuous Index:
Within 8" of Joint: **YES**
Remarks: **75% PLUGGED WITH DIRT.**

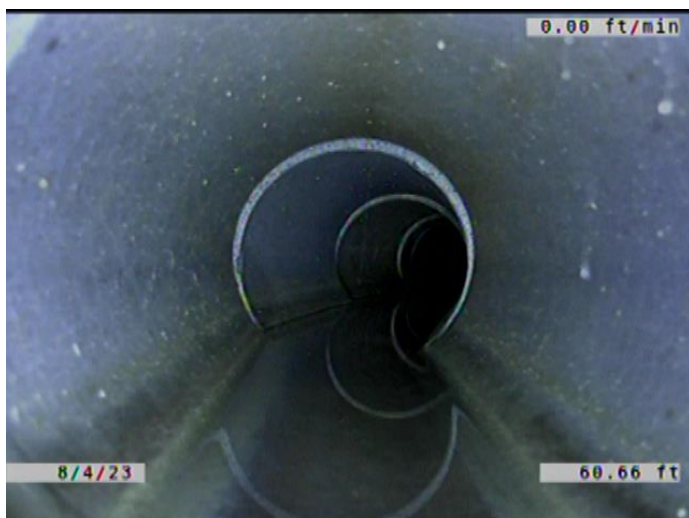
Code: **MWLS**
Description: **Miscellaneous Water Level Sag**

Distance (ft): **60.7**
Structural Grade: **2**
O&M Grade: **0**
Clock Start/From:
Clock To:
1st Value:
2nd Value:
Value Percent: **10.000**
Continuous Index: **S08**
Within 8" of Joint: **NO**
Remarks:

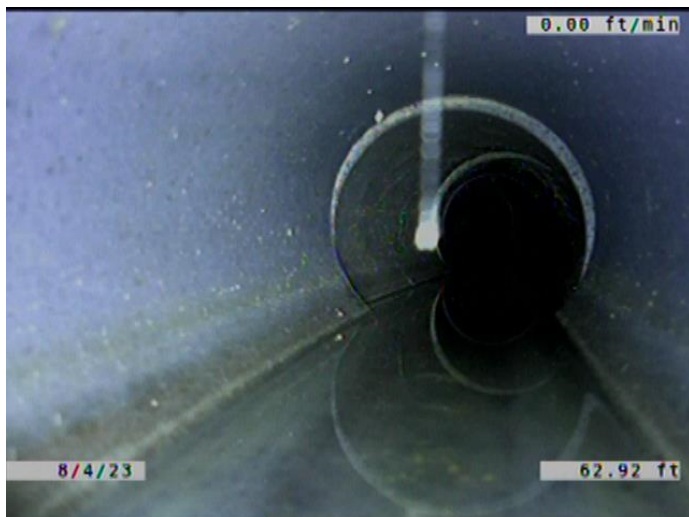
Code: **LR**
Description: **Line Right**

Distance (ft): **62.9**
Structural Grade: **0**
O&M Grade: **1**
Clock Start/From:
Clock To:
1st Value:
2nd Value:
Value Percent: **10.000**
Continuous Index:
Within 8" of Joint: **NO**
Remarks:

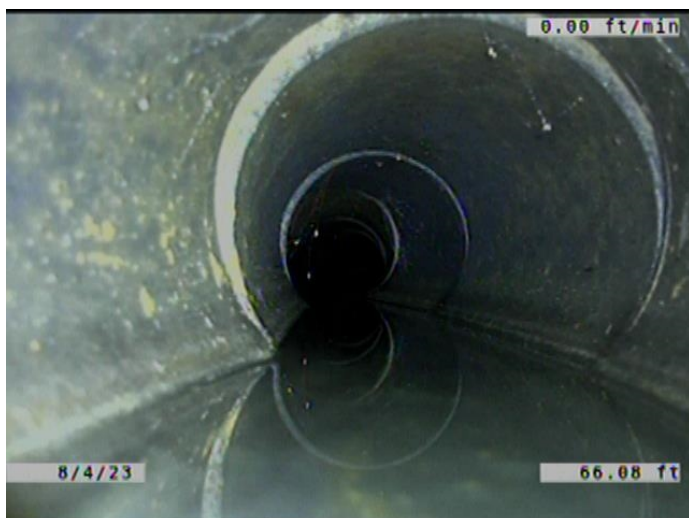
Code: **LL**
Description: **Line Left**

Distance (ft): **66.1**
Structural Grade: **0**
O&M Grade: **1**
Clock Start/From:
Clock To:
1st Value:
2nd Value:
Value Percent: **5.000**
Continuous Index: **F07**
Within 8" of Joint: **NO**
Remarks:

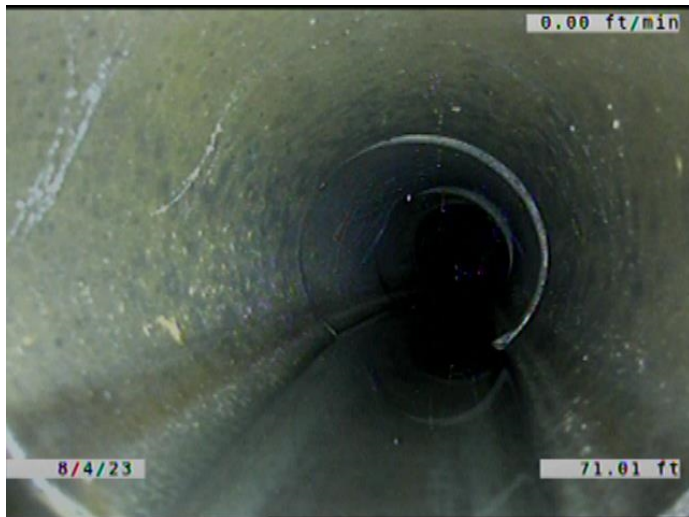
Code: **LR**
Description: **Line Right**

Distance (ft): **71.0**
Structural Grade: **0**
O&M Grade: **1**
Clock Start/From:
Clock To:
1st Value:
2nd Value:
Value Percent: **5.000**
Continuous Index:
Within 8" of Joint: **NO**
Remarks:

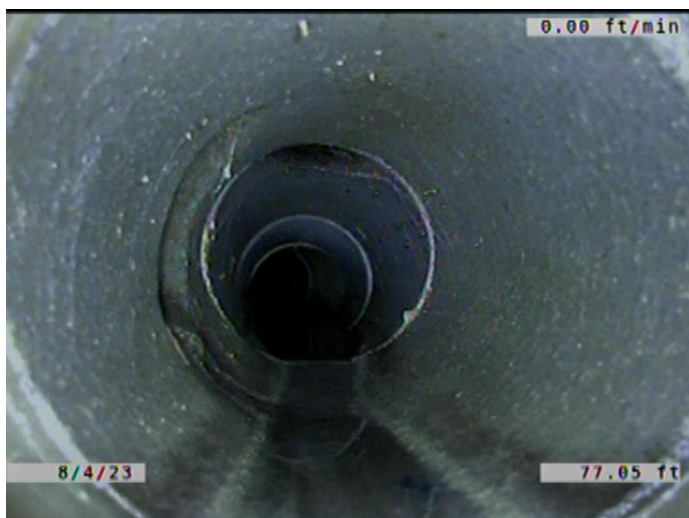
Code: **MWLS**
Description: **Miscellaneous Water Level Sag**

Distance (ft): **77.0**
Structural Grade: **2**
O&M Grade: **0**
Clock Start/From:
Clock To:
1st Value:
2nd Value:
Value Percent: **10.000**
Continuous Index: **F08**
Within 8" of Joint: **NO**
Remarks:

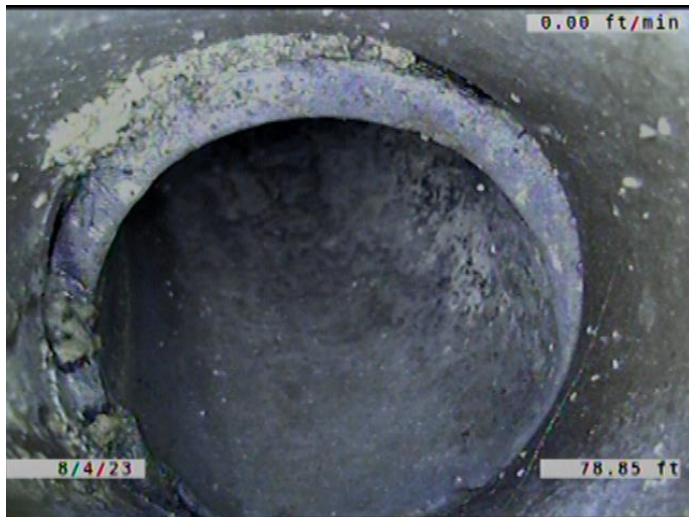
Code: **TF**
Description: **Tap Factory**

Distance (ft): **78.9**
Structural Grade: **0**
O&M Grade: **0**
Clock Start/From: **10**
Clock To:
1st Value: **6.000**
2nd Value:
Value Percent:
Continuous Index:
Within 8" of Joint: **YES**
Remarks: **SERVICE ANGLED. SOIL AND VOID VISIBLE.**

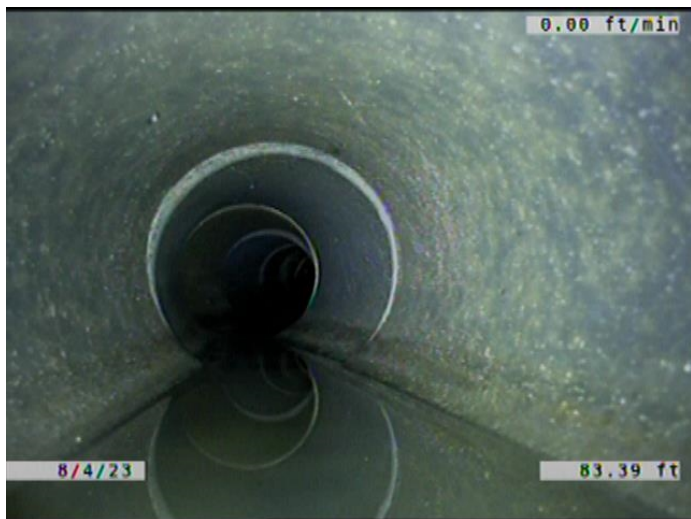
Code: **LL**
Description: **Line Left**

Distance (ft): **83.4**
Structural Grade: **0**
O&M Grade: **1**
Clock Start/From:
Clock To:
1st Value:
2nd Value:
Value Percent: **10.000**
Continuous Index:
Within 8" of Joint: **NO**
Remarks:

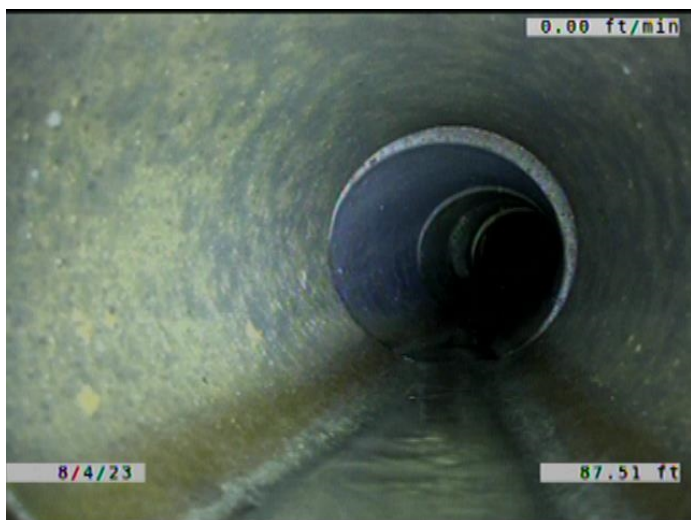
Code: **LR**
Description: **Line Right**

Distance (ft): **87.5**
Structural Grade: **0**
O&M Grade: **2**
Clock Start/From:
Clock To:
1st Value:
2nd Value:
Value Percent: **15.000**
Continuous Index: **S10**
Within 8" of Joint: **NO**
Remarks:

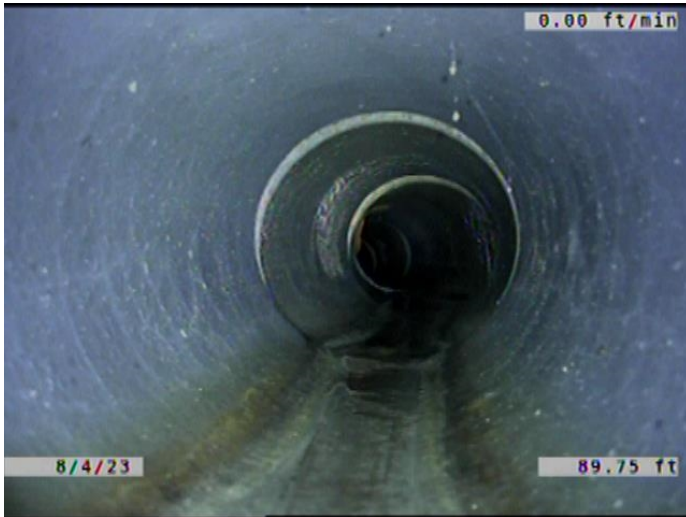
Code: **MWLS**
Description: **Miscellaneous Water Level Sag**

Distance (ft): **89.8**
Structural Grade: **2**
O&M Grade: **0**
Clock Start/From:
Clock To:
1st Value:
2nd Value:
Value Percent: **10.000**
Continuous Index: **F09**
Within 8" of Joint: **NO**
Remarks:

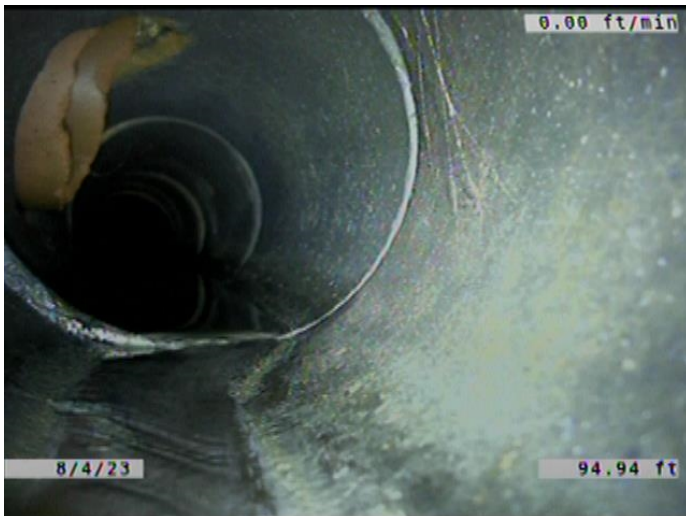
Code: **LR**
Description: **Line Right**

Distance (ft): **94.9**
Structural Grade: **0**
O&M Grade: **2**
Clock Start/From:
Clock To:
1st Value:
2nd Value:
Value Percent: **15.000**
Continuous Index: **F10**
Within 8" of Joint: **NO**
Remarks:

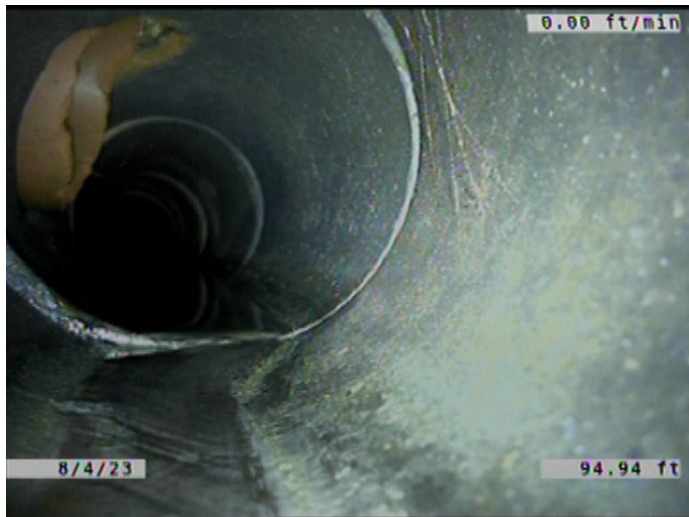
Code: **LL**
Description: **Line Left**

Distance (ft): **94.9**
Structural Grade: **0**
O&M Grade: **1**
Clock Start/From:
Clock To:
1st Value:
2nd Value:
Value Percent: **10.000**
Continuous Index:
Within 8" of Joint: **NO**
Remarks:

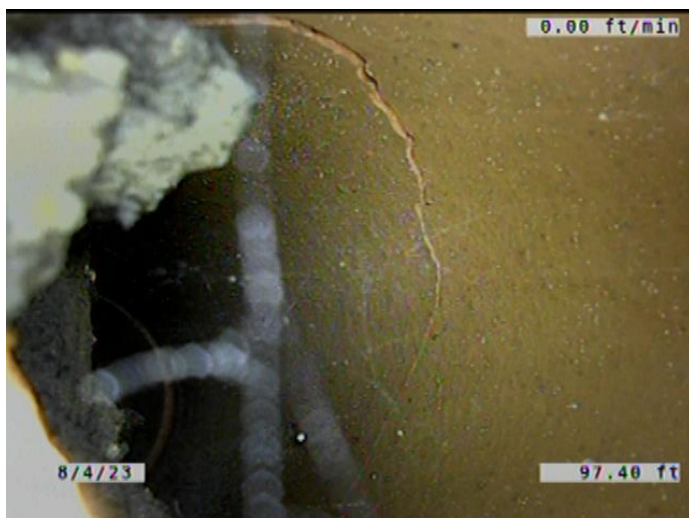
Code: **TBI**
Description: **Tap Break-in Intruding**

Distance (ft): **97.4**
Structural Grade: **0**
O&M Grade: **2**
Clock Start/From: **10**
Clock To:
1st Value: **6.000**
2nd Value: **2.000**
Value Percent:
Continuous Index:
Within 8" of Joint: **YES**
Remarks: **SERVICE BROKEN.**

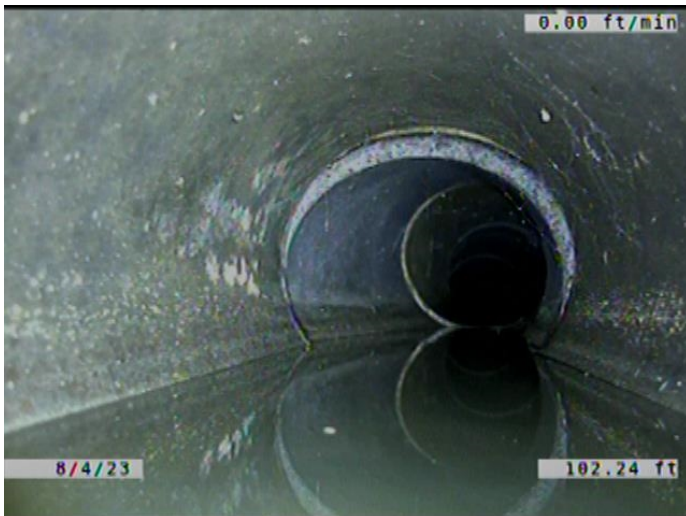
Code: **LR**
Description: **Line Right**

Distance (ft): **102.2**
Structural Grade: **0**
O&M Grade: **1**
Clock Start/From:
Clock To:
1st Value:
2nd Value:
Value Percent: **5.000**
Continuous Index:
Within 8" of Joint: **NO**
Remarks:

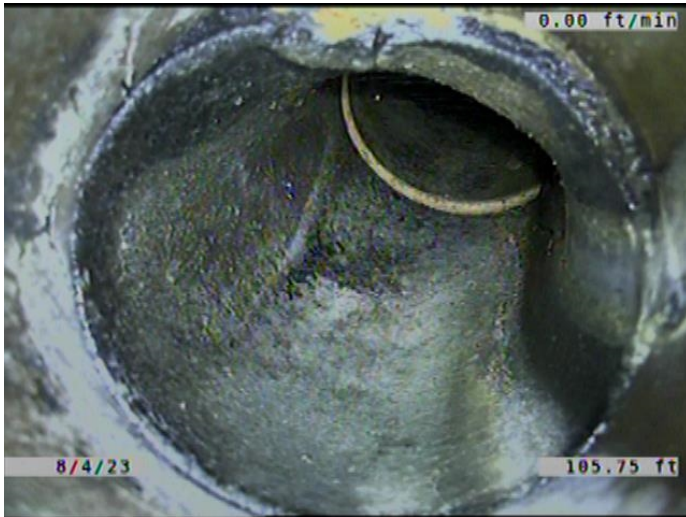
Code:	TFD
Description:	Tap Factory Defective
Distance (ft):	105.7
Structural Grade:	0
O&M Grade:	3
Clock Start/From:	2
Clock To:	
1st Value:	6.000
2nd Value:	
Value Percent:	
Continuous Index:	
Within 8" of Joint:	YES
Remarks:	TAP BROKEN. SERVICE BROKEN. SOIL VISIBLE.

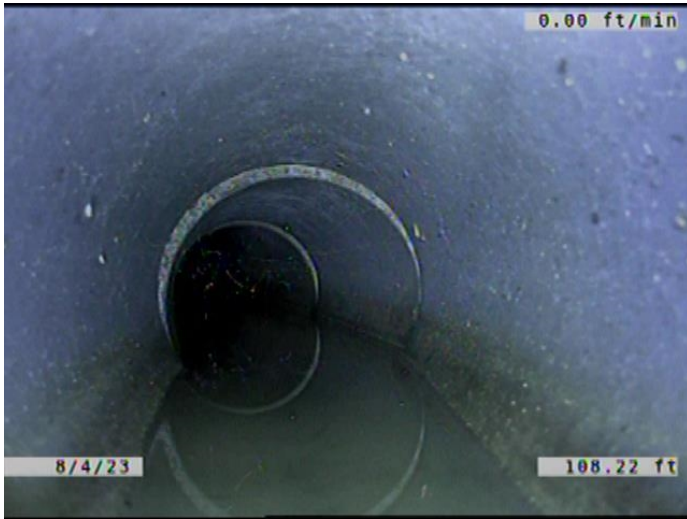
Code: **LL**
Description: **Line Left**

Distance (ft): **108.2**
Structural Grade: **0**
O&M Grade: **2**
Clock Start/From:
Clock To:
1st Value:
2nd Value:
Value Percent: **15.000**
Continuous Index:
Within 8" of Joint: **NO**
Remarks:

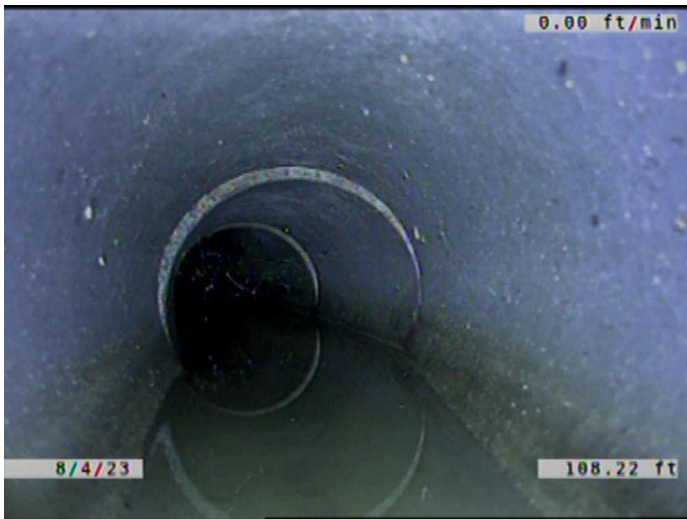
Code: **MWLS**
Description: **Miscellaneous Water Level Sag**

Distance (ft): **108.2**
Structural Grade: **2**
O&M Grade: **0**
Clock Start/From:
Clock To:
1st Value:
2nd Value:
Value Percent: **15.000**
Continuous Index: **S12**
Within 8" of Joint: **NO**
Remarks:

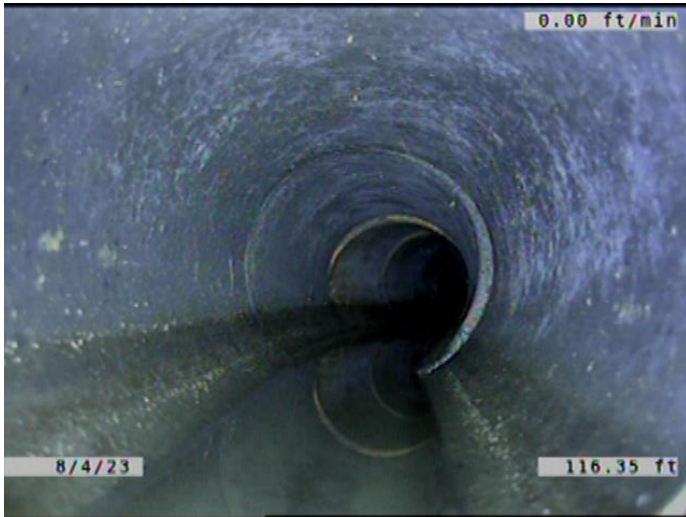
Code: **LR**
Description: **Line Right**

Distance (ft): **116.4**
Structural Grade: **0**
O&M Grade: **1**
Clock Start/From:
Clock To:
1st Value:
2nd Value:
Value Percent: **10.000**
Continuous Index:
Within 8" of Joint: **NO**
Remarks:

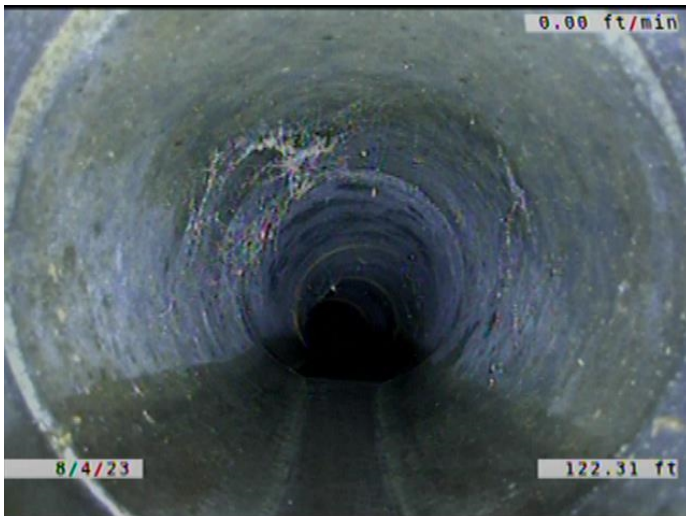
Code: **MWLS**
Description: **Miscellaneous Water Level Sag**

Distance (ft): **122.3**
Structural Grade: **2**
O&M Grade: **0**
Clock Start/From:
Clock To:
1st Value:
2nd Value:
Value Percent: **15.000**
Continuous Index: **F12**
Within 8" of Joint: **NO**
Remarks:

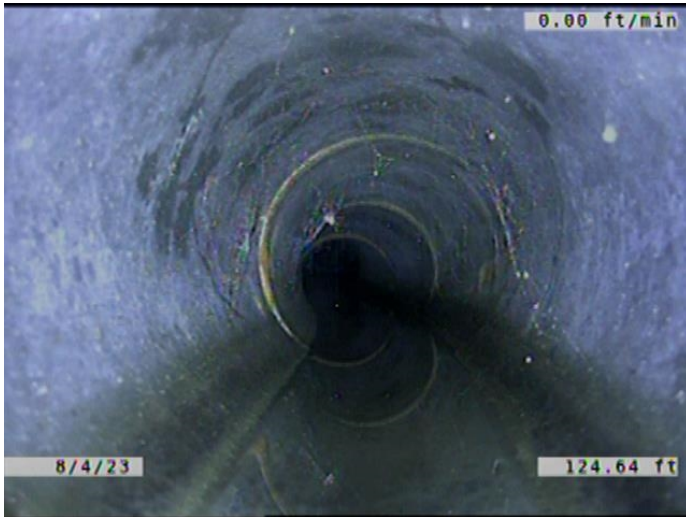
Code: **MWLS**
Description: **Miscellaneous Water Level Sag**

Distance (ft): **124.6**
Structural Grade: **2**
O&M Grade: **0**
Clock Start/From:
Clock To:
1st Value:
2nd Value:
Value Percent: **10.000**
Continuous Index: **S13**
Within 8" of Joint: **NO**
Remarks:

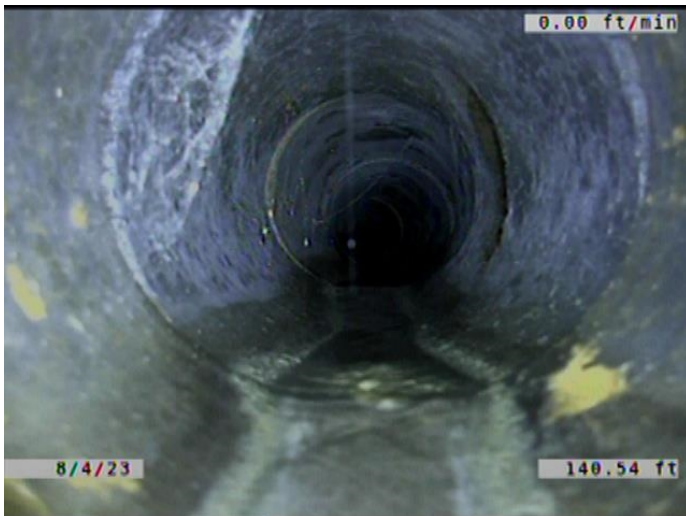
Code: **MWLS**
Description: **Miscellaneous Water Level Sag**

Distance (ft): **140.5**
Structural Grade: **2**
O&M Grade: **0**
Clock Start/From:
Clock To:
1st Value:
2nd Value:
Value Percent: **10.000**
Continuous Index: **F13**
Within 8" of Joint: **NO**
Remarks:

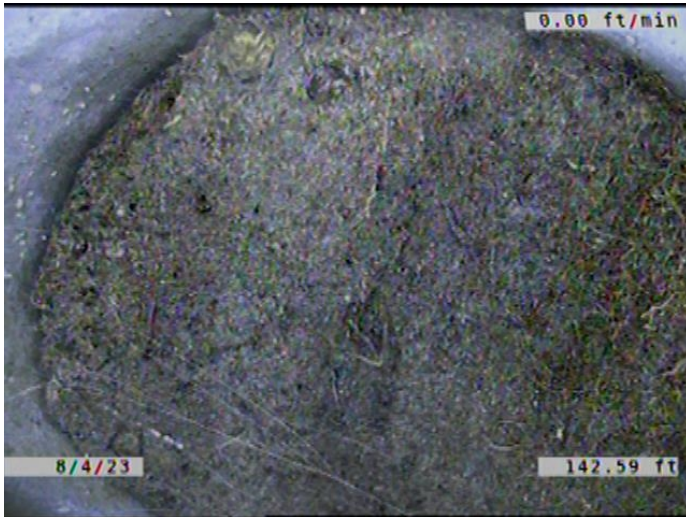
Code: **TFD**
Description: **Tap Factory Defective**

Distance (ft): **142.6**
Structural Grade: **0**
O&M Grade: **3**
Clock Start/From: **2**
Clock To:
1st Value: **6.000**
2nd Value:
Value Percent:
Continuous Index:
Within 8" of Joint: **YES**
Remarks: **100% PLUGGED WITH ROOTS.**

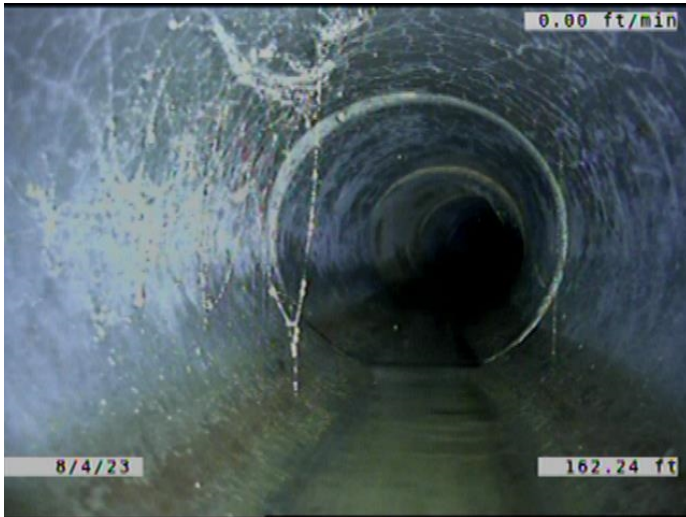
Code:	LL
Description:	Line Left
Distance (ft):	160.0
Structural Grade:	0
O&M Grade:	1
Clock Start/From:	
Clock To:	
1st Value:	
2nd Value:	
Value Percent:	10.000
Continuous Index:	
Within 8" of Joint:	NO
Remarks:

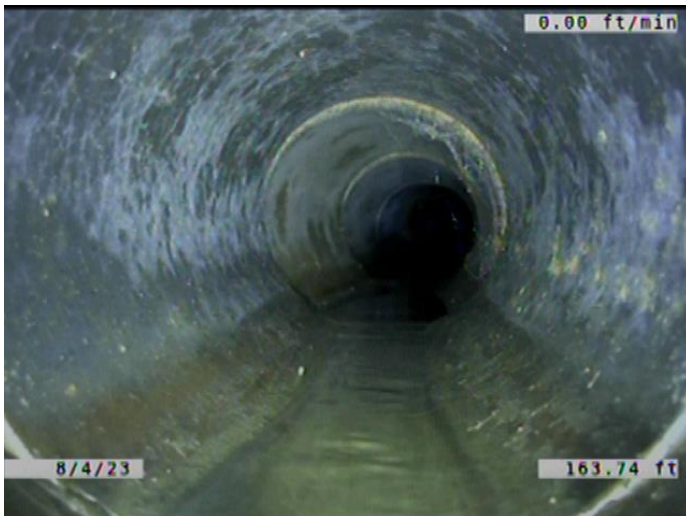
Code: **MWLS**
Description: **Miscellaneous Water Level Sag**

Distance (ft): **162.2**
Structural Grade: **2**
O&M Grade: **0**
Clock Start/From:
Clock To:
1st Value:
2nd Value:
Value Percent: **10.000**
Continuous Index: **F14**
Within 8" of Joint: **NO**
Remarks:

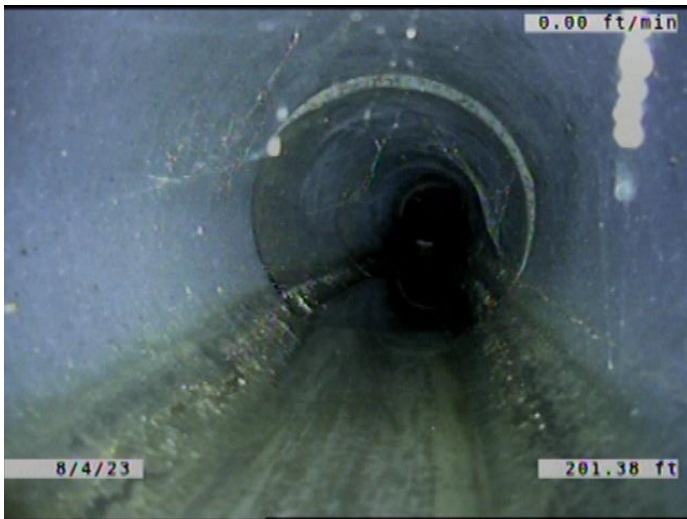
Code: **RFJ**
Description: **Roots Fine Joint**

Distance (ft): **199.7**
Structural Grade: **0**
O&M Grade: **1**
Clock Start/From: **7**
Clock To: **5**
1st Value:
2nd Value:
Value Percent:
Continuous Index: **S17**
Within 8" of Joint: **YES**
Remarks:

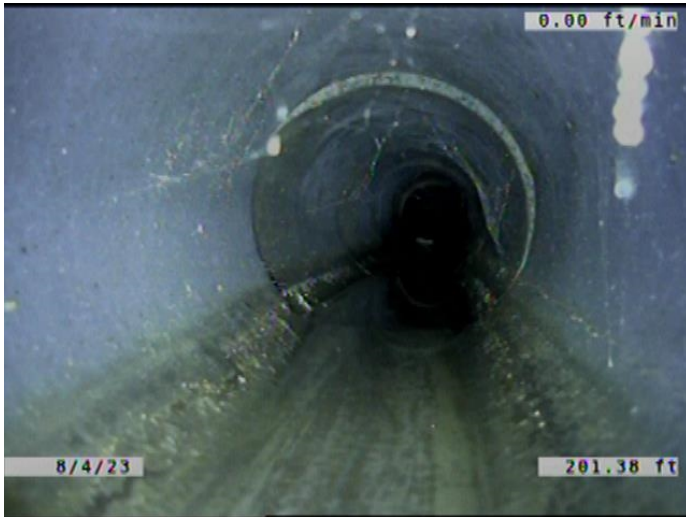
Code: **LR**
Description: **Line Right**

Distance (ft): **201.4**
Structural Grade: **0**
O&M Grade: **1**
Clock Start/From:
Clock To:
1st Value:
2nd Value:
Value Percent: **5.000**
Continuous Index:
Within 8" of Joint: **NO**
Remarks:

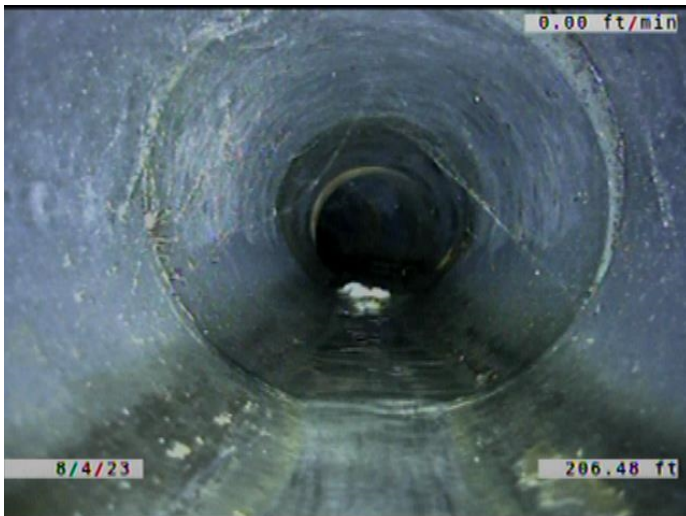
Code: **MWLS**
Description: **Miscellaneous Water Level Sag**

Distance (ft): **201.4**
Structural Grade: **2**
O&M Grade: **0**
Clock Start/From:
Clock To:
1st Value:
2nd Value:
Value Percent: **10.000**
Continuous Index: **S18**
Within 8" of Joint: **NO**
Remarks:

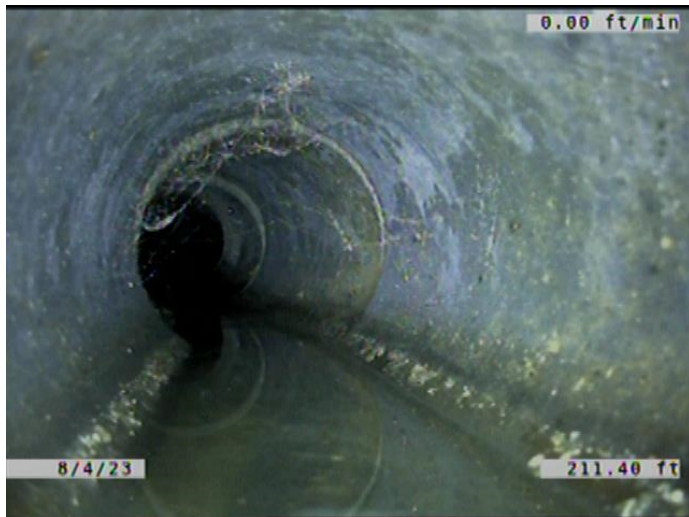
Code: **MWLS**
Description: **Miscellaneous Water Level Sag**

Distance (ft): **206.5**
Structural Grade: **2**
O&M Grade: **0**
Clock Start/From:
Clock To:
1st Value:
2nd Value:
Value Percent: **10.000**
Continuous Index: **F18**
Within 8" of Joint: **NO**
Remarks:

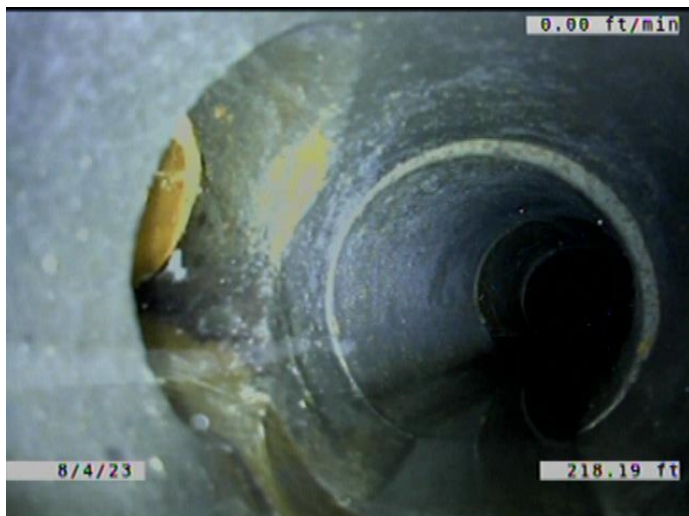
Code: **LL**
Description: **Line Left**

Distance (ft): **211.4**
Structural Grade: **0**
O&M Grade: **4**
Clock Start/From:
Clock To:
1st Value:
2nd Value:
Value Percent: **25.000**
Continuous Index:
Within 8" of Joint: **NO**
Remarks:

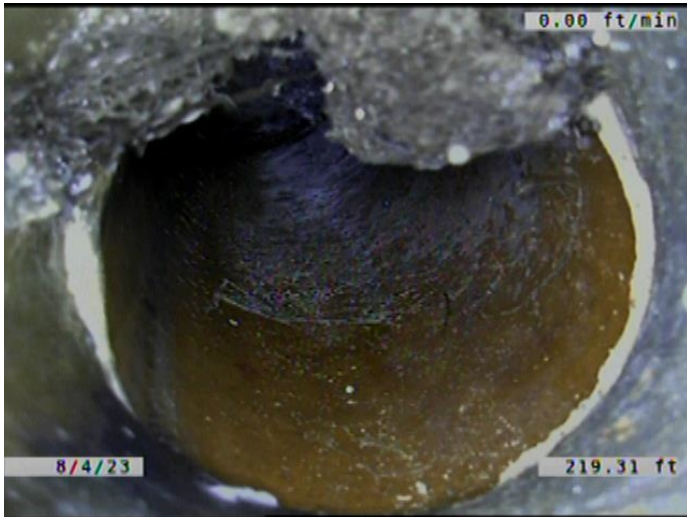
Code: **LR**
Description: **Line Right**

Distance (ft): **218.2**
Structural Grade: **0**
O&M Grade: **2**
Clock Start/From:
Clock To:
1st Value:
2nd Value:
Value Percent: **15.000**
Continuous Index:
Within 8" of Joint: **NO**
Remarks:

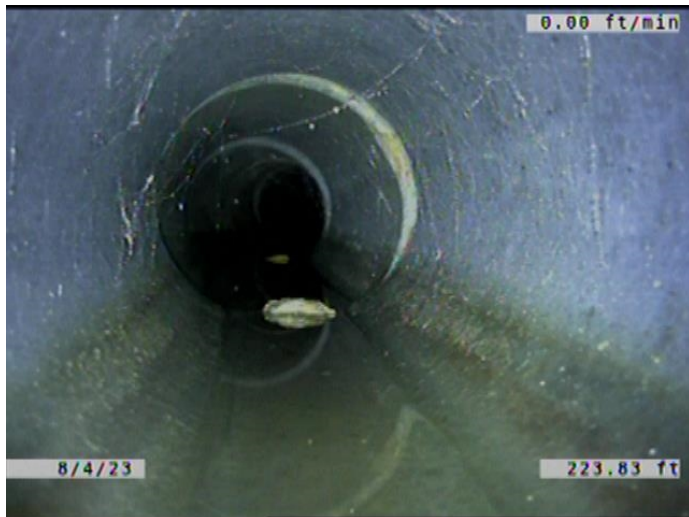
Code:	LL
Description:	Line Left
Distance (ft):	222.1
Structural Grade:	0
O&M Grade:	1
Clock Start/From:	
Clock To:	
1st Value:	
2nd Value:	
Value Percent:	10.000
Continuous Index:	S19
Within 8" of Joint:	NO
Remarks:

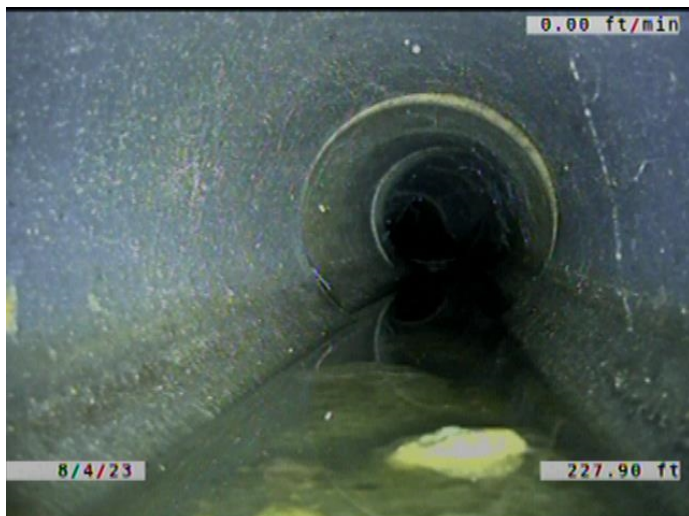
Code: **MWLS**
Description: **Miscellaneous Water Level Sag**

Distance (ft): **223.8**
Structural Grade: **2**
O&M Grade: **0**
Clock Start/From:
Clock To:
1st Value:
2nd Value:
Value Percent: **10.000**
Continuous Index: **S20**
Within 8" of Joint: **NO**
Remarks:

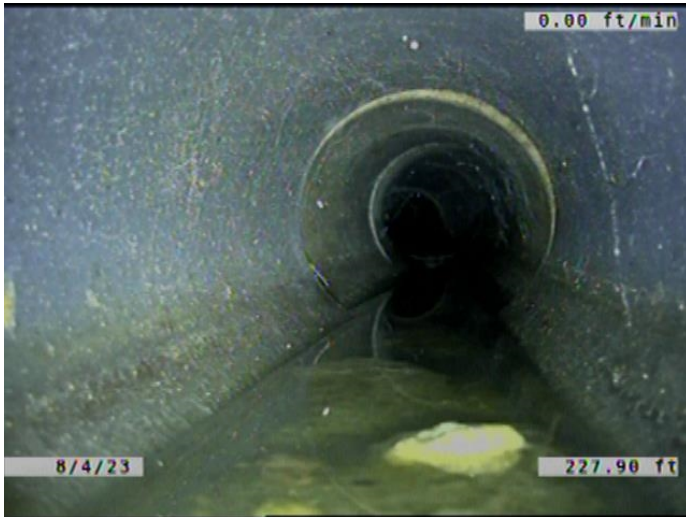
Code: **LL**
Description: **Line Left**

Distance (ft): **227.9**
Structural Grade: **0**
O&M Grade: **1**
Clock Start/From:
Clock To:
1st Value:
2nd Value:
Value Percent: **10.000**
Continuous Index: **F19**
Within 8" of Joint: **NO**
Remarks:

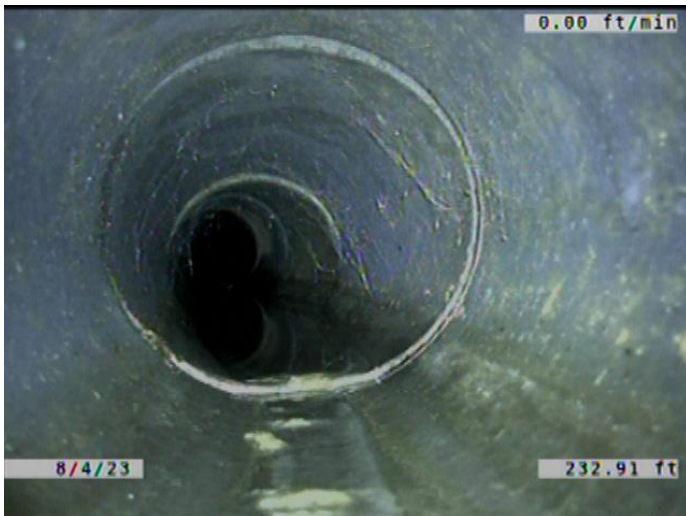
Code: **LR**
Description: **Line Right**

Distance (ft): **227.9**
Structural Grade: **0**
O&M Grade: **1**
Clock Start/From:
Clock To:
1st Value:
2nd Value:
Value Percent: **5.000**
Continuous Index:
Within 8" of Joint: **NO**
Remarks:

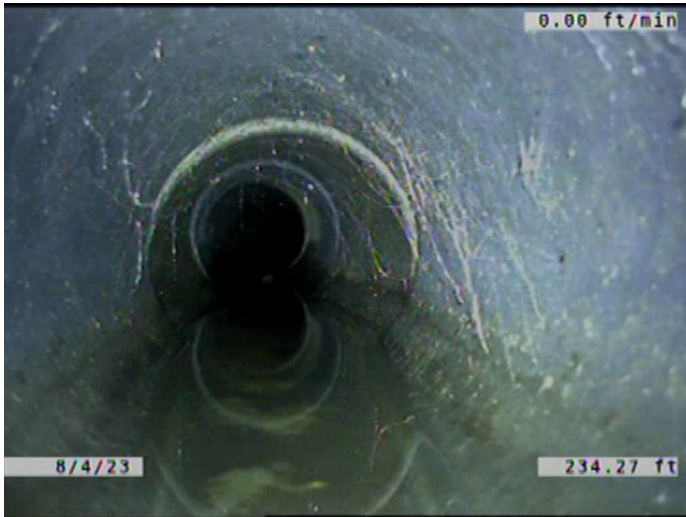
Code: **MWLS**
Description: **Miscellaneous Water Level Sag**

Distance (ft): **232.9**
Structural Grade: **2**
O&M Grade: **0**
Clock Start/From:
Clock To:
1st Value:
2nd Value:
Value Percent: **10.000**
Continuous Index: **F20**
Within 8" of Joint: **NO**
Remarks:

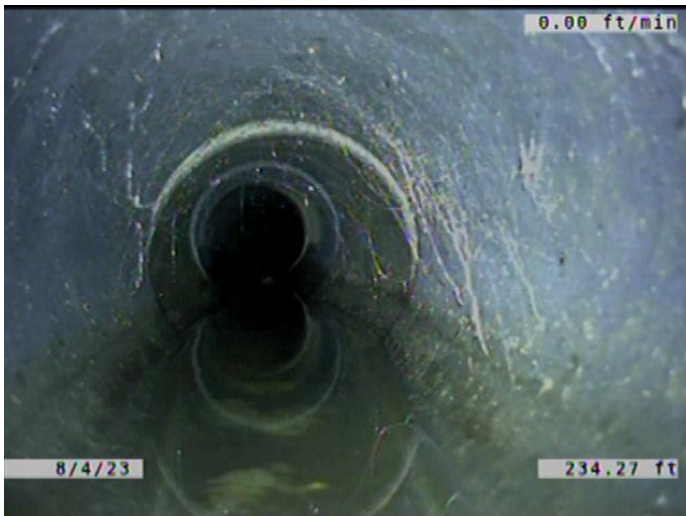
Code: **LL**
Description: **Line Left**

Distance (ft): **234.3**
Structural Grade: **0**
O&M Grade: **1**
Clock Start/From:
Clock To:
1st Value:
2nd Value:
Value Percent: **5.000**
Continuous Index:
Within 8" of Joint: **NO**
Remarks:
