Profile/Photo Observation Report

Street:	East Cleveland Avenue	Flow Control:	Not Controlled
City:	Hobart, IN	Year Renewed:	
Location:	Local rural streets with light traffic, t	Tape/Media #:	
Purpose:	Routine Assessment	Dia/Height:	8"
Use:	Sanitary Sewage Pipe	Material:	VCP
Drain Area:		Lining:	None
Category:	NA		
Comment:			
Location Details:		Direction of Survey:	Upstream
US MH:	M-804-010	DS MH:	M-804-011
		Total Length Surveyed (ft):	305.4

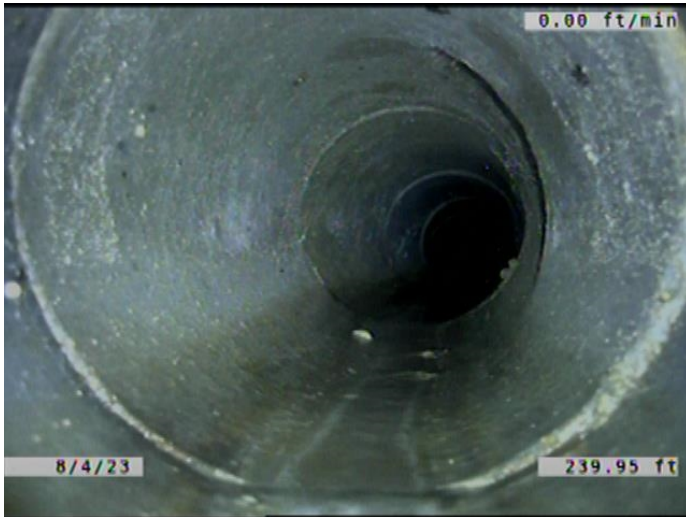
Code: **MWLS**
Description: **Miscellaneous Water Level Sag**

Distance (ft): **234.3**
Structural Grade: **2**
O&M Grade: **0**
Clock Start/From:
Clock To:
1st Value:
2nd Value:
Value Percent: **10.000**
Continuous Index: **S21**
Within 8" of Joint: **NO**
Remarks:

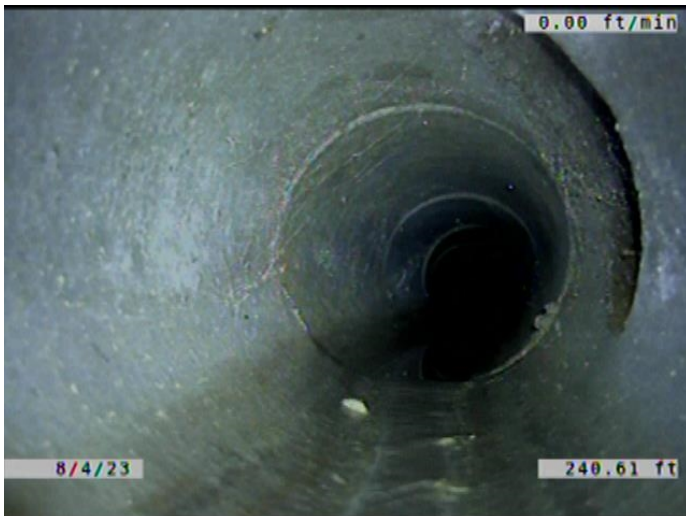
Code: **MWLS**
Description: **Miscellaneous Water Level Sag**

Distance (ft): **239.9**
Structural Grade: **2**
O&M Grade: **0**
Clock Start/From:
Clock To:
1st Value:
2nd Value:
Value Percent: **10.000**
Continuous Index: **F21**
Within 8" of Joint: **NO**
Remarks:

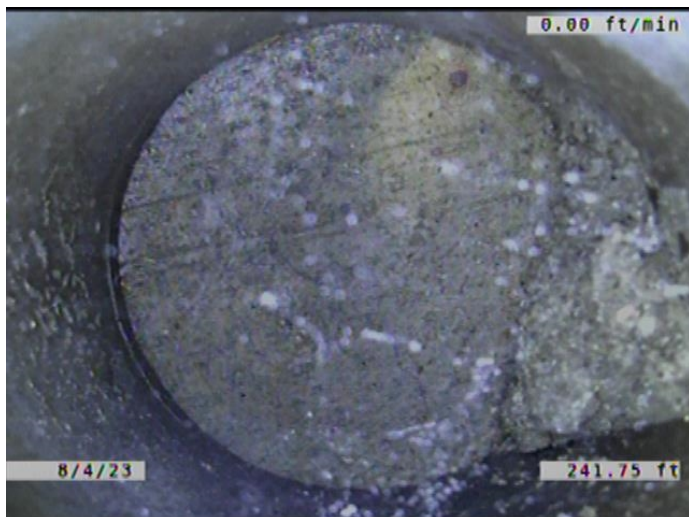
Code: **LR**
Description: **Line Right**

Distance (ft): **240.6**
Structural Grade: **0**
O&M Grade: **1**
Clock Start/From:
Clock To:
1st Value:
2nd Value:
Value Percent: **5.000**
Continuous Index:
Within 8" of Joint: **NO**
Remarks:

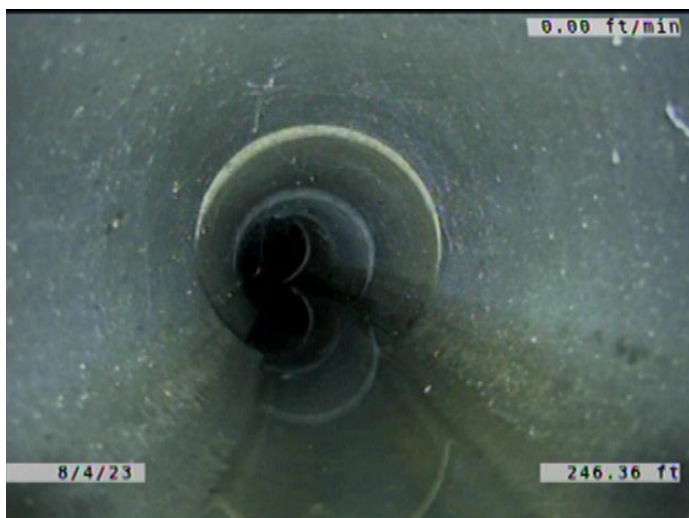
Code: **TFC**
 Description: **Tap Factory Capped**

Distance (ft): **241.7**
 Structural Grade: **0**
 O&M Grade: **0**
 Clock Start/From: **2**
 Clock To:
 1st Value: **6.000**
 2nd Value:
 Value Percent:
 Continuous Index:
 Within 8" of Joint: **YES**
 Remarks:

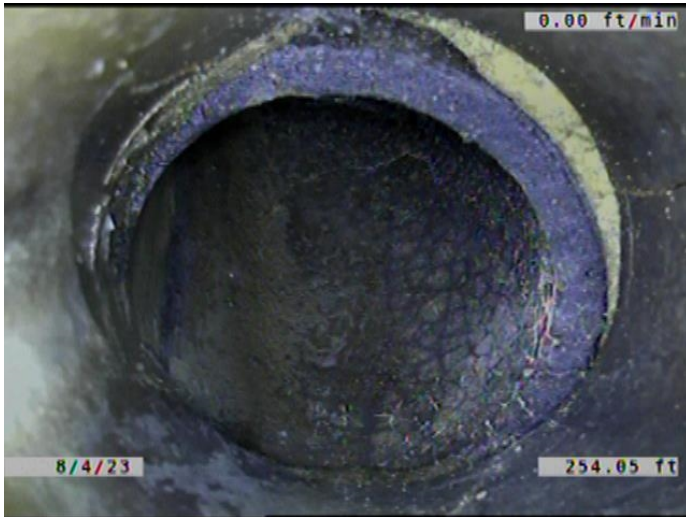
Code: **MWLS**
 Description: **Miscellaneous Water Level Sag**

Distance (ft): **246.4**
 Structural Grade: **2**
 O&M Grade: **0**
 Clock Start/From:
 Clock To:
 1st Value:
 2nd Value:
 Value Percent: **10.000**
 Continuous Index: **S22**
 Within 8" of Joint: **NO**
 Remarks:

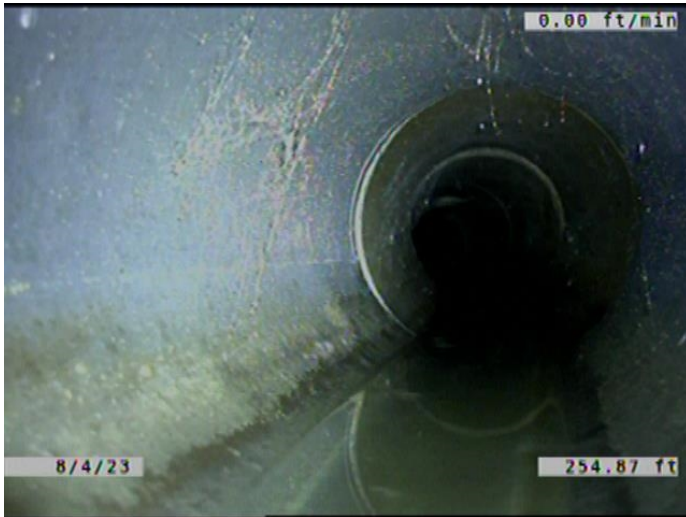
Code:	LR
Description:	Line Right
Distance (ft):	254.9
Structural Grade:	0
O&M Grade:	1
Clock Start/From:	
Clock To:	
1st Value:	
2nd Value:	
Value Percent:	10.000
Continuous Index:	
Within 8" of Joint:	NO
Remarks:

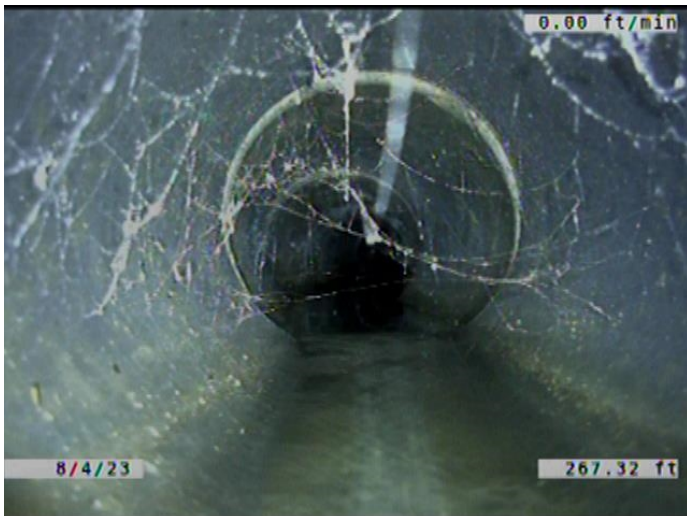
Code: **MWLS**
Description: **Miscellaneous Water Level Sag**

Distance (ft): **267.3**
Structural Grade: **2**
O&M Grade: **0**
Clock Start/From:
Clock To:
1st Value:
2nd Value:
Value Percent: **10.000**
Continuous Index: **F22**
Within 8" of Joint: **NO**
Remarks:

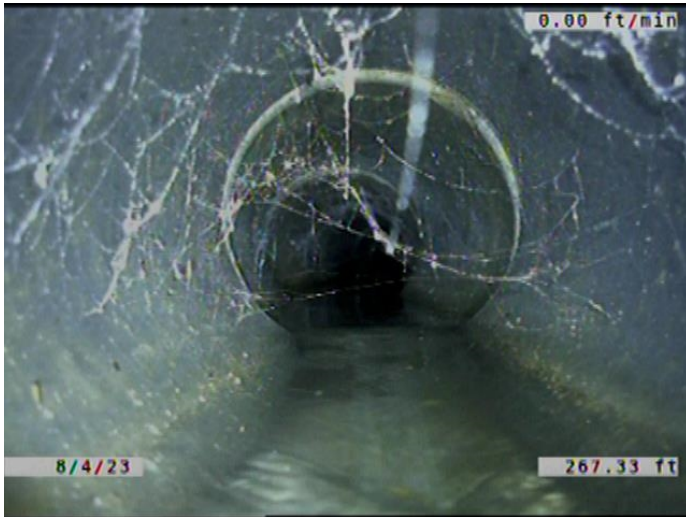
Code: **MWLS**
Description: **Miscellaneous Water Level Sag**

Distance (ft): **267.3**
Structural Grade: **2**
O&M Grade: **0**
Clock Start/From:
Clock To:
1st Value:
2nd Value:
Value Percent: **10.000**
Continuous Index: **F23**
Within 8" of Joint: **NO**
Remarks:

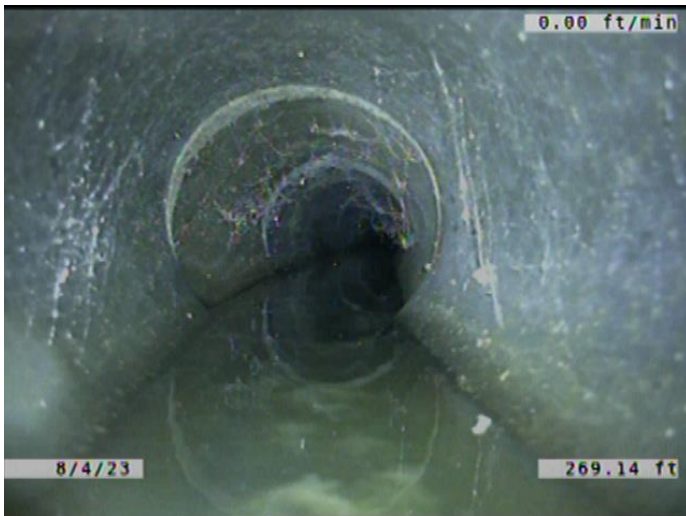
Code: **RFJ**
Description: **Roots Fine Joint**

Distance (ft): **267.3**
Structural Grade: **0**
O&M Grade: **1**
Clock Start/From: **7**
Clock To: **5**
1st Value:
2nd Value:
Value Percent:
Continuous Index: **F17**
Within 8" of Joint: **YES**
Remarks:

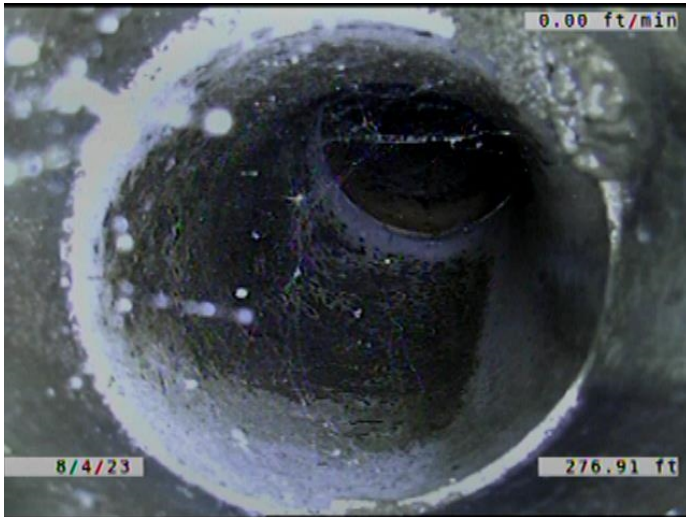
Code: **MWLS**
Description: **Miscellaneous Water Level Sag**

Distance (ft): **269.1**
Structural Grade: **2**
O&M Grade: **0**
Clock Start/From:
Clock To:
1st Value:
2nd Value:
Value Percent: **15.000**
Continuous Index: **S24**
Within 8" of Joint: **NO**
Remarks:

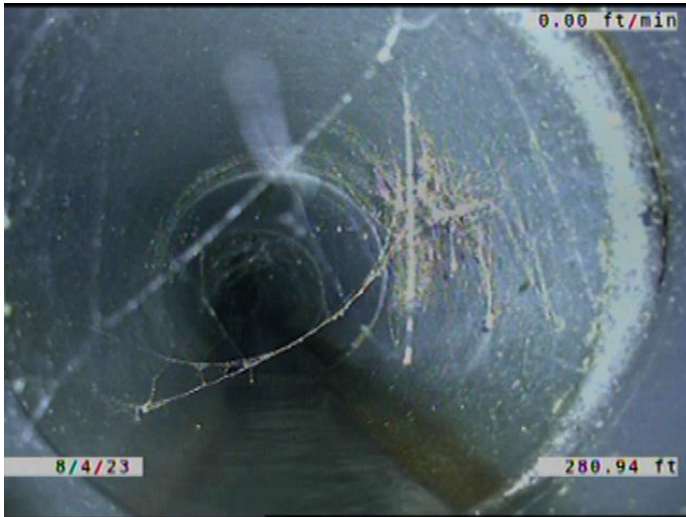
Code: **LL**
Description: **Line Left**

Distance (ft): **280.9**
Structural Grade: **0**
O&M Grade: **1**
Clock Start/From:
Clock To:
1st Value:
2nd Value:
Value Percent: **5.000**
Continuous Index:
Within 8" of Joint: **NO**
Remarks:

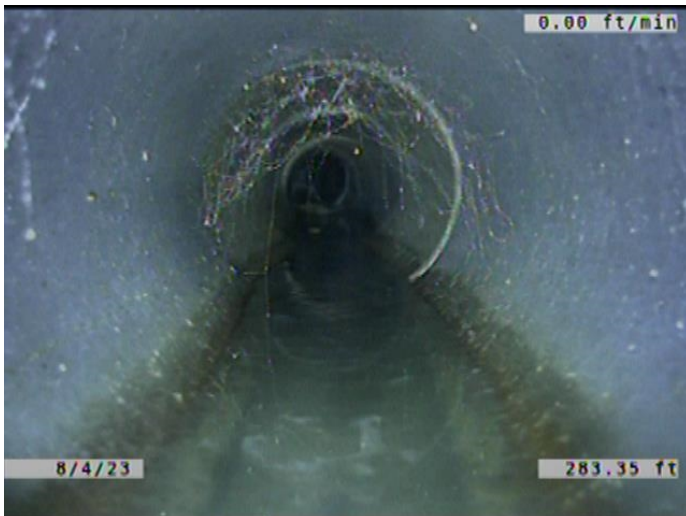
Code: **MWLS**
Description: **Miscellaneous Water Level Sag**

Distance (ft): **280.9**
Structural Grade: **2**
O&M Grade: **0**
Clock Start/From:
Clock To:
1st Value:
2nd Value:
Value Percent: **15.000**
Continuous Index: **F24**
Within 8" of Joint: **NO**
Remarks:

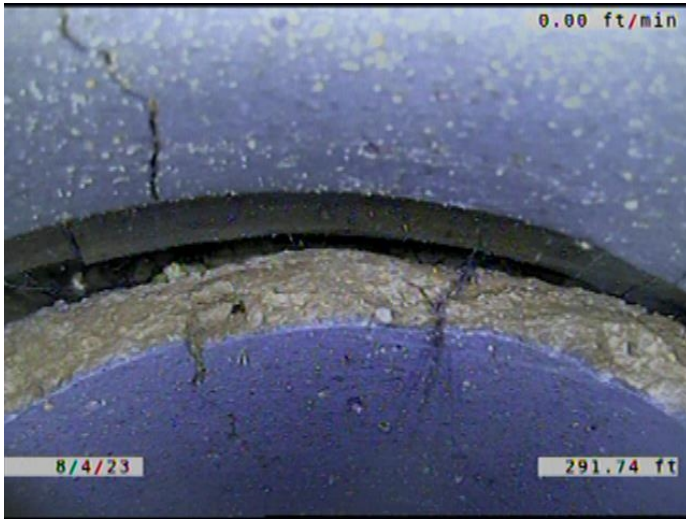
Code: **MWLS**
Description: **Miscellaneous Water Level Sag**

Distance (ft): **283.3**
Structural Grade: **2**
O&M Grade: **0**
Clock Start/From:
Clock To:
1st Value:
2nd Value:
Value Percent: **10.000**
Continuous Index: **S25**
Within 8" of Joint: **NO**
Remarks:

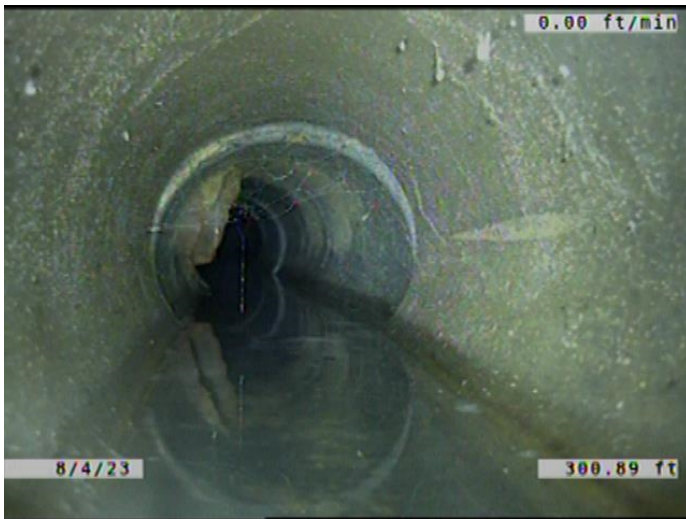
Code: **RFJ**
Description: **Roots Fine Joint**

Distance (ft): **291.7**
Structural Grade: **0**
O&M Grade: **1**
Clock Start/From: **11**
Clock To: **1**
1st Value:
2nd Value:
Value Percent:
Continuous Index:
Within 8" of Joint: **YES**
Remarks:

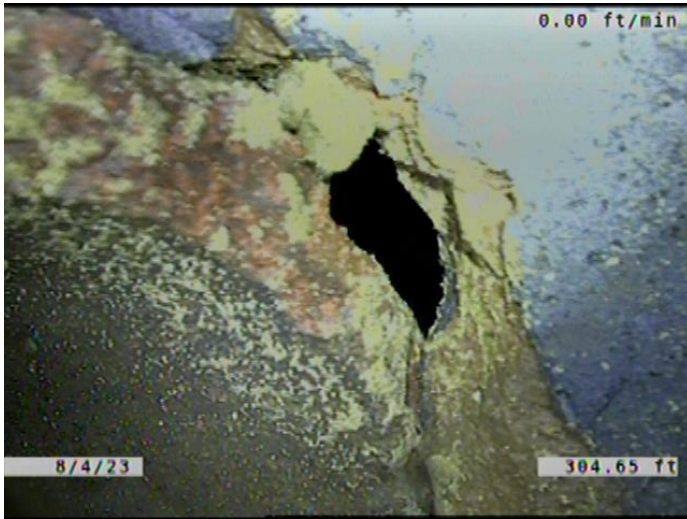
Code: **LL**
Description: **Line Left**

Distance (ft): **300.9**
Structural Grade: **0**
O&M Grade: **1**
Clock Start/From:
Clock To:
1st Value:
2nd Value:
Value Percent: **5.000**
Continuous Index:
Within 8" of Joint: **NO**
Remarks:

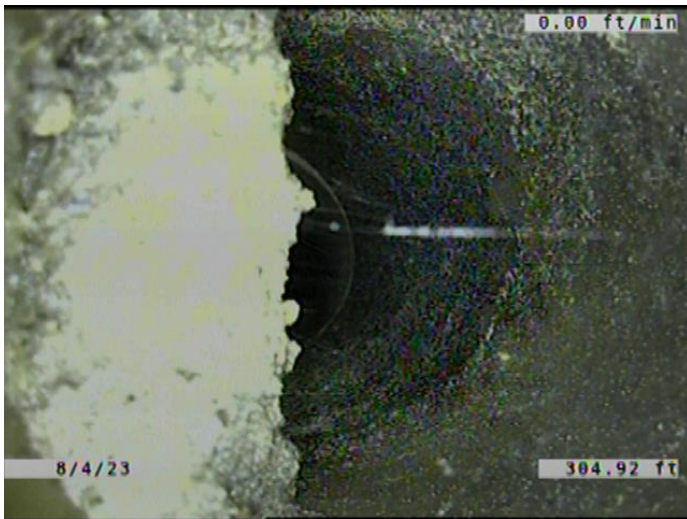
Code: **BVV**
Description: **Broken Void Visible**

Distance (ft): **304.6**
Structural Grade: **5**
O&M Grade: **0**
Clock Start/From: **8**
Clock To: **12**
1st Value:
2nd Value:
Value Percent:
Continuous Index:
Within 8" of Joint: **YES**
Remarks:

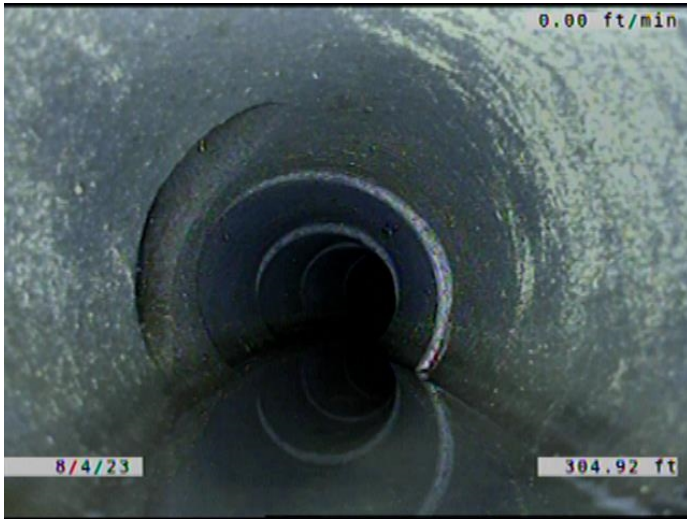
Code: **TBI**
Description: **Tap Break-in Intruding**

Distance (ft): **304.9**
Structural Grade: **0**
O&M Grade: **2**
Clock Start/From: **10**
Clock To:
1st Value: **6.000**
2nd Value: **3.000**
Value Percent:
Continuous Index:
Within 8" of Joint: **YES**
Remarks:

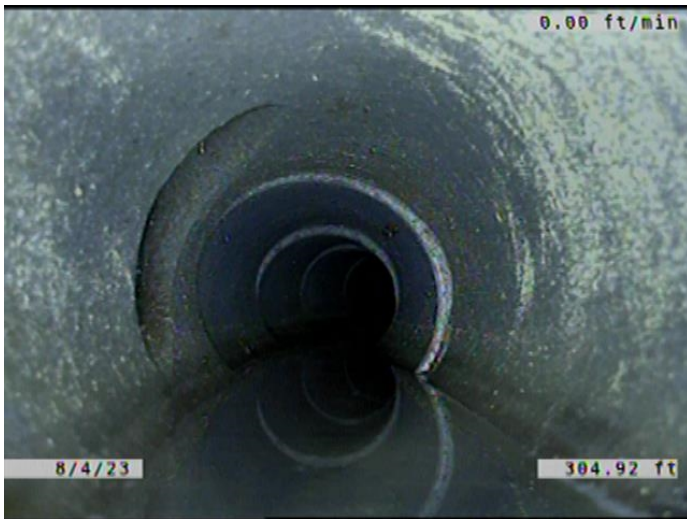
Code: **JOMD**
Description: **Joint Offset Medium Defective**

Distance (ft): **304.9**
Structural Grade: **3**
O&M Grade: **0**
Clock Start/From:
Clock To:
1st Value:
2nd Value:
Value Percent:
Continuous Index: **F02**
Within 8" of Joint: **NO**
Remarks: **VOID AND SOIL VISIBLE.**

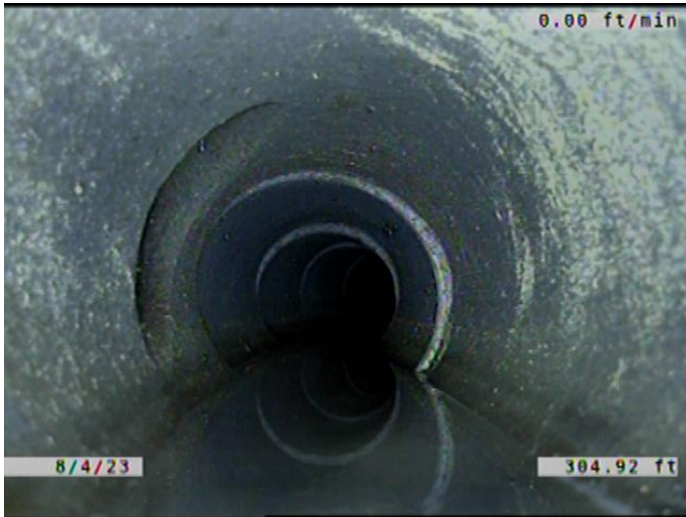
Code: **B**
Description: **Broken**

Distance (ft): **304.9**
Structural Grade: **4**
O&M Grade: **0**
Clock Start/From: **7**
Clock To: **5**
1st Value:
2nd Value:
Value Percent:
Continuous Index: **F04**
Within 8" of Joint: **YES**
Remarks: **At joints**

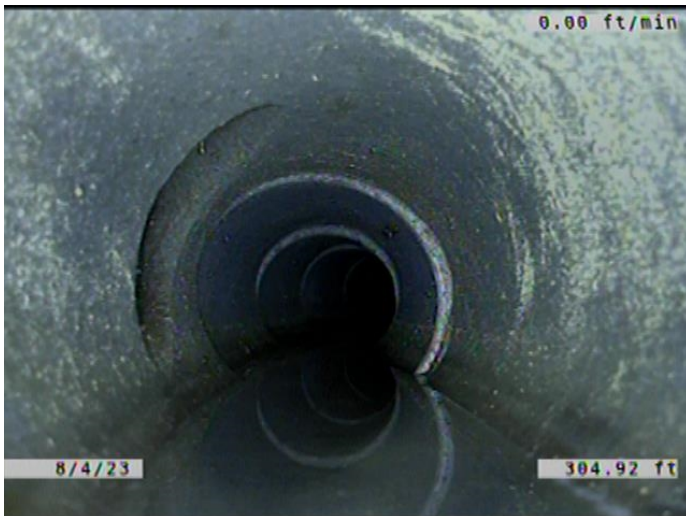
Code: **DSF**
Description: **Deposits Settled Fine**

Distance (ft): **304.9**
Structural Grade: **0**
O&M Grade: **2**
Clock Start/From: **5**
Clock To: **7**
1st Value:
2nd Value:
Value Percent: **5.000**
Continuous Index: **F16**
Within 8" of Joint: **YES**
Remarks:

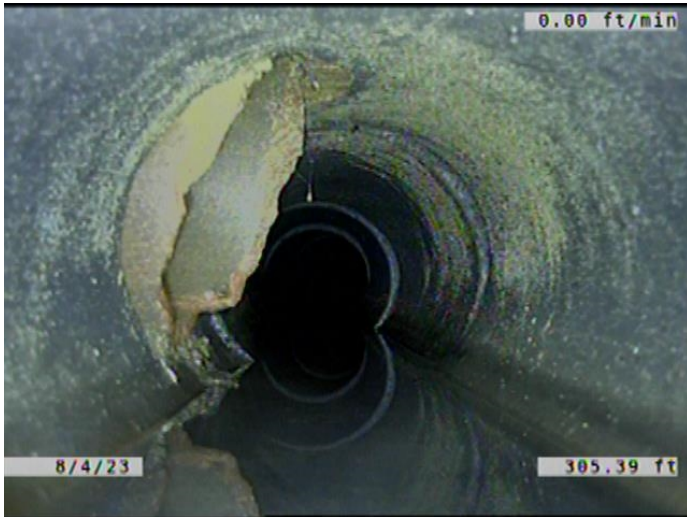
Code: **MWLS**
Description: **Miscellaneous Water Level Sag**

Distance (ft): **304.9**
Structural Grade: **2**
O&M Grade: **0**
Clock Start/From:
Clock To:
1st Value:
2nd Value:
Value Percent: **10.000**
Continuous Index: **F25**
Within 8" of Joint: **NO**
Remarks:
