Profile/Photo Observation Report

Date:	10/18/2021	Weather:		Coding:	PACP 7.0
Pipe Length (ft):	363.8	Owner:	City of Hobart	Pre Clean:	Heavy Cleaning
P.O.#:	YES502259	Surveyor:	S. Bucklin	PSR:	P-804-024-013
Customer:	City of Hobart	Clean Date:	10/16/2021	Shape:	C

Street:	North Kelly Street	Flow Control:	Not Controlled
City:	Hobart, IN	Year Renewed:	
Location:	Local rural streets with light traffic, t	Tape/Media #:	
Purpose:	Routine Assessment	Dia/Height:	12"
Use:	Sanitary Sewage Pipe	Material:	VCP
Drain Area:		Lining:	
Category:	NA		
Comment:			
Location Details:		Direction of Survey:	Downstream
US MH:	M-804-013	DS MH:	M-804-024
		Total Length Surveyed (ft):	363.8

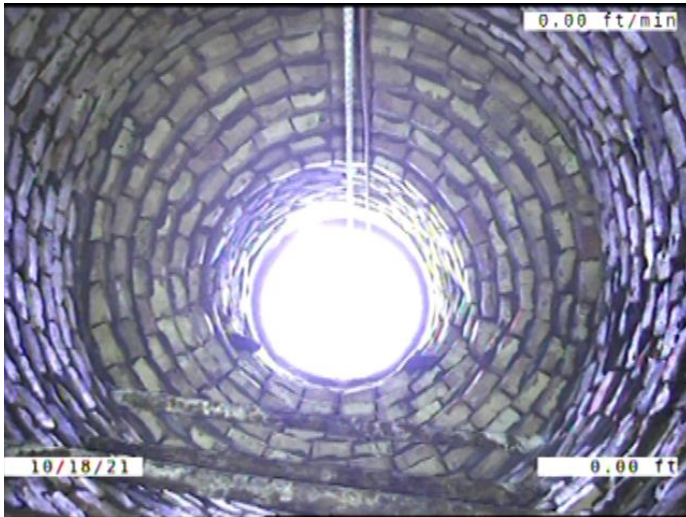
Code: **AMH**
Description: **Manhole**

Distance (ft): **.0**
Structural Grade: **0**
O&M Grade: **0**
Clock Start/From:
Clock To:
1st Value:
2nd Value:
Value Percent:
Continuous Index:
Within 8" of Joint: **NO**
Remarks: **M-804-013**

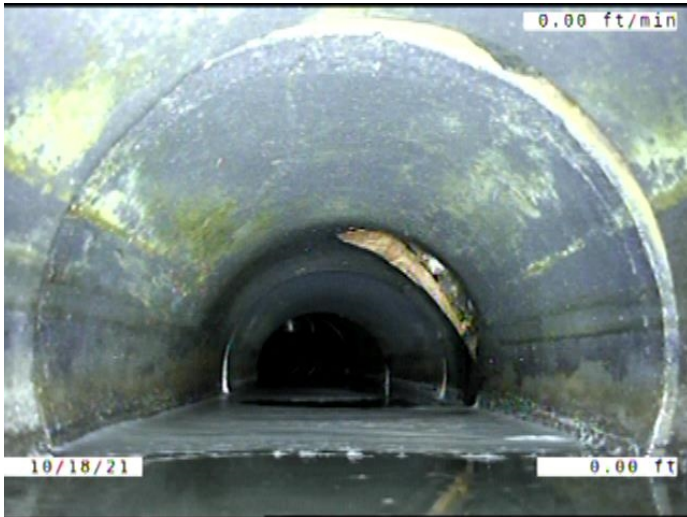
Code: **MWL**
 Description: **Miscellaneous Water Level**

Distance (ft): **.0**
 Structural Grade: **0**
 O&M Grade: **0**
 Clock Start/From:
 Clock To:
 1st Value:
 2nd Value:
 Value Percent: **15.000**
 Continuous Index:
 Within 8" of Joint: **NO**
 Remarks:

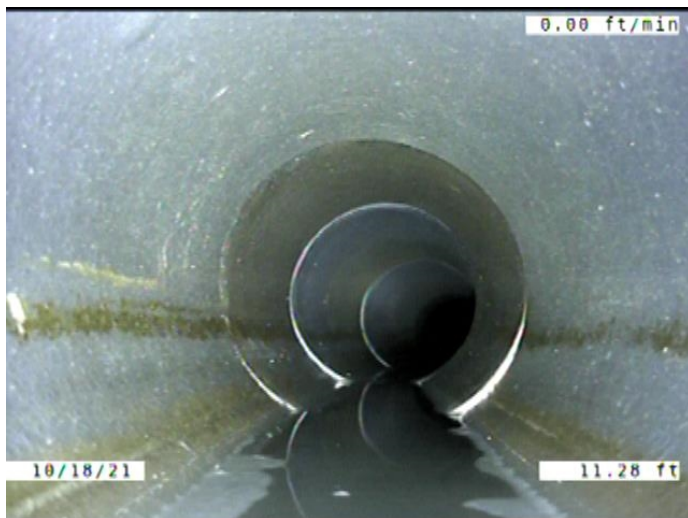
Code: **MWL**
 Description: **Miscellaneous Water Level**

Distance (ft): **11.3**
 Structural Grade: **0**
 O&M Grade: **0**
 Clock Start/From:
 Clock To:
 1st Value:
 2nd Value:
 Value Percent: **5.000**
 Continuous Index:
 Within 8" of Joint: **NO**
 Remarks:

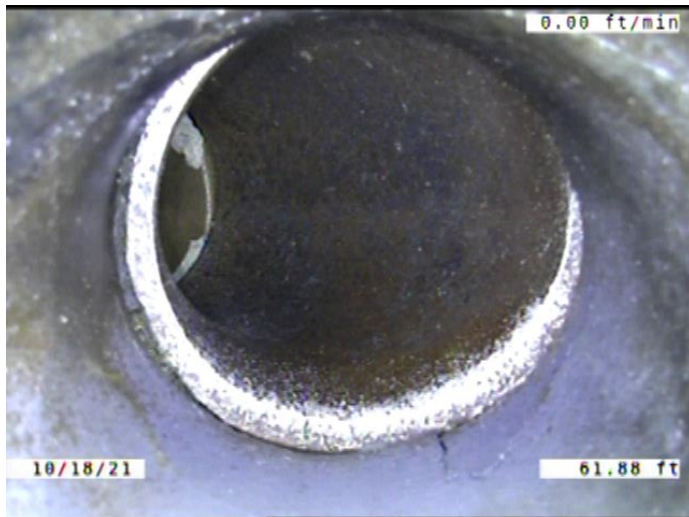
Code: **TF**
 Description: **Tap Factory**

Distance (ft): **61.9**
 Structural Grade: **0**
 O&M Grade: **0**
 Clock Start/From: **11**
 Clock To:
 1st Value: **4.000**
 2nd Value:
 Value Percent:
 Continuous Index:
 Within 8" of Joint: **YES**
 Remarks:

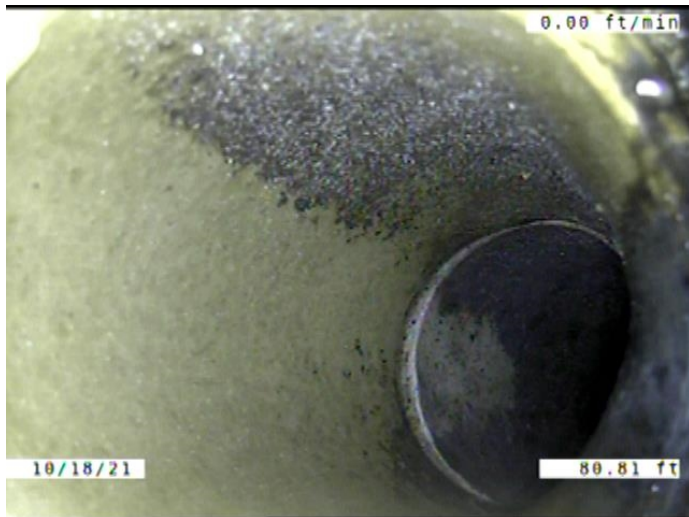
Code: **TB**
 Description: **Tap Break-in/Hammer**

Distance (ft): **80.8**
 Structural Grade: **0**
 O&M Grade: **0**
 Clock Start/From: **1**
 Clock To:
 1st Value: **4.000**
 2nd Value:
 Value Percent:
 Continuous Index:
 Within 8" of Joint: **YES**
 Remarks:

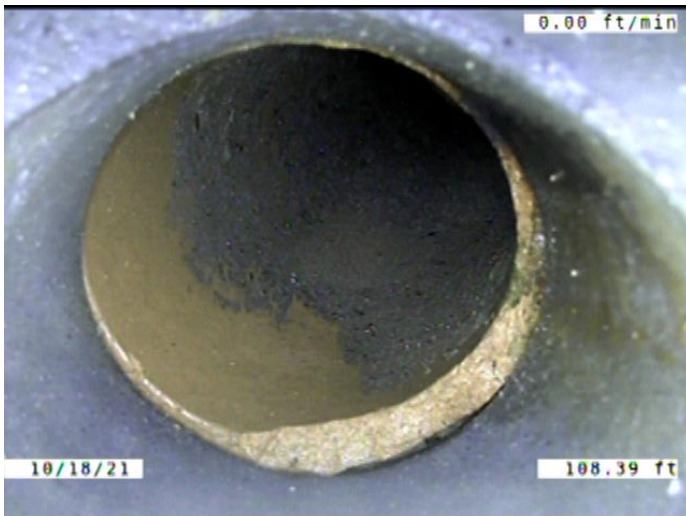
Code: **TF**
Description: **Tap Factory**

Distance (ft): **108.4**
Structural Grade: **0**
O&M Grade: **0**
Clock Start/From: **1**
Clock To:
1st Value: **4.000**
2nd Value:
Value Percent:
Continuous Index:
Within 8" of Joint: **YES**
Remarks:

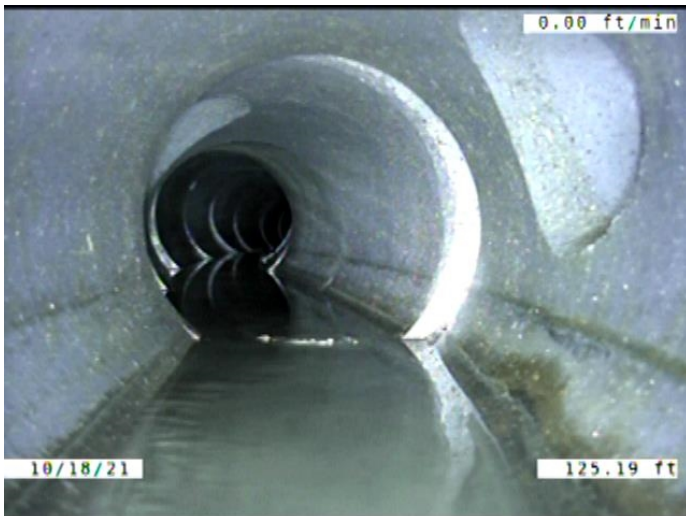
Code: **MWLS**
 Description: **Miscellaneous Water Level Sag**

Distance (ft): **125.2**
 Structural Grade: **2**
 O&M Grade: **0**
 Clock Start/From:
 Clock To:
 1st Value:
 2nd Value:
 Value Percent: **10.000**
 Continuous Index: **S04**
 Within 8" of Joint: **NO**
 Remarks:

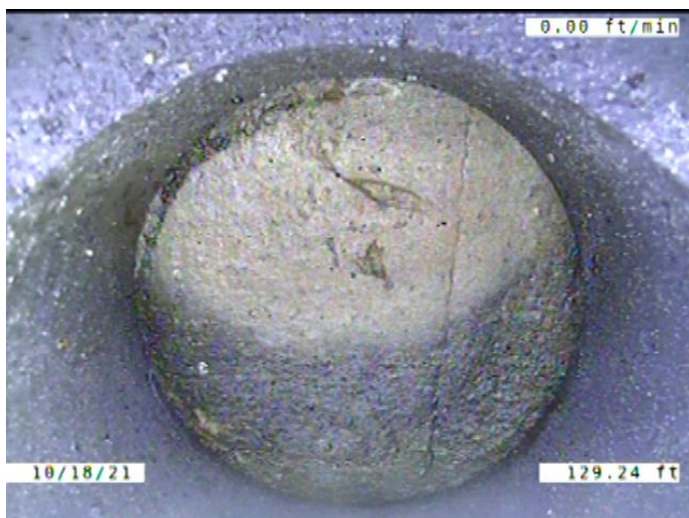
Code: **TFC**
 Description: **Tap Factory Capped**

Distance (ft): **129.2**
 Structural Grade: **0**
 O&M Grade: **0**
 Clock Start/From: **11**
 Clock To:
 1st Value: **4.000**
 2nd Value:
 Value Percent:
 Continuous Index:
 Within 8" of Joint: **YES**
 Remarks:

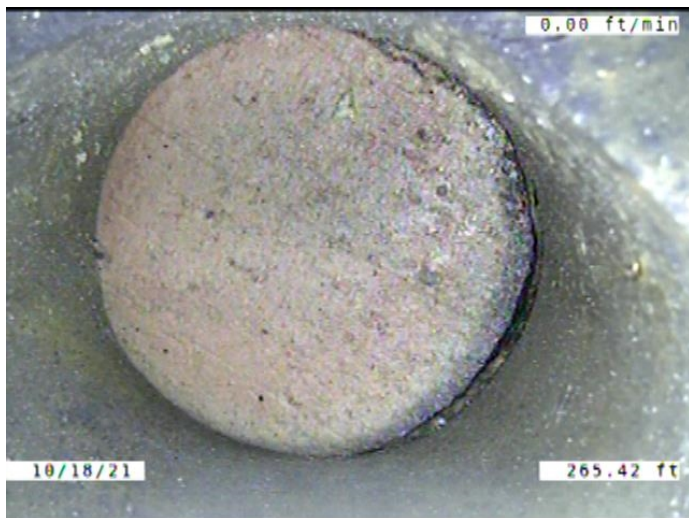
Code: **TFC**
 Description: **Tap Factory Capped**

Distance (ft): **265.4**
 Structural Grade: **0**
 O&M Grade: **0**
 Clock Start/From: **1**
 Clock To:
 1st Value: **4.000**
 2nd Value:
 Value Percent:
 Continuous Index:
 Within 8" of Joint: **YES**
 Remarks:

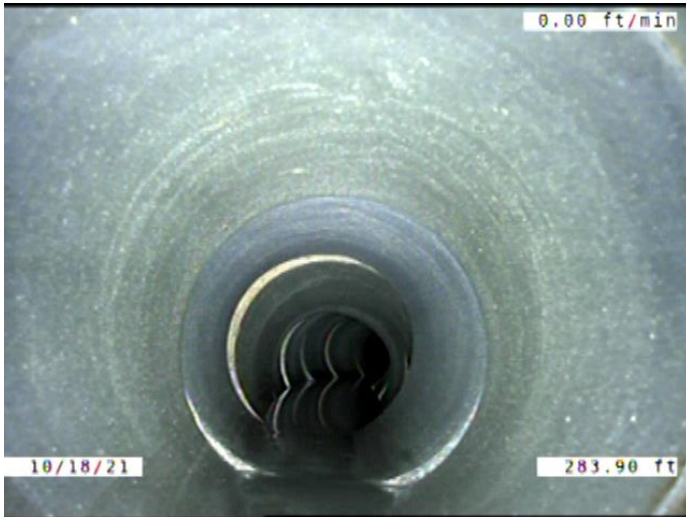
Code: **MWLS**
Description: **Miscellaneous Water Level Sag**

Distance (ft): **283.9**
Structural Grade: **2**
O&M Grade: **0**
Clock Start/From:
Clock To:
1st Value:
2nd Value:
Value Percent: **10.000**
Continuous Index: **F09**
Within 8" of Joint: **NO**
Remarks:

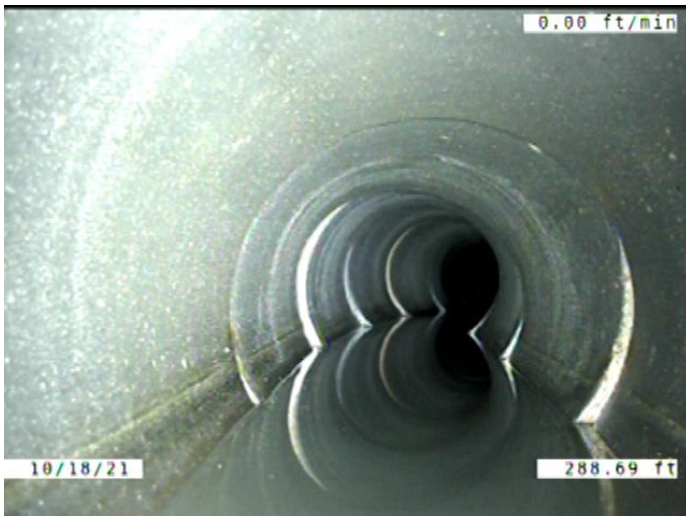
Code: **MWLS**
Description: **Miscellaneous Water Level Sag**

Distance (ft): **288.7**
Structural Grade: **2**
O&M Grade: **0**
Clock Start/From:
Clock To:
1st Value:
2nd Value:
Value Percent: **10.000**
Continuous Index: **S10**
Within 8" of Joint: **NO**
Remarks:

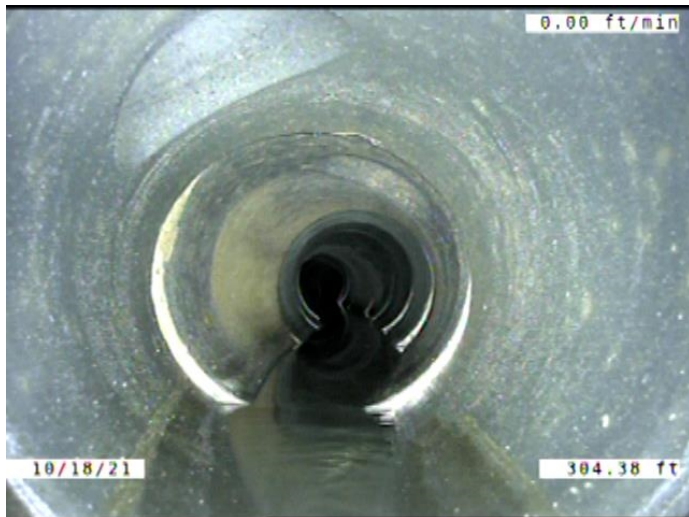
Code: **MWLS**
 Description: **Miscellaneous Water Level Sag**

Distance (ft): **304.4**
 Structural Grade: **2**
 O&M Grade: **0**
 Clock Start/From:
 Clock To:
 1st Value:
 2nd Value:
 Value Percent: **10.000**
 Continuous Index: **F10**
 Within 8" of Joint: **NO**
 Remarks:

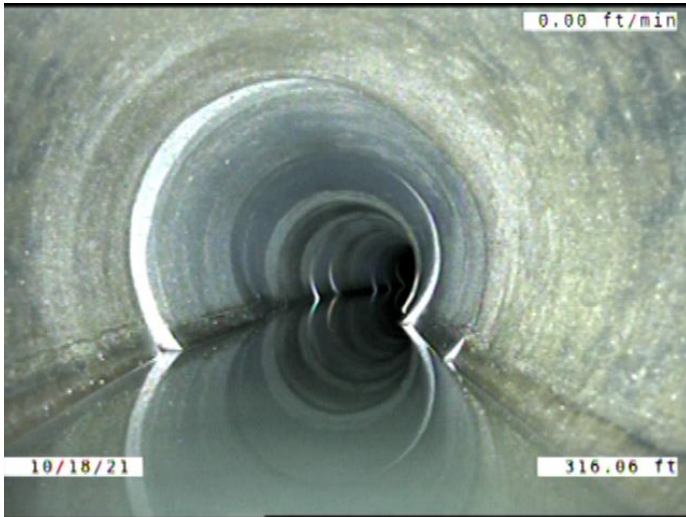
Code: **MWLS**
 Description: **Miscellaneous Water Level Sag**

Distance (ft): **316.1**
 Structural Grade: **2**
 O&M Grade: **0**
 Clock Start/From:
 Clock To:
 1st Value:
 2nd Value:
 Value Percent: **10.000**
 Continuous Index: **S11**
 Within 8" of Joint: **NO**
 Remarks:

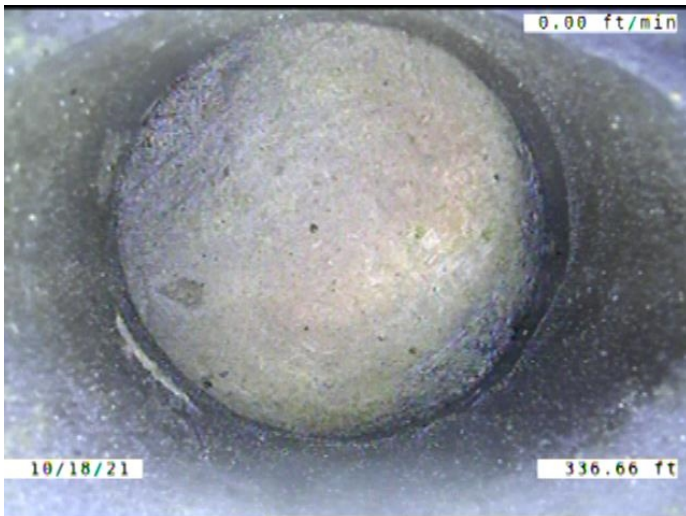
Code: **TFC**
 Description: **Tap Factory Capped**

Distance (ft): **336.7**
 Structural Grade: **0**
 O&M Grade: **0**
 Clock Start/From: **11**
 Clock To:
 1st Value: **4.000**
 2nd Value:
 Value Percent:
 Continuous Index:
 Within 8" of Joint: **YES**
 Remarks:

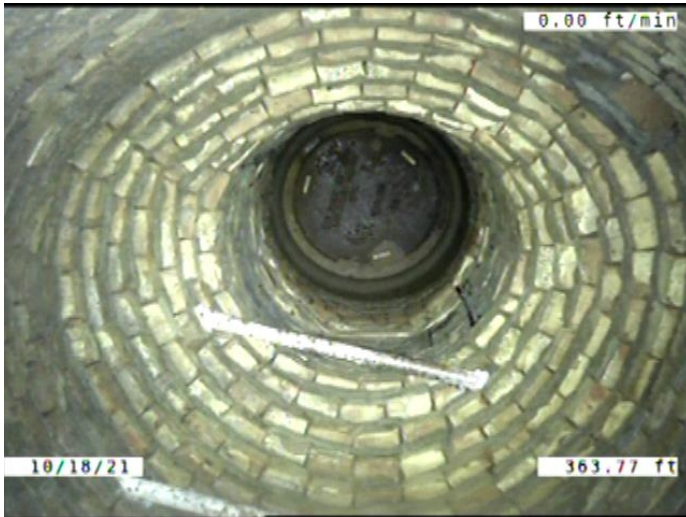
Code:	AMH
Description:	Manhole
Distance (ft):	363.8
Structural Grade:	0
O&M Grade:	0
Clock Start/From:	
Clock To:	
1st Value:	
2nd Value:	
Value Percent:	
Continuous Index:	
Within 8" of Joint:	NO
Remarks:	M-804-024
