Profile/Photo Observation Report

| Pipe Length (ft): | 363.8 | Owner: | City of Hobart | Pre Clean: | Heavy Cleaning |

| Street: | North Kelly Street | Flow Control: | Not Controlled |
| US MH: | M-804-013 | DS MH: | M-804-024 |

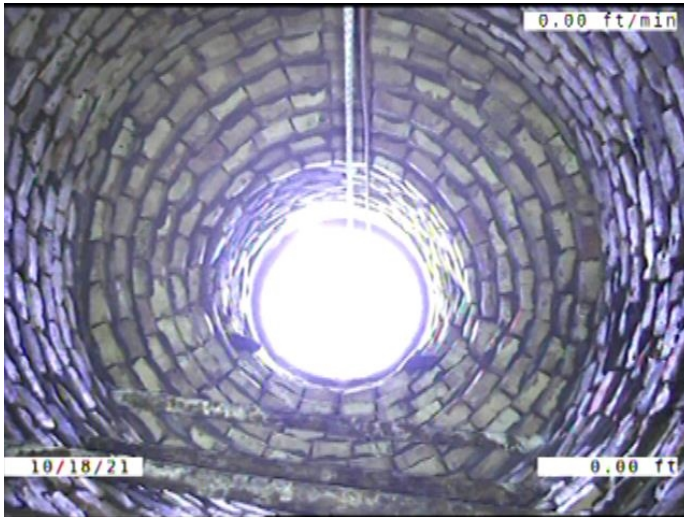
Code: **AMH**
Description: **Manhole**

Distance (ft): **.0**
Structural Grade: **0**
O&M Grade: **0**
Clock Start/From:
Clock To:
1st Value:
2nd Value:
Value Percent:
Continuous Index:
Within 8" of Joint: **NO**
Remarks: **M-804-013**

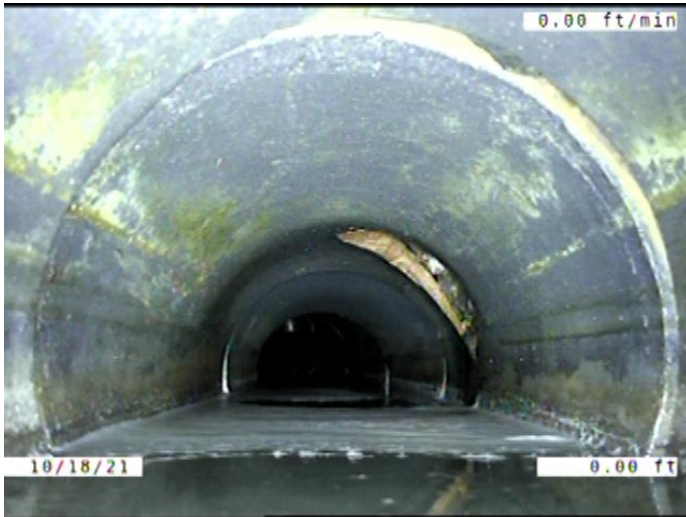
Code: **MWL**
 Description: **Miscellaneous Water Level**

Distance (ft): **.0**
 Structural Grade: **0**
 O&M Grade: **0**
 Clock Start/From:
 Clock To:
 1st Value:
 2nd Value:
 Value Percent: **15.000**
 Continuous Index:
 Within 8" of Joint: **NO**
 Remarks:

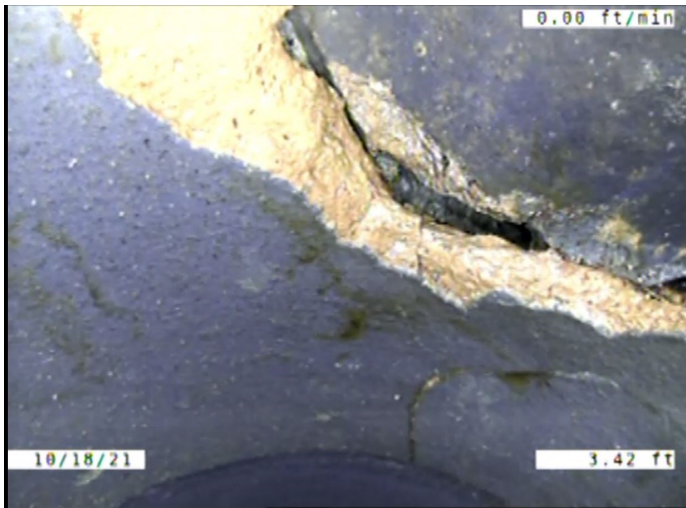
Code: **FC**
 Description: **Fracture Circumferential**

Distance (ft): **3.4**
 Structural Grade: **2**
 O&M Grade: **0**
 Clock Start/From: **2**
 Clock To: **3**
 1st Value:
 2nd Value:
 Value Percent:
 Continuous Index:
 Within 8" of Joint: **YES**
 Remarks:

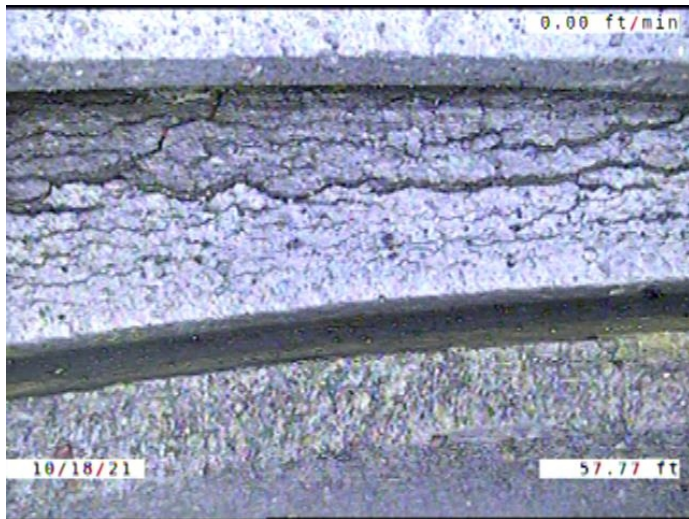
Code: **JAL**
 Description: **Joint Angular Large**

Distance (ft): **57.8**
 Structural Grade: **4**
 O&M Grade: **0**
 Clock Start/From:
 Clock To:
 1st Value:
 2nd Value:
 Value Percent:
 Continuous Index:
 Within 8" of Joint: **NO**
 Remarks:

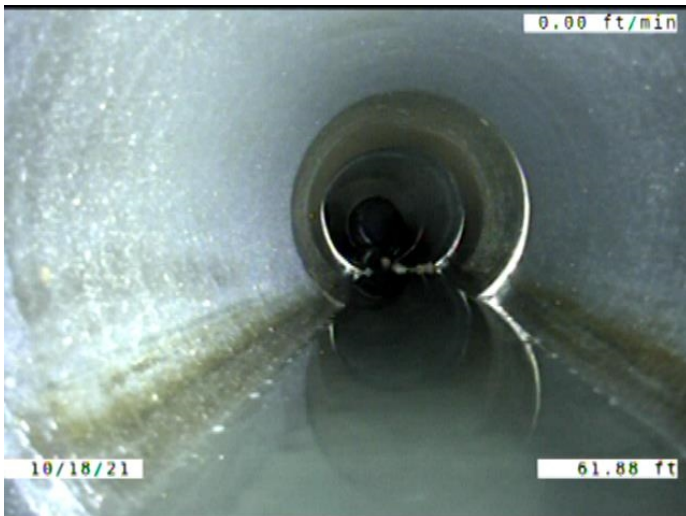
Code: **MWLS**
 Description: **Miscellaneous Water Level Sag**

Distance (ft): **61.9**
 Structural Grade: **2**
 O&M Grade: **0**
 Clock Start/From:
 Clock To:
 1st Value:
 2nd Value:
 Value Percent: **5.000**
 Continuous Index:
 Within 8" of Joint: **NO**
 Remarks:

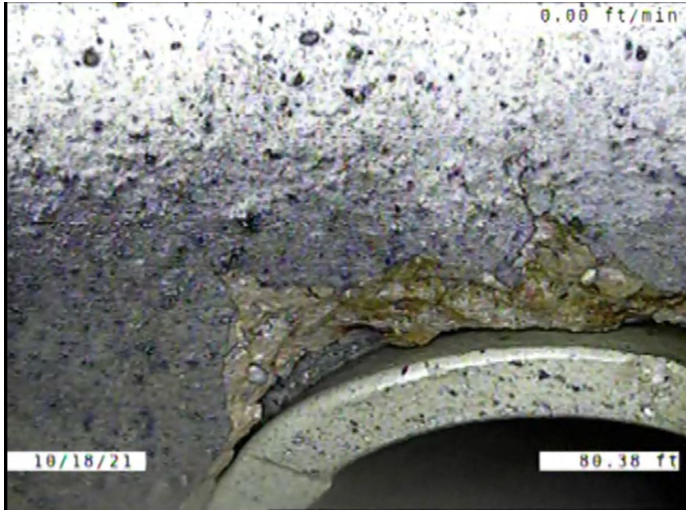
Code: **SSS**
Description: **Surface Damage Surface Spalling**

Distance (ft): **80.4**
Structural Grade: **2**
O&M Grade: **0**
Clock Start/From: **11**
Clock To: **2**
1st Value:
2nd Value:
Value Percent:
Continuous Index:
Within 8" of Joint: **NO**
Remarks:

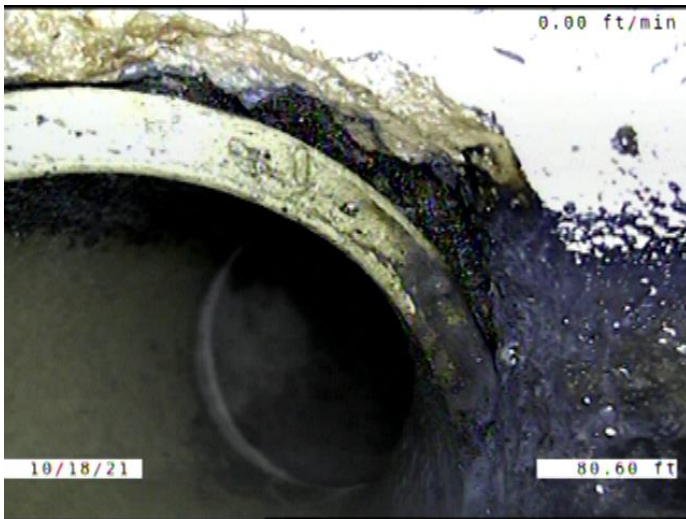
Code: **FM**
Description: **Fracture Multiple**

Distance (ft): **80.6**
Structural Grade: **4**
O&M Grade: **0**
Clock Start/From: **11**
Clock To: **2**
1st Value:
2nd Value:
Value Percent:
Continuous Index:
Within 8" of Joint: **YES**
Remarks:

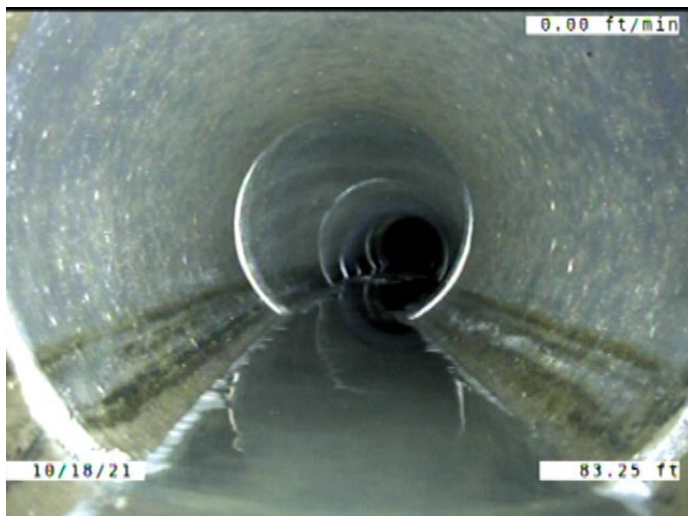
Code: **MWLS**
 Description: **Miscellaneous Water Level Sag**

Distance (ft): **83.3**
 Structural Grade: **2**
 O&M Grade: **0**
 Clock Start/From:
 Clock To:
 1st Value:
 2nd Value:
 Value Percent: **10.000**
 Continuous Index: **S02**
 Within 8" of Joint: **NO**
 Remarks:

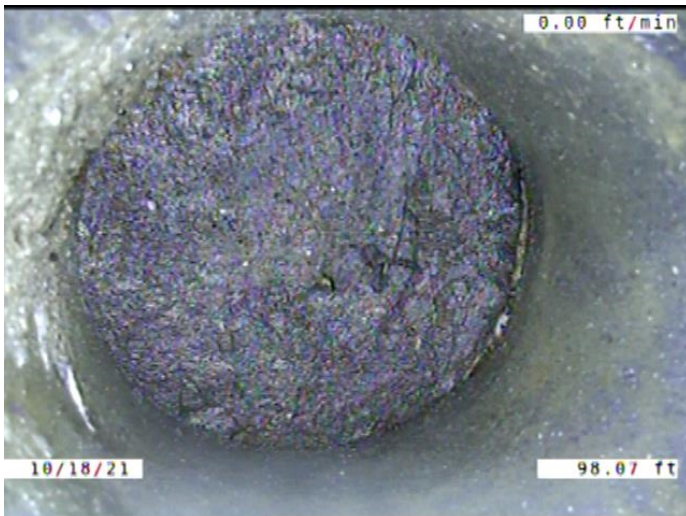
Code: **TFC**
 Description: **Tap Factory Capped**

Distance (ft): **98.1**
 Structural Grade: **0**
 O&M Grade: **0**
 Clock Start/From: **11**
 Clock To:
 1st Value: **4.000**
 2nd Value:
 Value Percent:
 Continuous Index:
 Within 8" of Joint: **YES**
 Remarks:

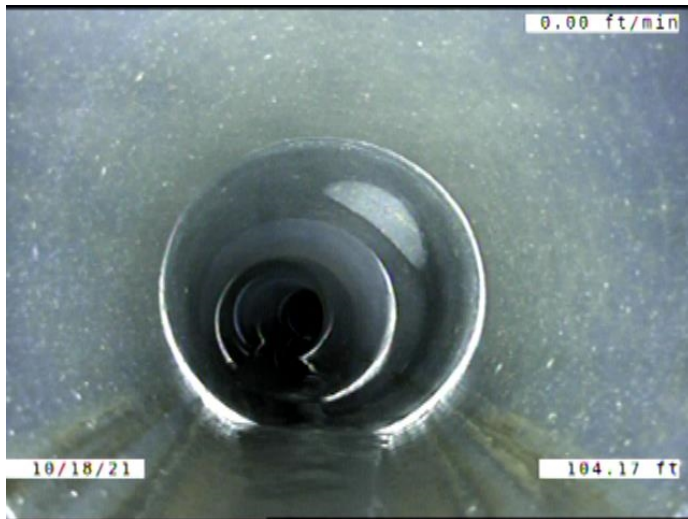
Code: **MWLS**
Description: **Miscellaneous Water Level Sag**

Distance (ft): **104.2**
Structural Grade: **2**
O&M Grade: **0**
Clock Start/From:
Clock To:
1st Value:
2nd Value:
Value Percent: **10.000**
Continuous Index: **F02**
Within 8" of Joint: **NO**
Remarks:

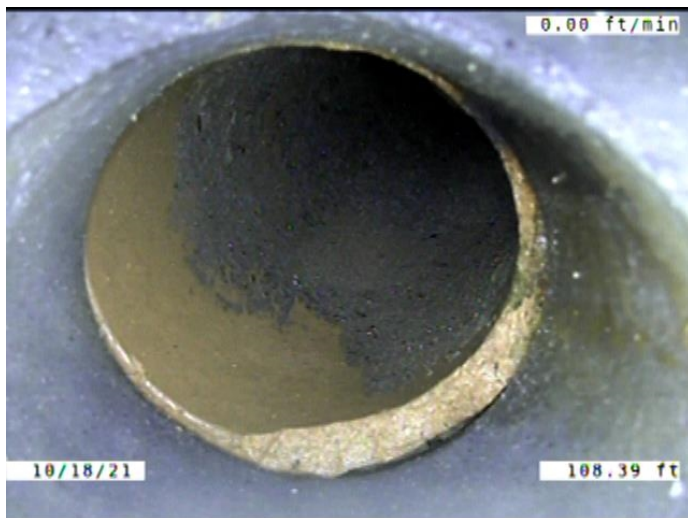
Code: **TF**
Description: **Tap Factory**

Distance (ft): **108.4**
Structural Grade: **0**
O&M Grade: **0**
Clock Start/From: **1**
Clock To:
1st Value: **4.000**
2nd Value:
Value Percent:
Continuous Index:
Within 8" of Joint: **YES**
Remarks:

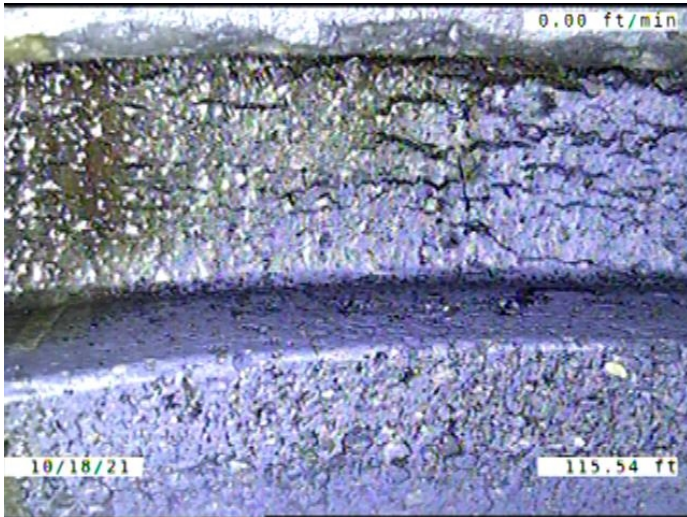
Code: **JAM**
 Description: **Joint Angular Medium**

Distance (ft): **115.5**
 Structural Grade: **3**
 O&M Grade: **0**
 Clock Start/From:
 Clock To:
 1st Value:
 2nd Value:
 Value Percent:
 Continuous Index:
 Within 8" of Joint: **NO**
 Remarks:

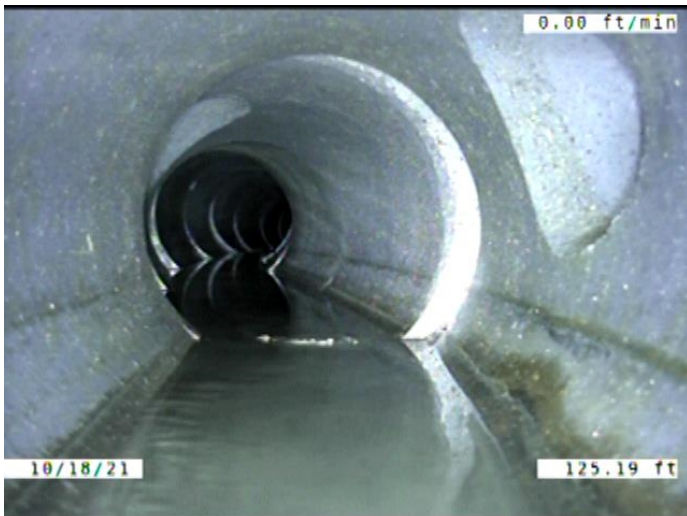
Code: **MWLS**
 Description: **Miscellaneous Water Level Sag**

Distance (ft): **125.2**
 Structural Grade: **2**
 O&M Grade: **0**
 Clock Start/From:
 Clock To:
 1st Value:
 2nd Value:
 Value Percent: **10.000**
 Continuous Index: **S04**
 Within 8" of Joint: **NO**
 Remarks:

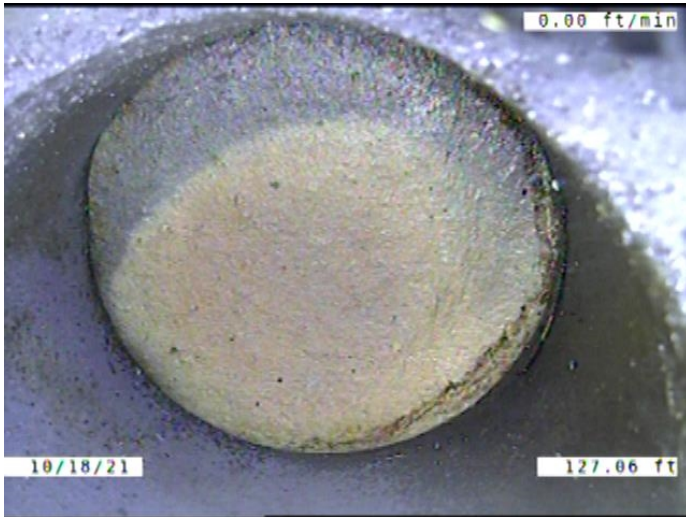
Code: **TFC**
Description: **Tap Factory Capped**

Distance (ft): **127.1**
Structural Grade: **0**
O&M Grade: **0**
Clock Start/From: **2**
Clock To:
1st Value: **4.000**
2nd Value:
Value Percent:
Continuous Index:
Within 8" of Joint: **YES**
Remarks:

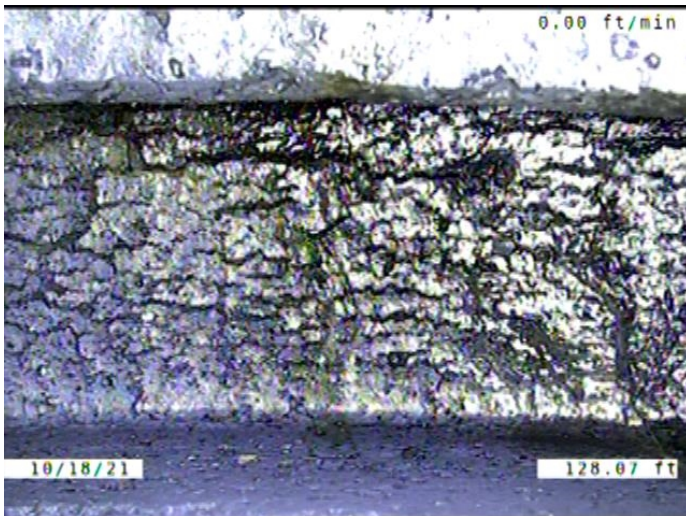
Code: **JAL**
Description: **Joint Angular Large**

Distance (ft): **128.1**
Structural Grade: **4**
O&M Grade: **0**
Clock Start/From:
Clock To:
1st Value:
2nd Value:
Value Percent:
Continuous Index: **S05**
Within 8" of Joint: **NO**
Remarks:

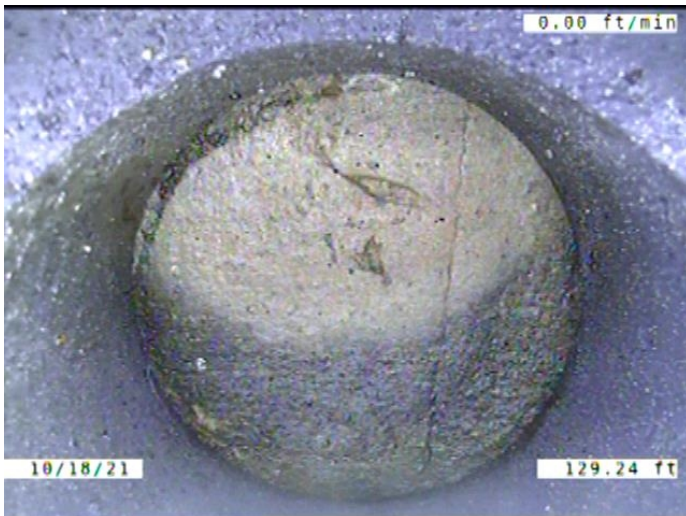
Code: **TFC**
Description: **Tap Factory Capped**

Distance (ft): **129.2**
Structural Grade: **0**
O&M Grade: **0**
Clock Start/From: **11**
Clock To:
1st Value: **4.000**
2nd Value:
Value Percent:
Continuous Index:
Within 8" of Joint: **YES**
Remarks:

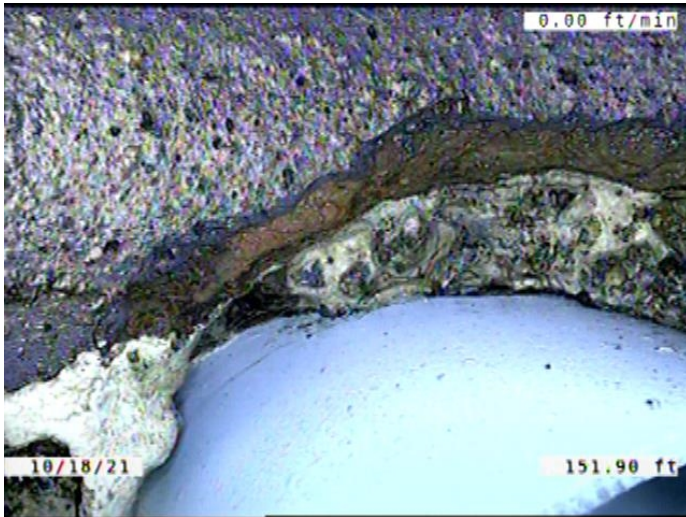
Code: **SSS**
 Description: **Surface Damage Surface Spalling**

Distance (ft): **151.9**
 Structural Grade: **2**
 O&M Grade: **0**
 Clock Start/From: **10**
 Clock To: **1**
 1st Value:
 2nd Value:
 Value Percent:
 Continuous Index:
 Within 8" of Joint: **YES**
 Remarks:

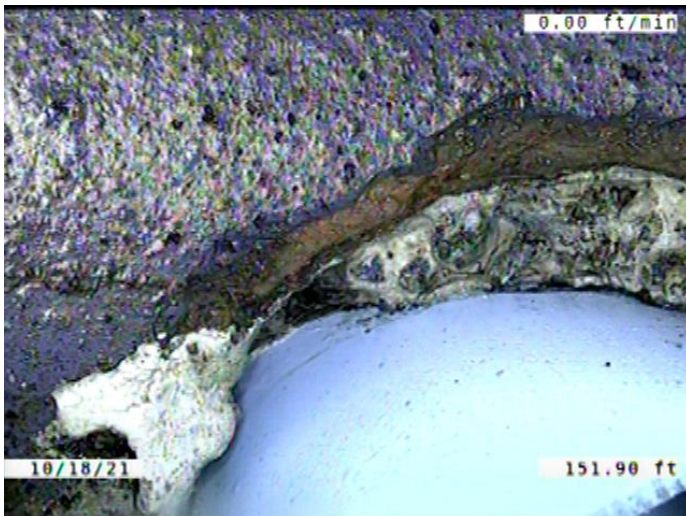
Code: **DAE**
 Description: **Deposits Attached Encrustation**

Distance (ft): **151.9**
 Structural Grade: **0**
 O&M Grade: **2**
 Clock Start/From: **7**
 Clock To: **1**
 1st Value:
 2nd Value:
 Value Percent: **5.000**
 Continuous Index:
 Within 8" of Joint: **YES**
 Remarks:

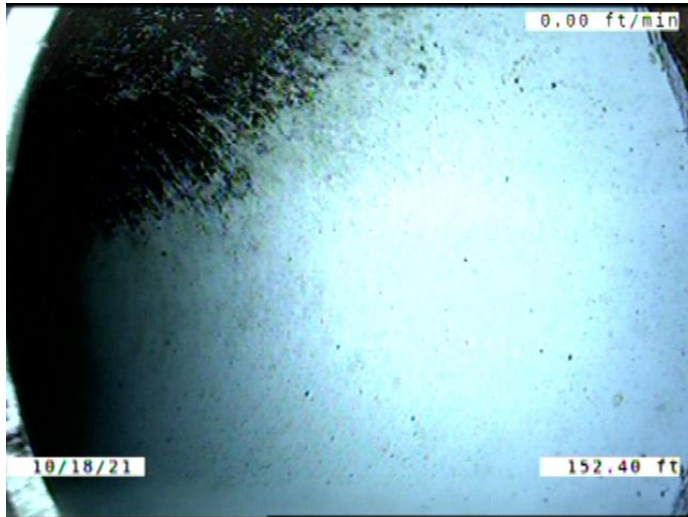
Code: **TBI**
 Description: **Tap Break-in Intruding**

Distance (ft): **152.4**
 Structural Grade: **0**
 O&M Grade: **2**
 Clock Start/From: **11**
 Clock To:
 1st Value: **4.000**
 2nd Value: **4.000**
 Value Percent:
 Continuous Index:
 Within 8" of Joint: **YES**
 Remarks: **CONSTANTLY DRIPPING WATER**

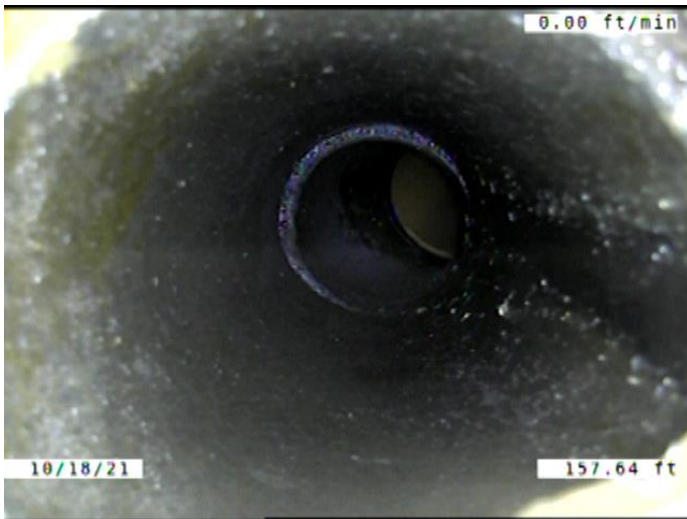
Code: **TBD**
 Description: **Tap Break-in/Hammer Defective**

Distance (ft): **157.6**
 Structural Grade: **0**
 O&M Grade: **3**
 Clock Start/From: **2**
 Clock To:
 1st Value: **4.000**
 2nd Value:
 Value Percent:
 Continuous Index:
 Within 8" of Joint: **YES**
 Remarks: **Defective**

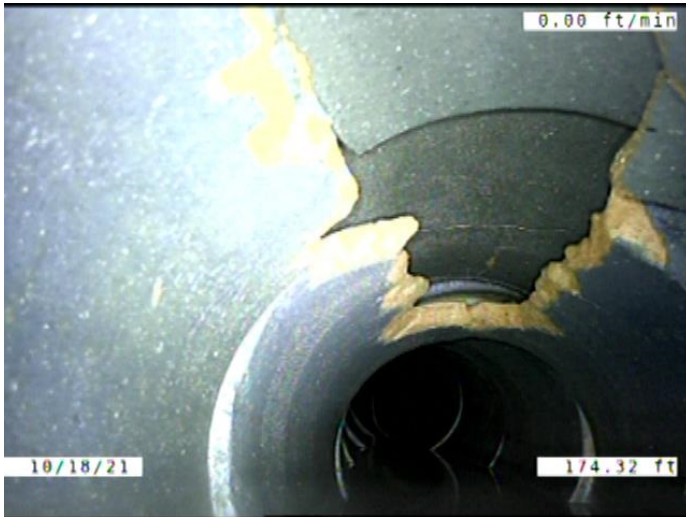
Code: **H**
Description: **Hole**

Distance (ft): **174.3**
Structural Grade: **5**
O&M Grade: **0**
Clock Start/From: **10**
Clock To: **4**
1st Value:
2nd Value:
Value Percent:
Continuous Index: **S07**
Within 8" of Joint: **YES**
Remarks:

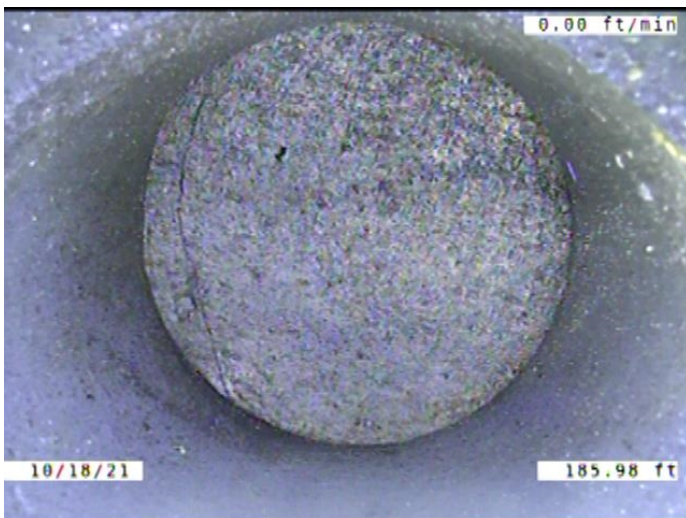
Code: **TFC**
 Description: **Tap Factory Capped**

Distance (ft): **186.0**
 Structural Grade: **0**
 O&M Grade: **0**
 Clock Start/From: **1**
 Clock To:
 1st Value: **4.000**
 2nd Value:
 Value Percent:
 Continuous Index:
 Within 8" of Joint: **YES**
 Remarks: **CAP CRACKED**

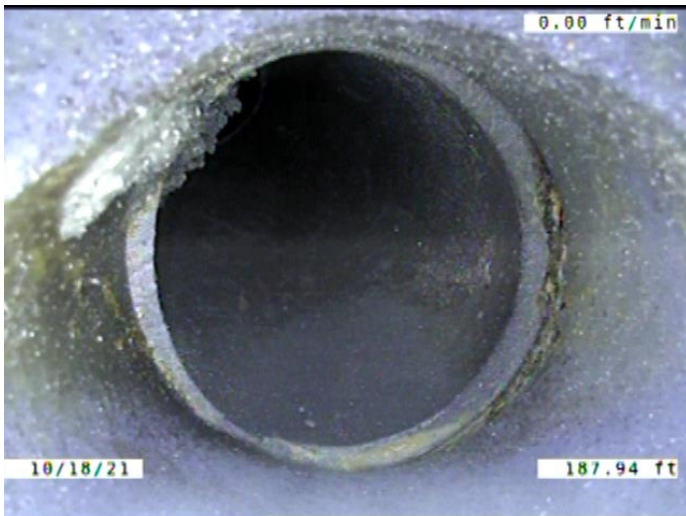
Code: **TF**
 Description: **Tap Factory**

Distance (ft): **187.9**
 Structural Grade: **0**
 O&M Grade: **0**
 Clock Start/From: **11**
 Clock To:
 1st Value: **4.000**
 2nd Value:
 Value Percent:
 Continuous Index:
 Within 8" of Joint: **YES**
 Remarks:

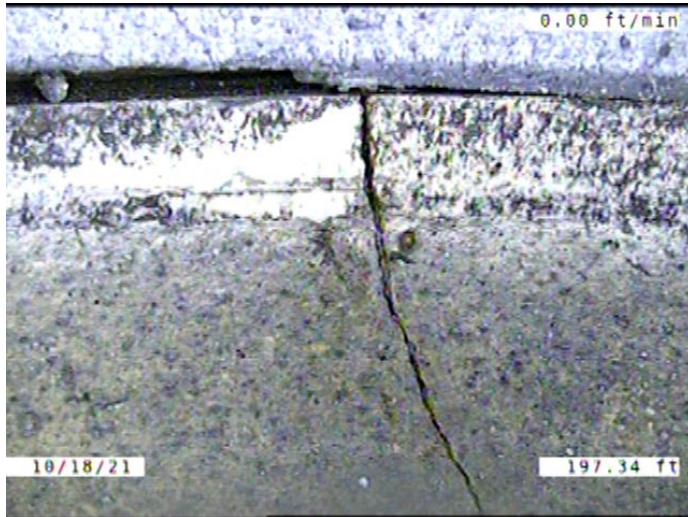
Code: **FM**
 Description: **Fracture Multiple**

Distance (ft): **197.3**
 Structural Grade: **4**
 O&M Grade: **0**
 Clock Start/From: **8**
 Clock To: **1**
 1st Value:
 2nd Value:
 Value Percent:
 Continuous Index:
 Within 8" of Joint: **YES**
 Remarks:

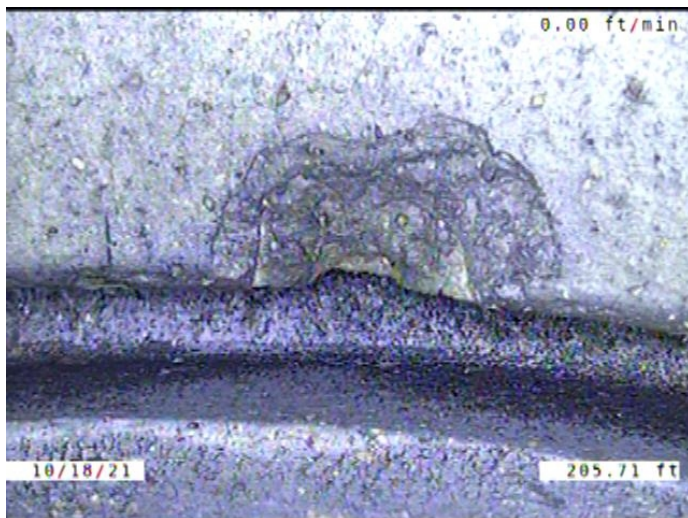
Code: **SZ**
 Description: **Surface Damage Other**

Distance (ft): **205.7**
 Structural Grade: **0**
 O&M Grade: **0**
 Clock Start/From: **2**
 Clock To:
 1st Value:
 2nd Value:
 Value Percent:
 Continuous Index:
 Within 8" of Joint: **YES**
 Remarks: **A PIECE CHIPPED AWAY FROM THE JOINT**

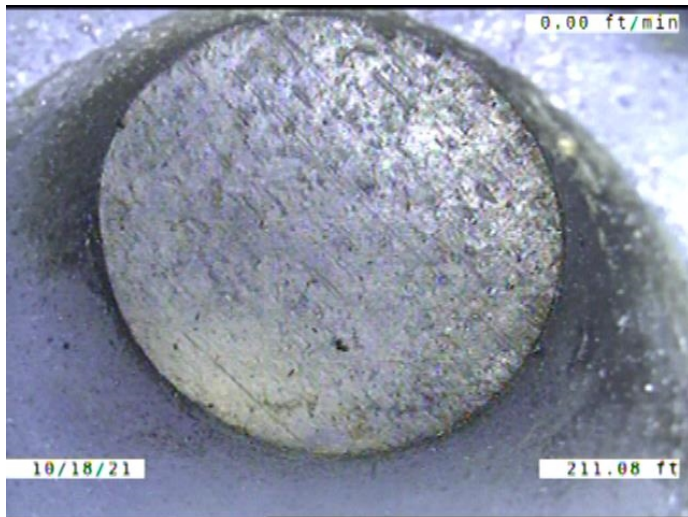
Code: **TFC**
 Description: **Tap Factory Capped**

Distance (ft): **211.1**
 Structural Grade: **0**
 O&M Grade: **0**
 Clock Start/From: **2**
 Clock To:
 1st Value: **4.000**
 2nd Value:
 Value Percent:
 Continuous Index:
 Within 8" of Joint: **YES**
 Remarks:

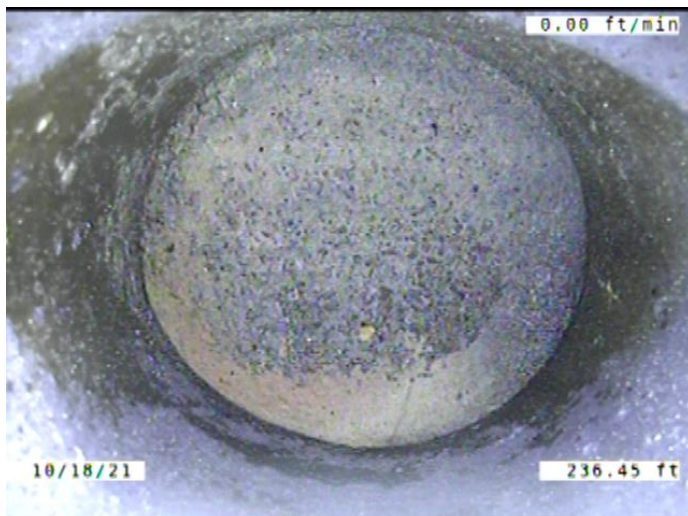
Code: **TFC**
 Description: **Tap Factory Capped**

Distance (ft): **236.4**
 Structural Grade: **0**
 O&M Grade: **0**
 Clock Start/From: **11**
 Clock To:
 1st Value: **4.000**
 2nd Value:
 Value Percent:
 Continuous Index:
 Within 8" of Joint: **YES**
 Remarks:

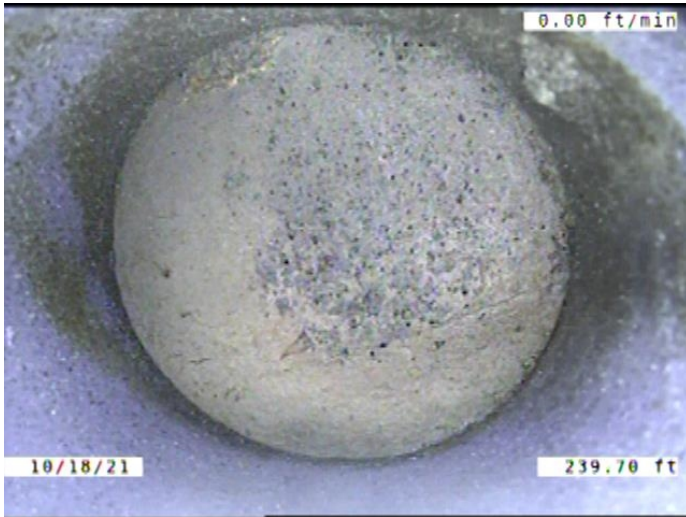
Code: **TFC**
 Description: **Tap Factory Capped**

Distance (ft): **239.7**
 Structural Grade: **0**
 O&M Grade: **0**
 Clock Start/From: **1**
 Clock To:
 1st Value: **4.000**
 2nd Value:
 Value Percent:
 Continuous Index:
 Within 8" of Joint: **YES**
 Remarks:

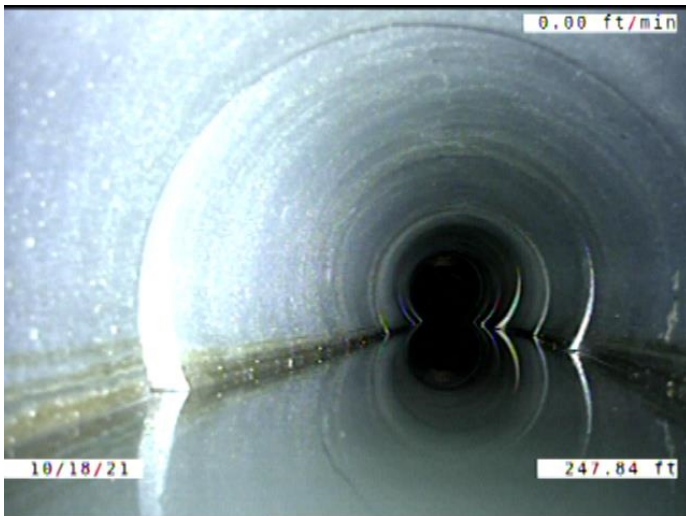
Code: **MWLS**
 Description: **Miscellaneous Water Level Sag**

Distance (ft): **247.8**
 Structural Grade: **2**
 O&M Grade: **0**
 Clock Start/From:
 Clock To:
 1st Value:
 2nd Value:
 Value Percent: **15.000**
 Continuous Index: **S08**
 Within 8" of Joint: **NO**
 Remarks:

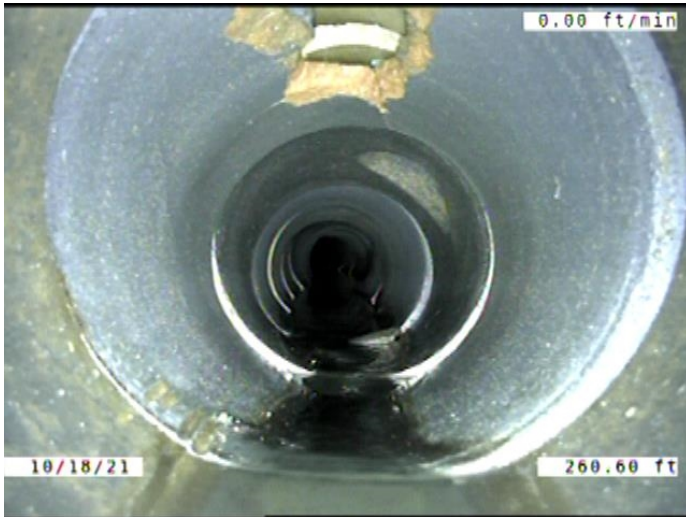
Code: **MWLS**
 Description: **Miscellaneous Water Level Sag**

Distance (ft): **260.6**
 Structural Grade: **2**
 O&M Grade: **0**
 Clock Start/From:
 Clock To:
 1st Value:
 2nd Value:
 Value Percent: **15.000**
 Continuous Index: **F08**
 Within 8" of Joint: **NO**
 Remarks:

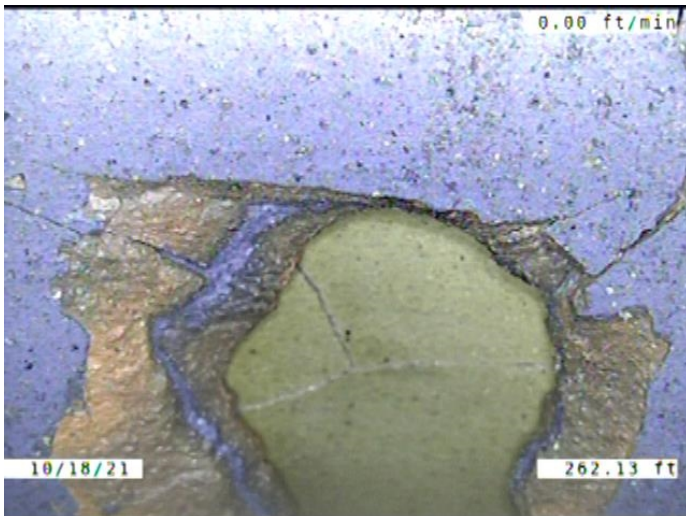
Code: **B**
 Description: **Broken**

Distance (ft): **262.1**
 Structural Grade: **4**
 O&M Grade: **0**
 Clock Start/From: **11**
 Clock To: **1**
 1st Value:
 2nd Value:
 Value Percent:
 Continuous Index:
 Within 8" of Joint: **YES**
 Remarks:

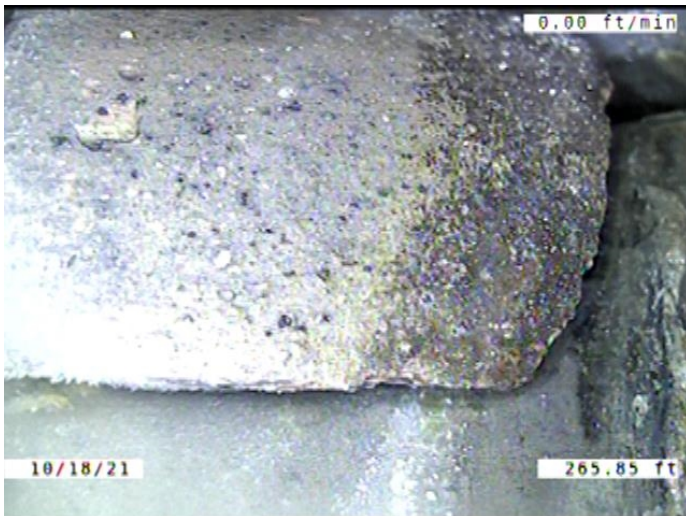
Code: **OBM**
 Description: **Obstruction Pipe Material in Invert**

Distance (ft): **265.8**
 Structural Grade: **0**
 O&M Grade: **2**
 Clock Start/From: **5**
 Clock To: **6**
 1st Value:
 2nd Value:
 Value Percent: **5.000**
 Continuous Index:
 Within 8" of Joint: **YES**
 Remarks:

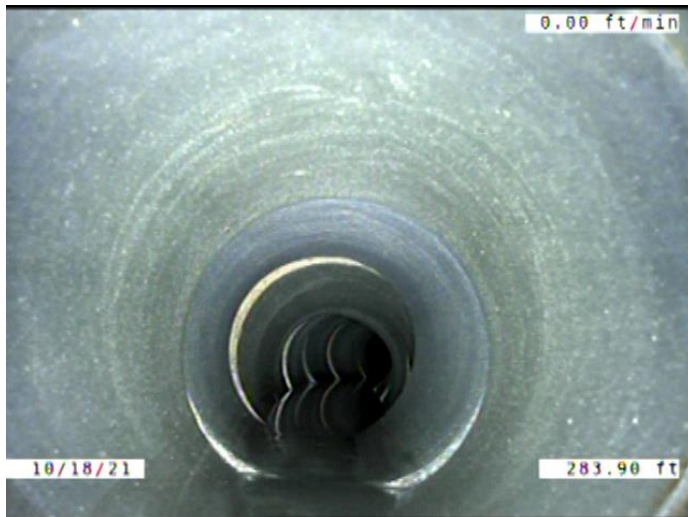
Code: **MWLS**
 Description: **Miscellaneous Water Level Sag**

Distance (ft): **283.9**
 Structural Grade: **2**
 O&M Grade: **0**
 Clock Start/From:
 Clock To:
 1st Value:
 2nd Value:
 Value Percent: **10.000**
 Continuous Index: **F09**
 Within 8" of Joint: **NO**
 Remarks:

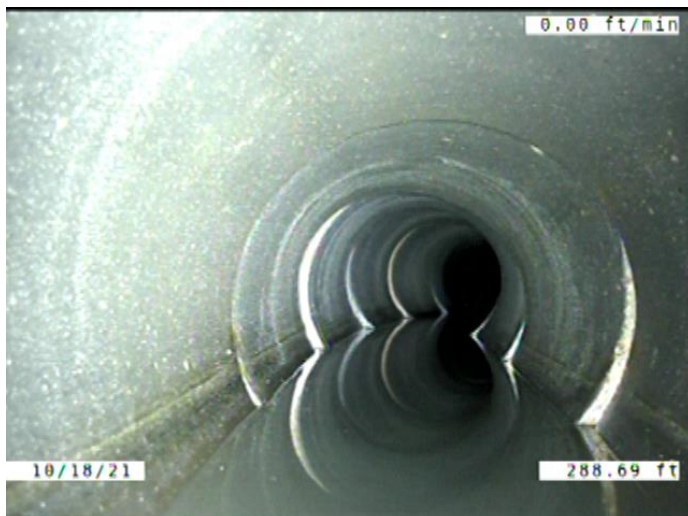
Code: **MWLS**
 Description: **Miscellaneous Water Level Sag**

Distance (ft): **288.7**
 Structural Grade: **2**
 O&M Grade: **0**
 Clock Start/From:
 Clock To:
 1st Value:
 2nd Value:
 Value Percent: **10.000**
 Continuous Index: **S10**
 Within 8" of Joint: **NO**
 Remarks:

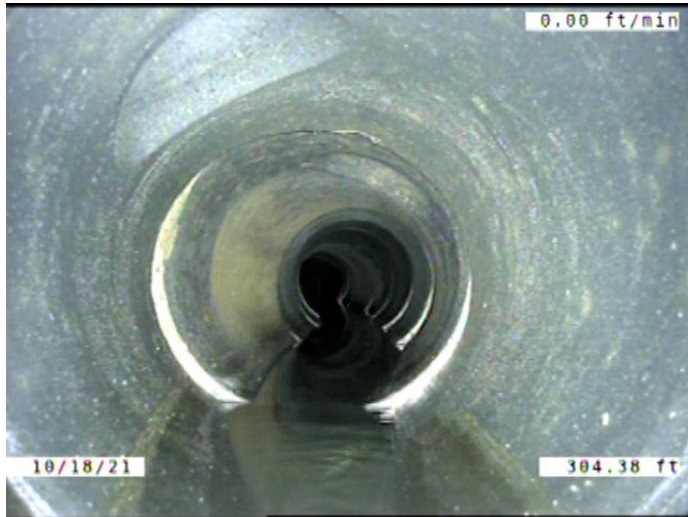
Code: **MWLS**
 Description: **Miscellaneous Water Level Sag**

Distance (ft): **304.4**
 Structural Grade: **2**
 O&M Grade: **0**
 Clock Start/From:
 Clock To:
 1st Value:
 2nd Value:
 Value Percent: **10.000**
 Continuous Index: **F10**
 Within 8" of Joint: **NO**
 Remarks:

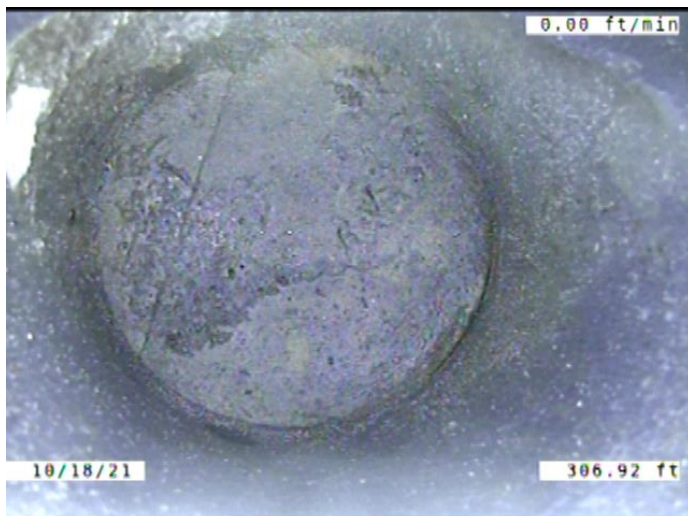
Code: **TFC**
 Description: **Tap Factory Capped**

Distance (ft): **306.9**
 Structural Grade: **0**
 O&M Grade: **0**
 Clock Start/From: **11**
 Clock To:
 1st Value: **4.000**
 2nd Value:
 Value Percent:
 Continuous Index:
 Within 8" of Joint: **YES**
 Remarks: **CAP CRACKED**

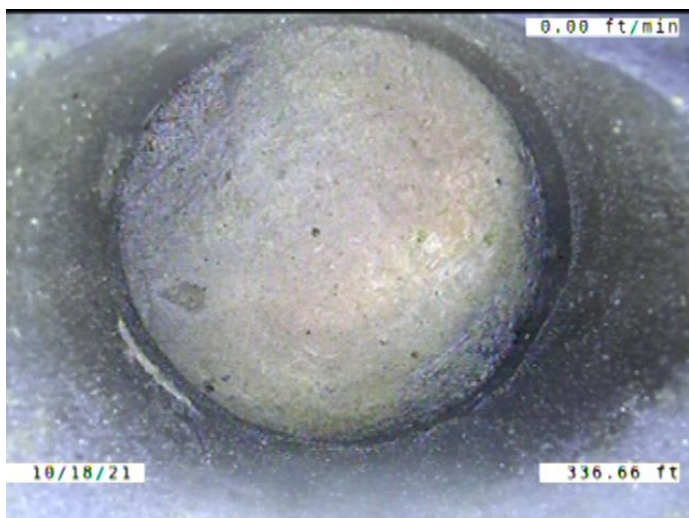
Code: **TFC**
 Description: **Tap Factory Capped**

Distance (ft): **336.7**
 Structural Grade: **0**
 O&M Grade: **0**
 Clock Start/From: **11**
 Clock To:
 1st Value: **4.000**
 2nd Value:
 Value Percent:
 Continuous Index:
 Within 8" of Joint: **YES**
 Remarks:

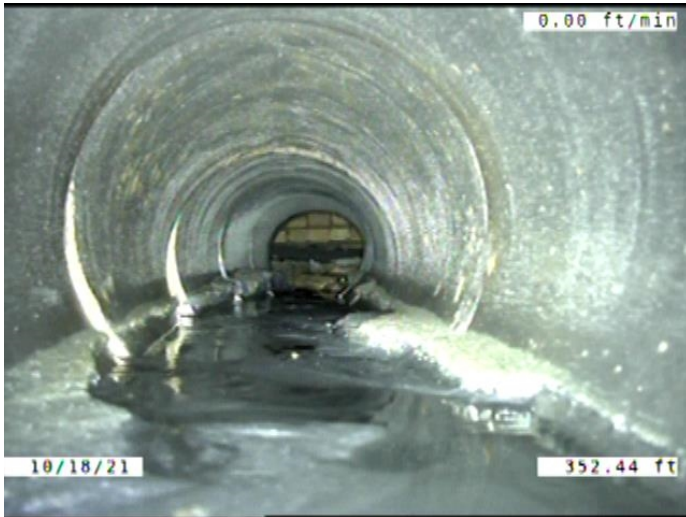
Code: **DSF**
 Description: **Deposits Settled Fine**

Distance (ft): **352.4**
 Structural Grade: **0**
 O&M Grade: **2**
 Clock Start/From: **4**
 Clock To: **8**
 1st Value:
 2nd Value:
 Value Percent: **5.000**
 Continuous Index: **S12**
 Within 8" of Joint: **YES**
 Remarks:

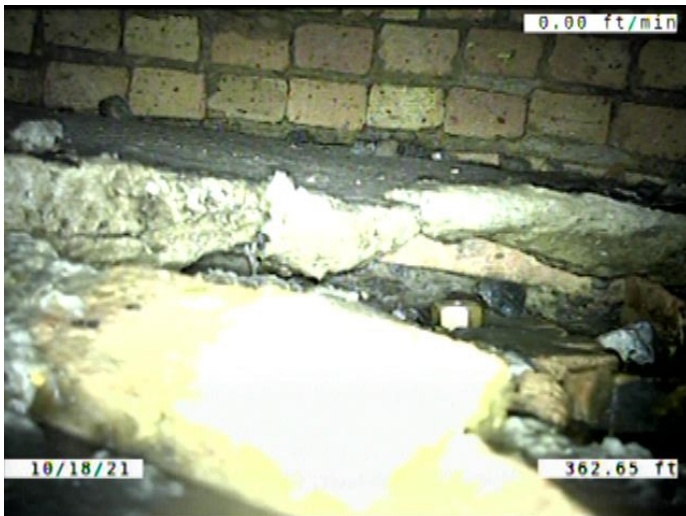
Code: **JAL**
 Description: **Joint Angular Large**

Distance (ft): **362.6**
 Structural Grade: **4**
 O&M Grade: **0**
 Clock Start/From:
 Clock To:
 1st Value:
 2nd Value:
 Value Percent:
 Continuous Index: **F05**
 Within 8" of Joint: **NO**
 Remarks:
