Profile/Photo Observation Report

Date:	10/10/2021	Weather:		Coding:	PACP 7.0
Pipe Length (ft):	378.6	Owner:	City of Hobart	Pre Clean:	Heavy Cleaning
P.O.#:	YES502259	Surveyor:	S. Bucklin	PSR:	P-804-013-014
Customer:	City of Hobart	Clean Date:	10/09/2021	Shape:	C

Street:	East Home Avenue	Flow Control:	Not Controlled
City:	Hobart, IN	Year Renewed:	
Location:	Local rural streets with light traffic, t	Tape/Media #:	
Purpose:	Routine Assessment	Dia/Height:	12"
Use:	Sanitary Sewage Pipe	Material:	VCP
Drain Area:		Lining:	
Category:	NA		
Comment:			
Location Details:		Direction of Survey:	Upstream
US MH:	M-804-014	DS MH:	M-804-013
		Total Length Surveyed (ft):	378.6

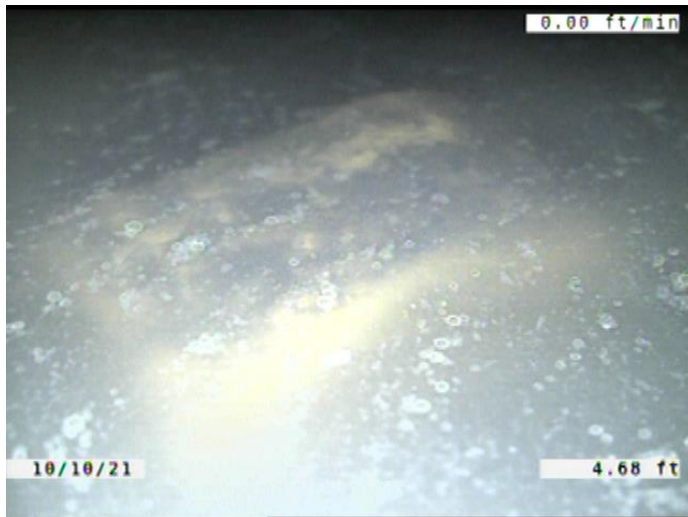
Code: **OBB**
 Description: **Obstruction Brick or Masonry**

Distance (ft): **4.7**
 Structural Grade: **0**
 O&M Grade: **2**
 Clock Start/From: **6**
 Clock To:
 1st Value:
 2nd Value:
 Value Percent: **5.000**
 Continuous Index:
 Within 8" of Joint: **YES**
 Remarks:

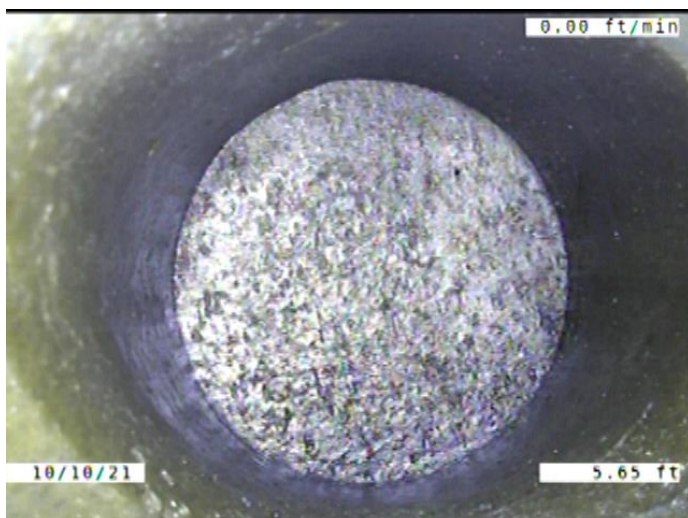
Code: **TFC**
 Description: **Tap Factory Capped**

Distance (ft): **5.6**
 Structural Grade: **0**
 O&M Grade: **0**
 Clock Start/From: **10**
 Clock To:
 1st Value: **4.000**
 2nd Value:
 Value Percent:
 Continuous Index:
 Within 8" of Joint: **YES**
 Remarks:

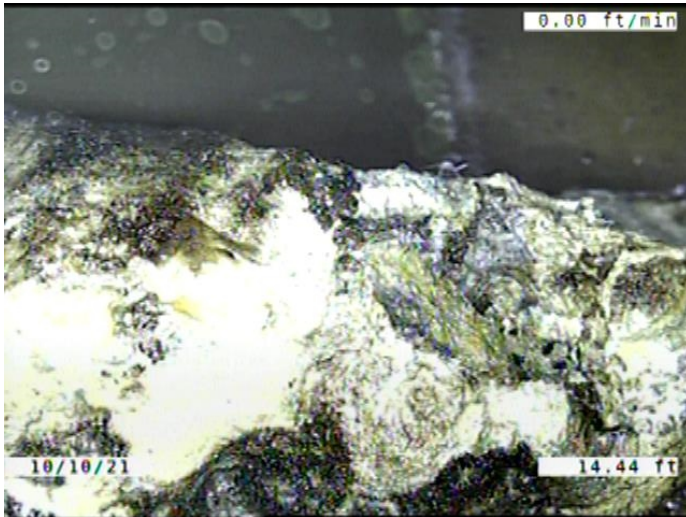
Code: **DAE**
 Description: **Deposits Attached Encrustation**

Distance (ft): **14.4**
 Structural Grade: **0**
 O&M Grade: **2**
 Clock Start/From: **3**
 Clock To: **6**
 1st Value:
 2nd Value:
 Value Percent: **5.000**
 Continuous Index:
 Within 8" of Joint: **YES**
 Remarks:

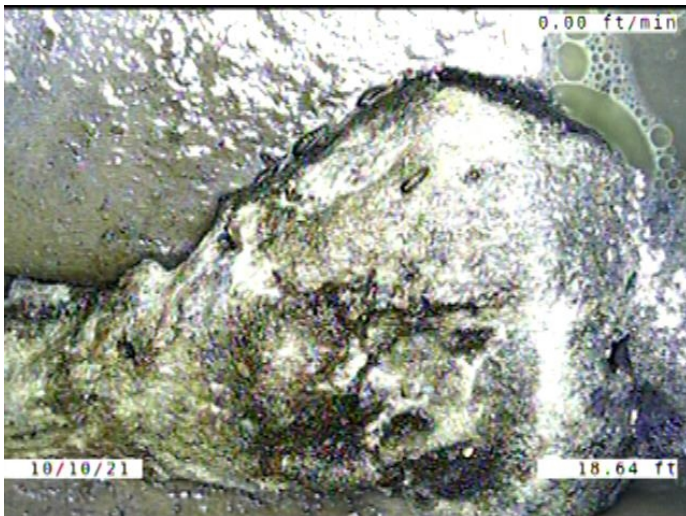
Code: **DAE**
 Description: **Deposits Attached Encrustation**

Distance (ft): **18.6**
 Structural Grade: **0**
 O&M Grade: **2**
 Clock Start/From: **5**
 Clock To: **9**
 1st Value:
 2nd Value:
 Value Percent: **5.000**
 Continuous Index:
 Within 8" of Joint: **YES**
 Remarks:

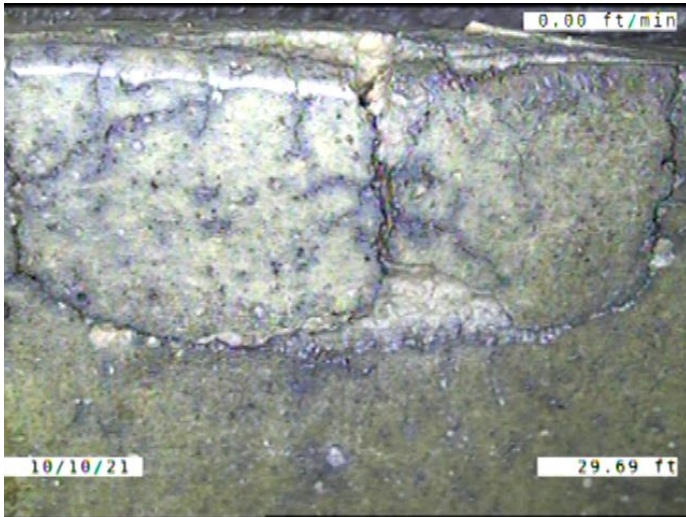
Code: **B**
 Description: **Broken**

Distance (ft): **29.7**
 Structural Grade: **4**
 O&M Grade: **0**
 Clock Start/From: **9**
 Clock To: **10**
 1st Value:
 2nd Value:
 Value Percent:
 Continuous Index:
 Within 8" of Joint: **YES**
 Remarks:

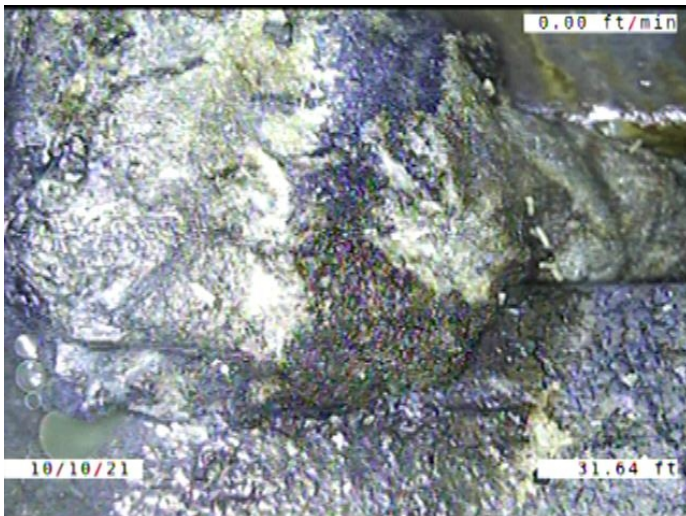
Code: **DAE**
 Description: **Deposits Attached Encrustation**

Distance (ft): **31.6**
 Structural Grade: **0**
 O&M Grade: **2**
 Clock Start/From: **3**
 Clock To: **5**
 1st Value:
 2nd Value:
 Value Percent: **5.000**
 Continuous Index:
 Within 8" of Joint: **YES**
 Remarks:

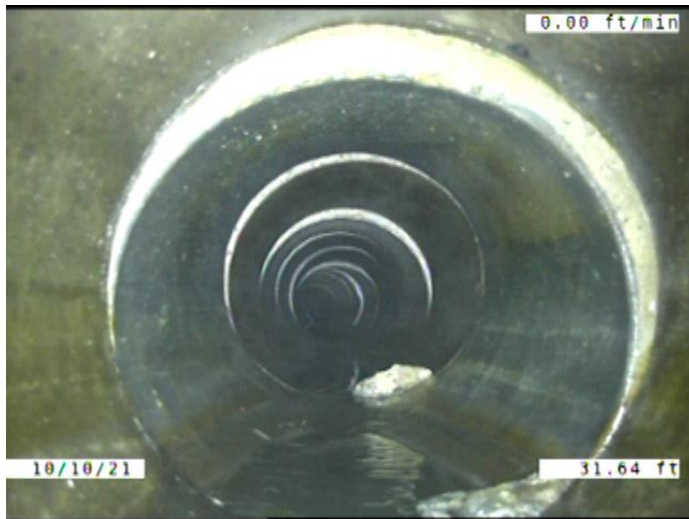
Code: **JOMD**
 Description: **Joint Offset Medium Defective**

Distance (ft): **31.6**
 Structural Grade: **3**
 O&M Grade: **0**
 Clock Start/From:
 Clock To:
 1st Value:
 2nd Value:
 Value Percent:
 Continuous Index: **S01**
 Within 8" of Joint: **NO**
 Remarks:

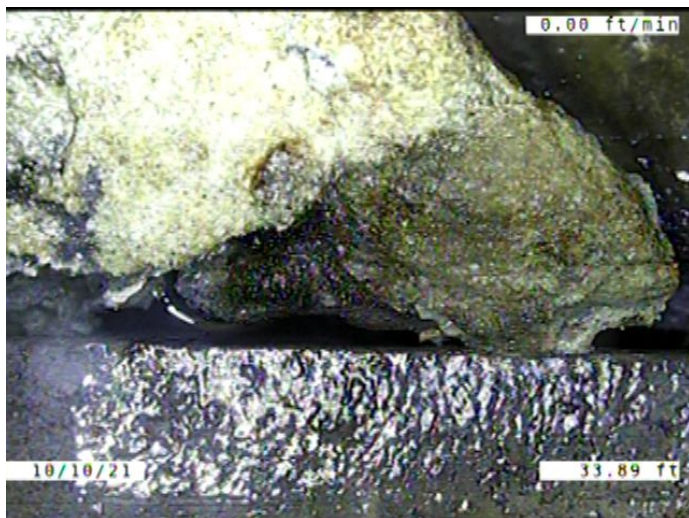
Code: **DAE**
 Description: **Deposits Attached Encrustation**

Distance (ft): **33.9**
 Structural Grade: **0**
 O&M Grade: **2**
 Clock Start/From: **4**
 Clock To: **6**
 1st Value:
 2nd Value:
 Value Percent: **5.000**
 Continuous Index:
 Within 8" of Joint: **YES**
 Remarks:

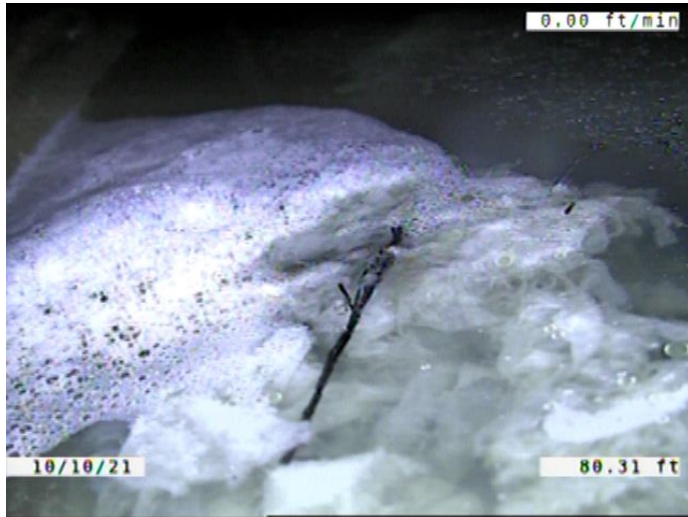
Code: **DSF**
 Description: **Deposits Settled Fine**

Distance (ft): **80.3**
 Structural Grade: **0**
 O&M Grade: **2**
 Clock Start/From: **5**
 Clock To: **7**
 1st Value:
 2nd Value:
 Value Percent: **5.000**
 Continuous Index: **S02**
 Within 8" of Joint: **YES**
 Remarks:

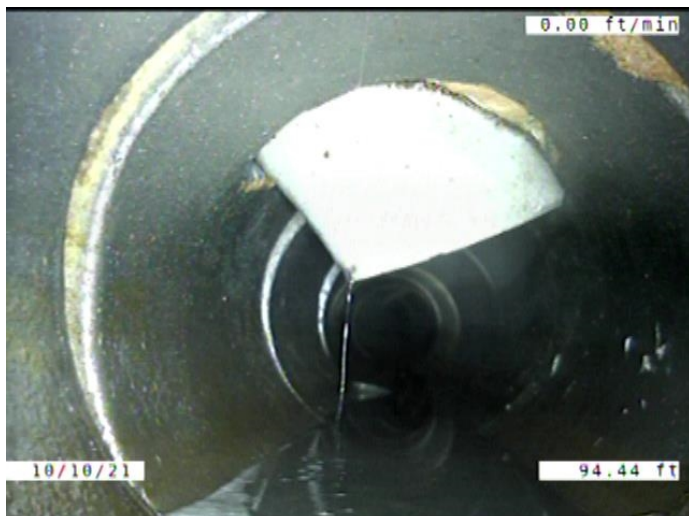
Code: **TBI**
 Description: **Tap Break-in Intruding**

Distance (ft): **94.4**
 Structural Grade: **0**
 O&M Grade: **2**
 Clock Start/From: **11**
 Clock To:
 1st Value: **4.000**
 2nd Value: **4.000**
 Value Percent:
 Continuous Index:
 Within 8" of Joint: **YES**
 Remarks:

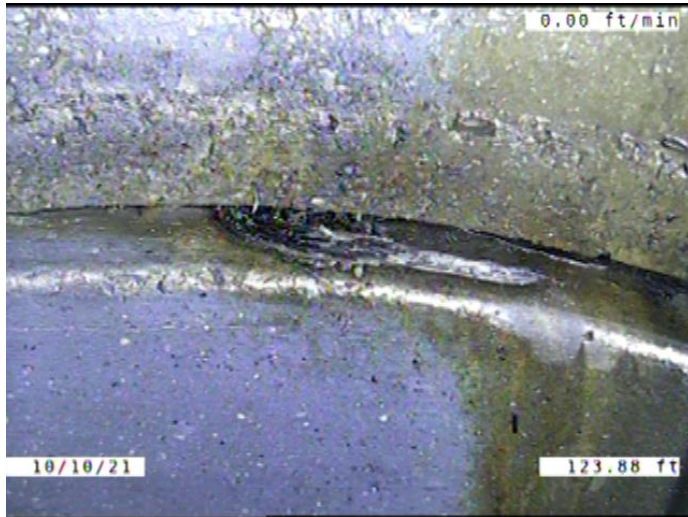
Code: **RFJ**
 Description: **Roots Fine Joint**

Distance (ft): **123.9**
 Structural Grade: **0**
 O&M Grade: **1**
 Clock Start/From: **3**
 Clock To:
 1st Value:
 2nd Value:
 Value Percent:
 Continuous Index:
 Within 8" of Joint: **YES**
 Remarks:

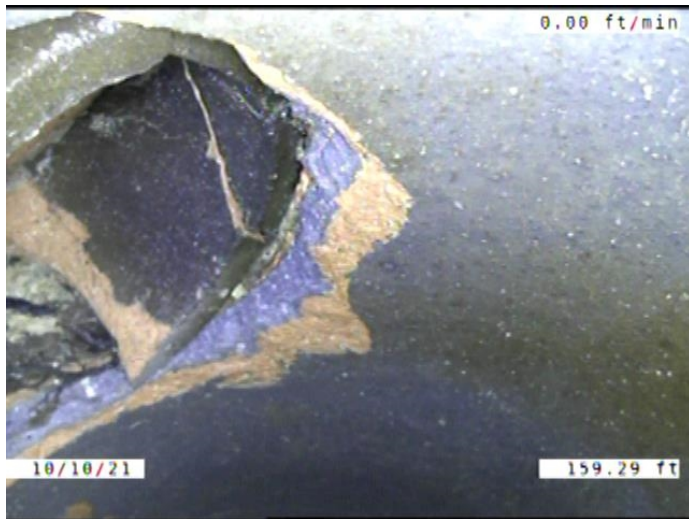
Code: **SSS**
 Description: **Surface Damage Surface Spalling**

Distance (ft): **159.3**
 Structural Grade: **2**
 O&M Grade: **0**
 Clock Start/From: **9**
 Clock To: **12**
 1st Value:
 2nd Value:
 Value Percent:
 Continuous Index:
 Within 8" of Joint: **YES**
 Remarks:

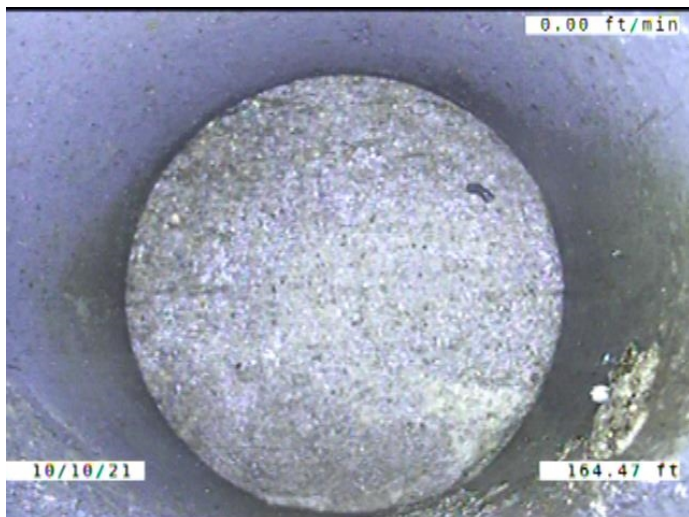
Code: **TFC**
 Description: **Tap Factory Capped**

Distance (ft): **164.5**
 Structural Grade: **0**
 O&M Grade: **0**
 Clock Start/From: **2**
 Clock To:
 1st Value: **4.000**
 2nd Value:
 Value Percent:
 Continuous Index:
 Within 8" of Joint: **YES**
 Remarks:

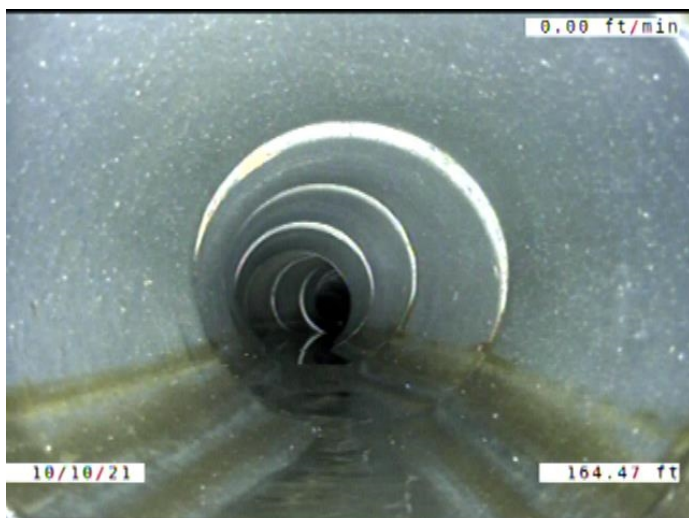
Code: **MWLS**
 Description: **Miscellaneous Water Level Sag**

Distance (ft): **164.5**
 Structural Grade: **2**
 O&M Grade: **0**
 Clock Start/From:
 Clock To:
 1st Value:
 2nd Value:
 Value Percent: **10.000**
 Continuous Index: **F03**
 Within 8" of Joint: **NO**
 Remarks:

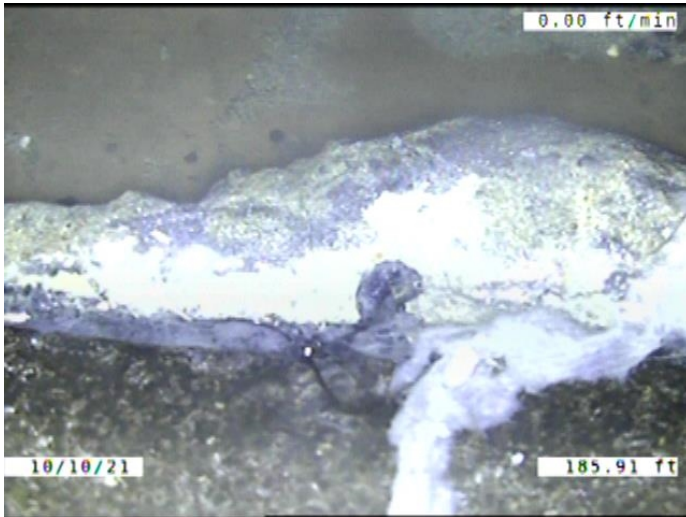
Code:	DAE
Description:	Deposits Attached Encrustation
Distance (ft):	185.9
Structural Grade:	0
O&M Grade:	2
Clock Start/From:	4
Clock To:	7
1st Value:	
2nd Value:	
Value Percent:	5.000
Continuous Index:	
Within 8" of Joint:	YES
Remarks:

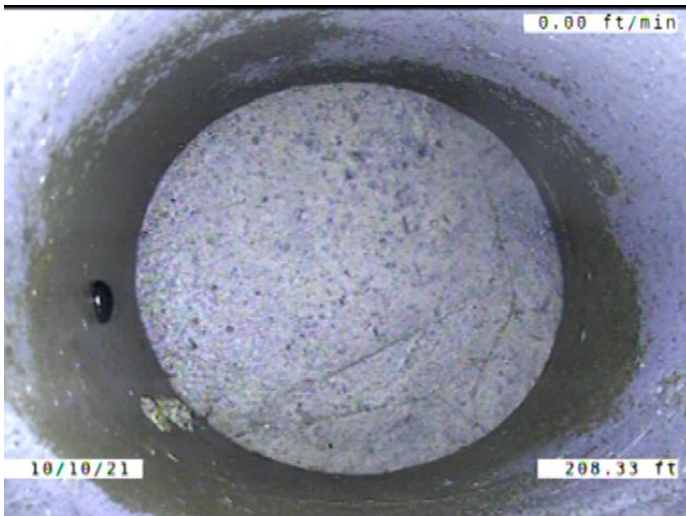
Code:	TFC
Description:	Tap Factory Capped
Distance (ft):	208.3
Structural Grade:	0
O&M Grade:	0
Clock Start/From:	10
Clock To:	
1st Value:	4.000
2nd Value:	
Value Percent:	
Continuous Index:	
Within 8" of Joint:	YES
Remarks:

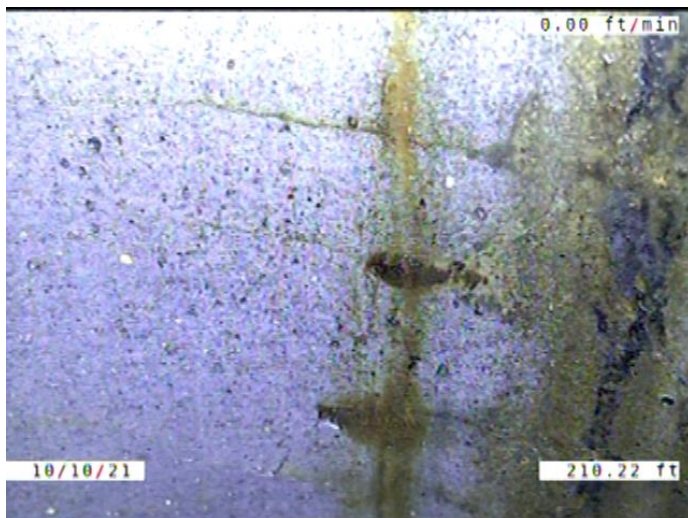
Code: **ISB**
Description: **Infiltration Stain Barrel**

Distance (ft): **210.2**
Structural Grade: **0**
O&M Grade: **1**
Clock Start/From: **3**
Clock To: **4**
1st Value:
2nd Value:
Value Percent:
Continuous Index:
Within 8" of Joint: **NO**
Remarks:

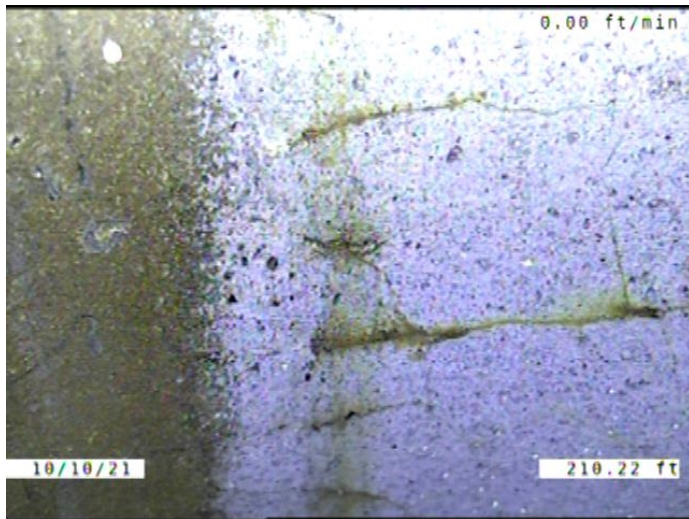
Code: **ISB**
 Description: **Infiltration Stain Barrel**

Distance (ft): **210.2**
 Structural Grade: **0**
 O&M Grade: **1**
 Clock Start/From: **3**
 Clock To: **4**
 1st Value:
 2nd Value:
 Value Percent:
 Continuous Index:
 Within 8" of Joint: **NO**
 Remarks:

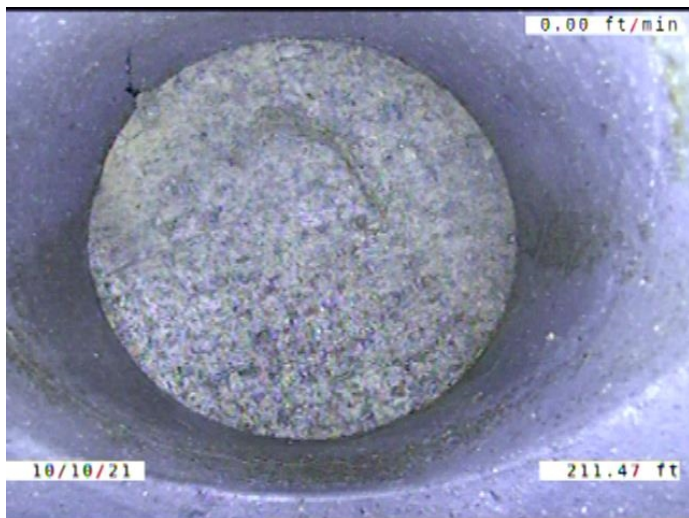
Code: **TFC**
 Description: **Tap Factory Capped**

Distance (ft): **211.5**
 Structural Grade: **0**
 O&M Grade: **0**
 Clock Start/From: **2**
 Clock To:
 1st Value: **4.000**
 2nd Value:
 Value Percent:
 Continuous Index:
 Within 8" of Joint: **YES**
 Remarks:

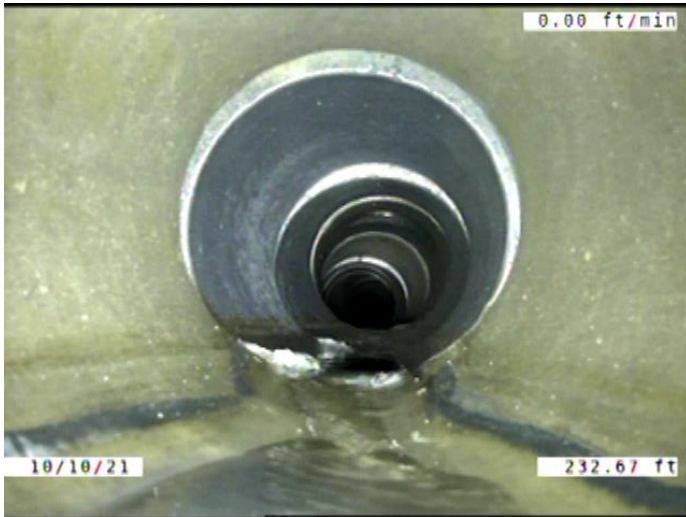
Code: **MWLS**
 Description: **Miscellaneous Water Level Sag**

Distance (ft): **232.7**
 Structural Grade: **2**
 O&M Grade: **0**
 Clock Start/From:
 Clock To:
 1st Value:
 2nd Value:
 Value Percent: **5.000**
 Continuous Index:
 Within 8" of Joint: **NO**
 Remarks:

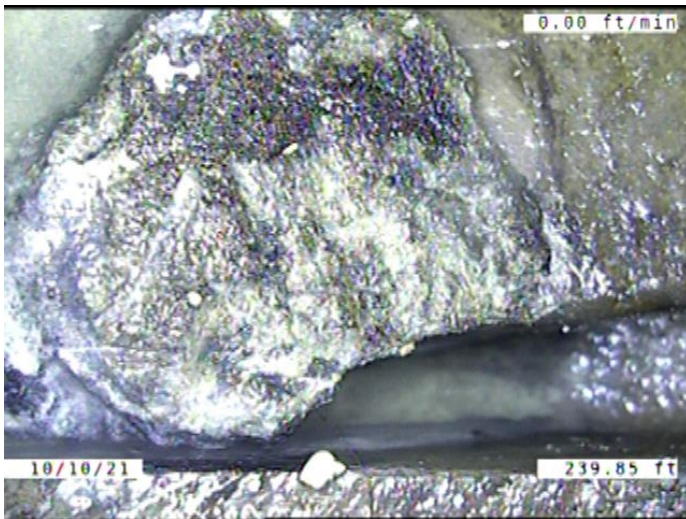
Code: **DAE**
 Description: **Deposits Attached Encrustation**

Distance (ft): **239.8**
 Structural Grade: **0**
 O&M Grade: **2**
 Clock Start/From: **4**
 Clock To: **5**
 1st Value:
 2nd Value:
 Value Percent: **5.000**
 Continuous Index:
 Within 8" of Joint: **YES**
 Remarks:

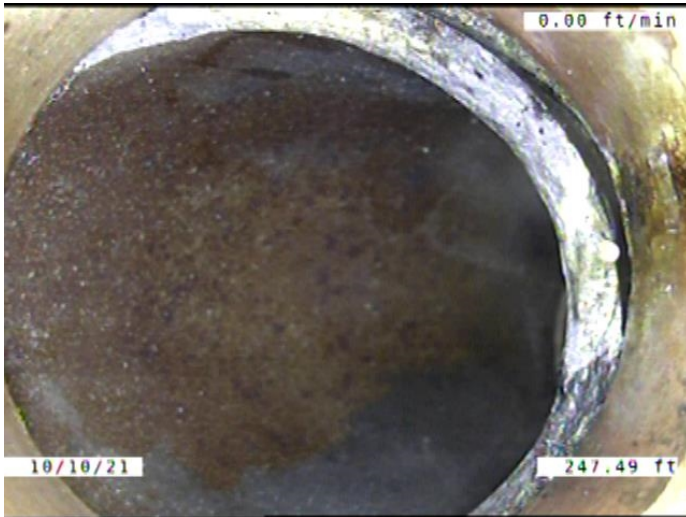
Code: **SSS**
 Description: **Surface Damage Surface Spalling**

Distance (ft): **247.2**
 Structural Grade: **2**
 O&M Grade: **0**
 Clock Start/From: **11**
 Clock To: **2**
 1st Value:
 2nd Value:
 Value Percent:
 Continuous Index:
 Within 8" of Joint: **YES**
 Remarks:

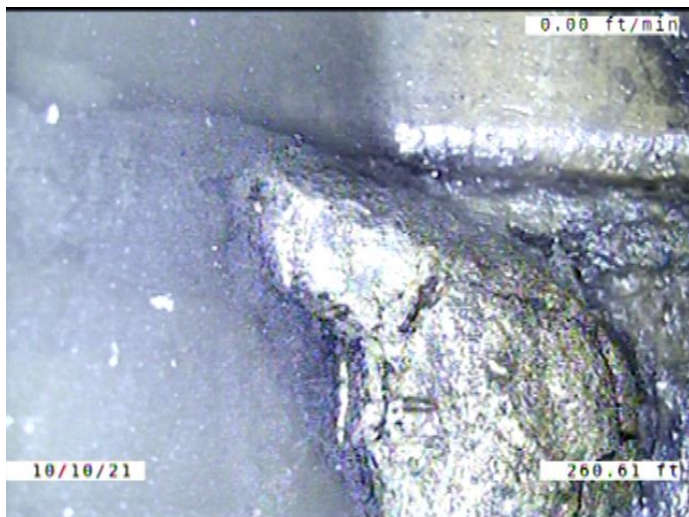
Code: **SZ**
Description: **Surface Damage Other**

Distance (ft): **256.5**
Structural Grade: **0**
O&M Grade: **0**
Clock Start/From: **3**
Clock To:
1st Value:
2nd Value:
Value Percent:
Continuous Index:
Within 8" of Joint: **YES**
Remarks: **A PIECE CHIPPED AWAY FROM THE JOINT**

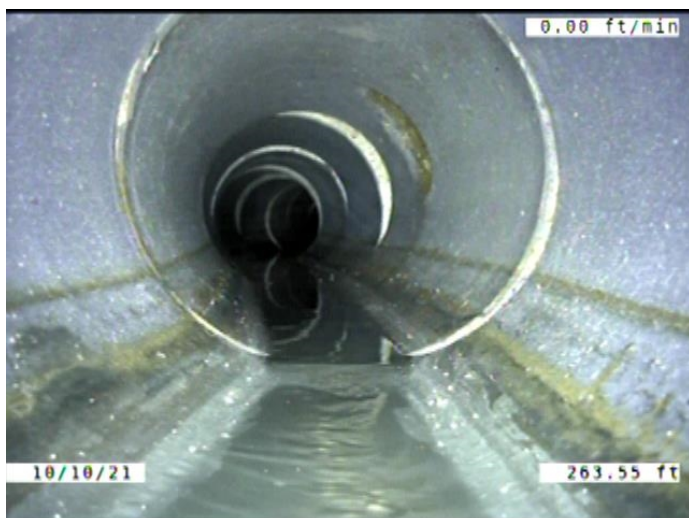
Code: **DAE**
 Description: **Deposits Attached Encrustation**

Distance (ft): **260.6**
 Structural Grade: **0**
 O&M Grade: **2**
 Clock Start/From: **4**
 Clock To: **7**
 1st Value:
 2nd Value:
 Value Percent: **5.000**
 Continuous Index:
 Within 8" of Joint: **YES**
 Remarks:

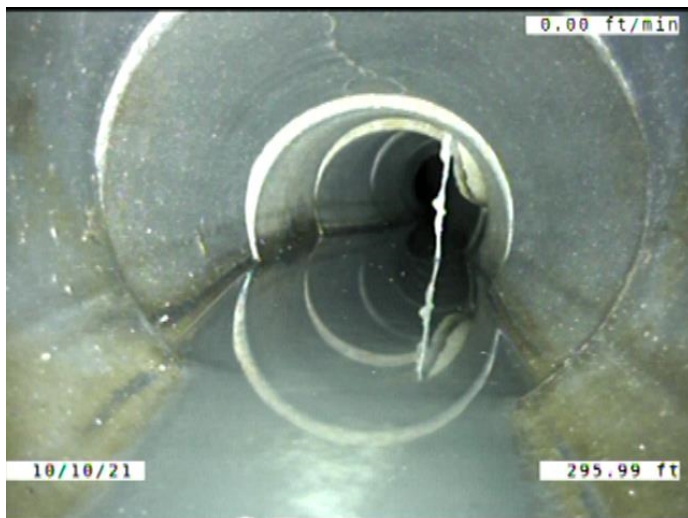
Code: **FM**
 Description: **Fracture Multiple**

Distance (ft): **295.7**
 Structural Grade: **4**
 O&M Grade: **0**
 Clock Start/From: **10**
 Clock To: **3**
 1st Value:
 2nd Value:
 Value Percent:
 Continuous Index:
 Within 8" of Joint: **YES**
 Remarks:

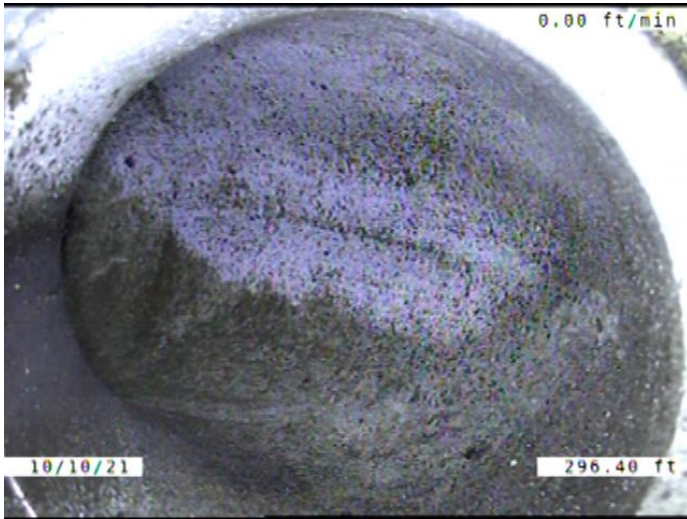
Code: **MWLS**
 Description: **Miscellaneous Water Level Sag**

Distance (ft): **296.0**
 Structural Grade: **2**
 O&M Grade: **0**
 Clock Start/From:
 Clock To:
 1st Value:
 2nd Value:
 Value Percent: **15.000**
 Continuous Index: **S07**
 Within 8" of Joint: **NO**
 Remarks:

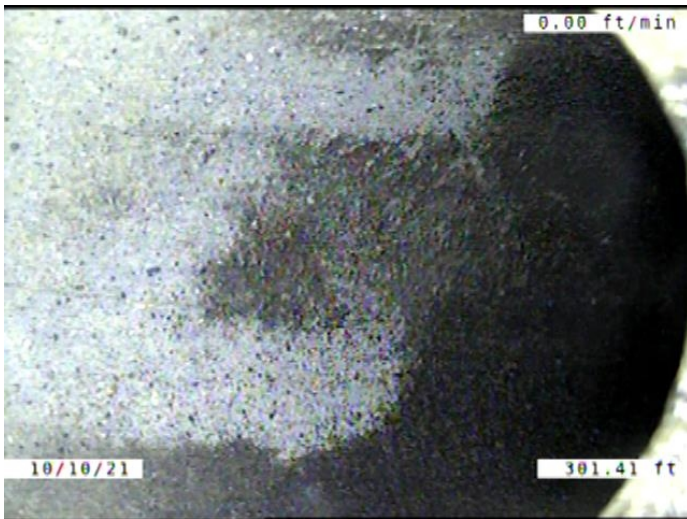
Code: **TB**
Description: **Tap Break-in/Hammer**

Distance (ft): **296.4**
Structural Grade: **0**
O&M Grade: **0**
Clock Start/From: **11**
Clock To:
1st Value: **4.000**
2nd Value:
Value Percent:
Continuous Index:
Within 8" of Joint: **YES**
Remarks:

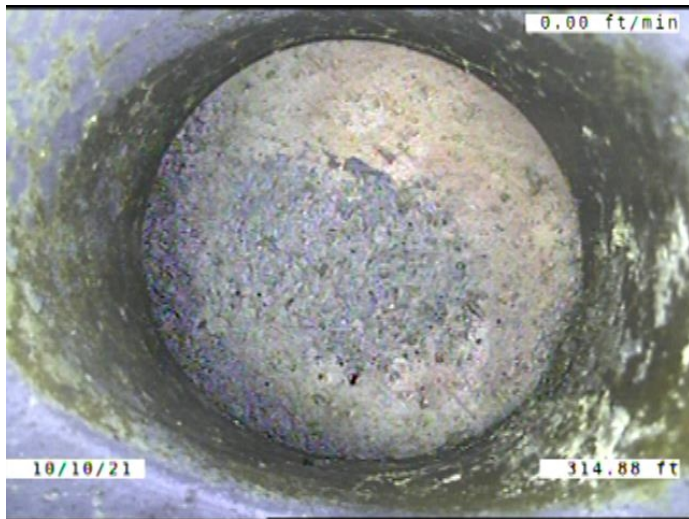
Code: **TFC**
 Description: **Tap Factory Capped**

Distance (ft): **311.7**
 Structural Grade: **0**
 O&M Grade: **0**
 Clock Start/From: **11**
 Clock To:
 1st Value: **4.000**
 2nd Value:
 Value Percent:
 Continuous Index:
 Within 8" of Joint: **YES**
 Remarks:

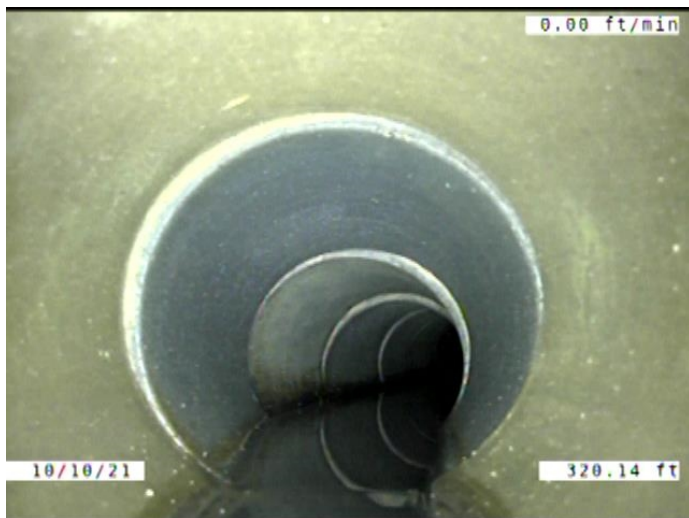
Code: **TFC**
 Description: **Tap Factory Capped**

Distance (ft): **314.9**
 Structural Grade: **0**
 O&M Grade: **0**
 Clock Start/From: **2**
 Clock To:
 1st Value: **4.000**
 2nd Value:
 Value Percent:
 Continuous Index:
 Within 8" of Joint: **YES**
 Remarks:

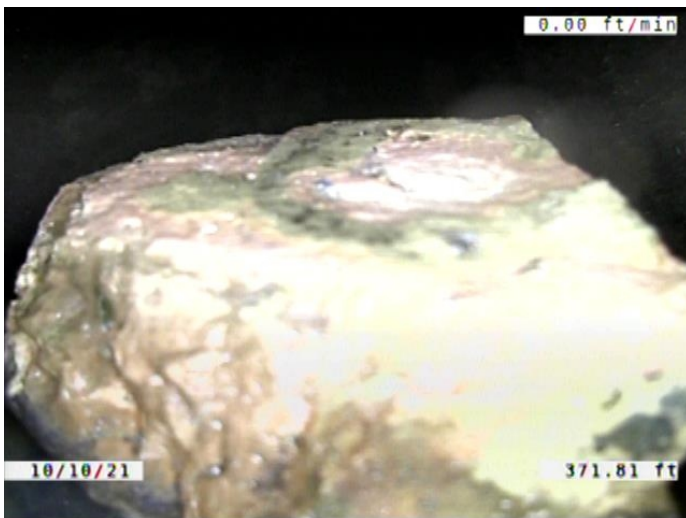
Code: **MWLS**
 Description: **Miscellaneous Water Level Sag**

Distance (ft): **371.3**
 Structural Grade: **2**
 O&M Grade: **0**
 Clock Start/From:
 Clock To:
 1st Value:
 2nd Value:
 Value Percent: **15.000**
 Continuous Index: **F08**
 Within 8" of Joint: **NO**
 Remarks:
