Profile/Photo Observation Report

Date:	10/10/2021	Weather:		Coding:	PACP 7.0
Pipe Length (ft):	378.6	Owner:	City of Hobart	Pre Clean:	Heavy Cleaning
P.O.#:	YES502259	Surveyor:	S. Bucklin	PSR:	P-804-013-014
Customer:	City of Hobart	Clean Date:	10/09/2021	Shape:	C

Street:	East Home Avenue	Flow Control:	Not Controlled
City:	Hobart, IN	Year Renewed:	
Location:	Local rural streets with light traffic, t	Tape/Media #:	
Purpose:	Routine Assessment	Dia/Height:	12"
Use:	Sanitary Sewage Pipe	Material:	VCP
Drain Area:		Lining:	
Category:	NA		
Comment:			
Location Details:		Direction of Survey:	Upstream
US MH:	M-804-014	DS MH:	M-804-013
		Total Length Surveyed (ft):	378.6

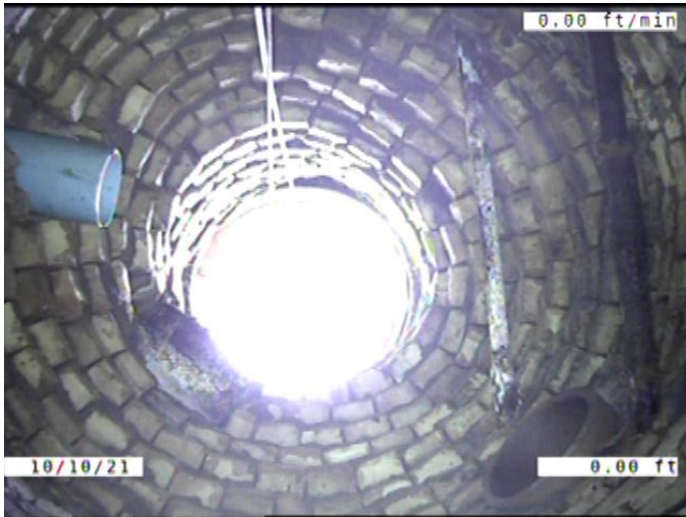
Code: **AMH**
 Description: **Manhole**

Distance (ft): **.0**
 Structural Grade: **0**
 O&M Grade: **0**
 Clock Start/From:
 Clock To:
 1st Value:
 2nd Value:
 Value Percent:
 Continuous Index:
 Within 8" of Joint: **NO**
 Remarks: **M-804-013**

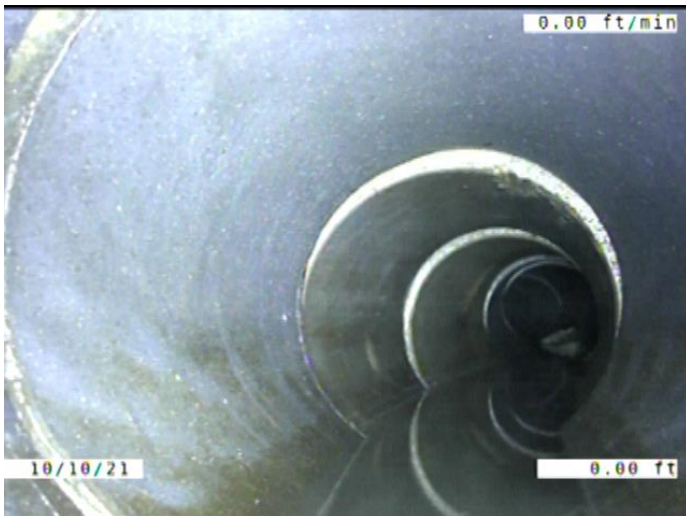
Code: **MWL**
 Description: **Miscellaneous Water Level**

Distance (ft): **.0**
 Structural Grade: **0**
 O&M Grade: **0**
 Clock Start/From:
 Clock To:
 1st Value:
 2nd Value:
 Value Percent: **5.000**
 Continuous Index:
 Within 8" of Joint: **NO**
 Remarks:

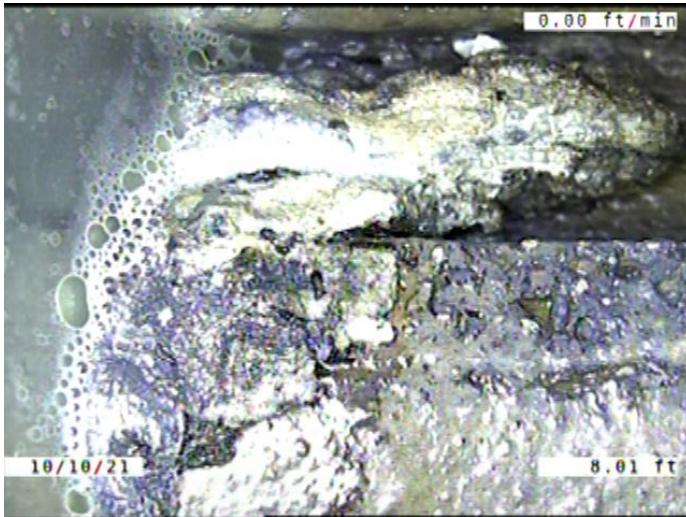
Code: **DAE**
 Description: **Deposits Attached Encrustation**

Distance (ft): **8.0**
 Structural Grade: **0**
 O&M Grade: **2**
 Clock Start/From: **3**
 Clock To: **4**
 1st Value:
 2nd Value:
 Value Percent: **5.000**
 Continuous Index:
 Within 8" of Joint: **YES**
 Remarks:

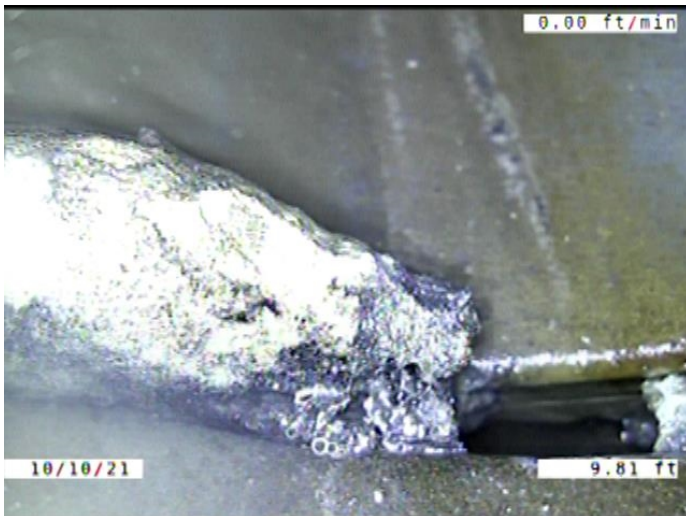
Code: **DAE**
 Description: **Deposits Attached Encrustation**

Distance (ft): **9.8**
 Structural Grade: **0**
 O&M Grade: **2**
 Clock Start/From: **4**
 Clock To: **6**
 1st Value:
 2nd Value:
 Value Percent: **5.000**
 Continuous Index:
 Within 8" of Joint: **YES**
 Remarks:

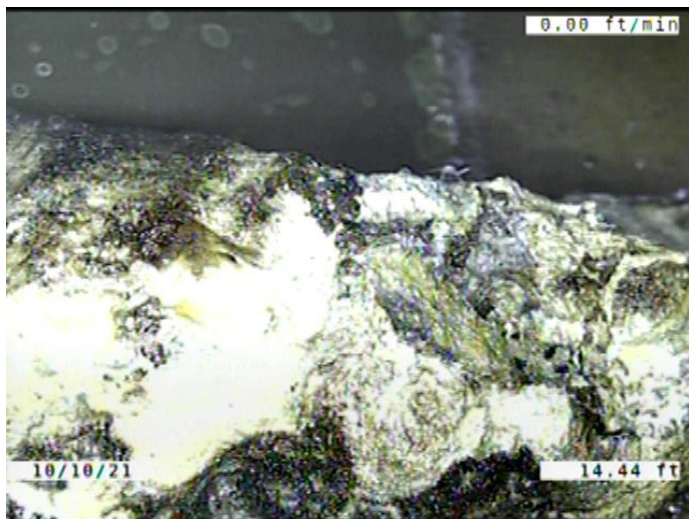
Code: **DAE**
 Description: **Deposits Attached Encrustation**

Distance (ft): **14.4**
 Structural Grade: **0**
 O&M Grade: **2**
 Clock Start/From: **3**
 Clock To: **6**
 1st Value:
 2nd Value:
 Value Percent: **5.000**
 Continuous Index:
 Within 8" of Joint: **YES**
 Remarks:

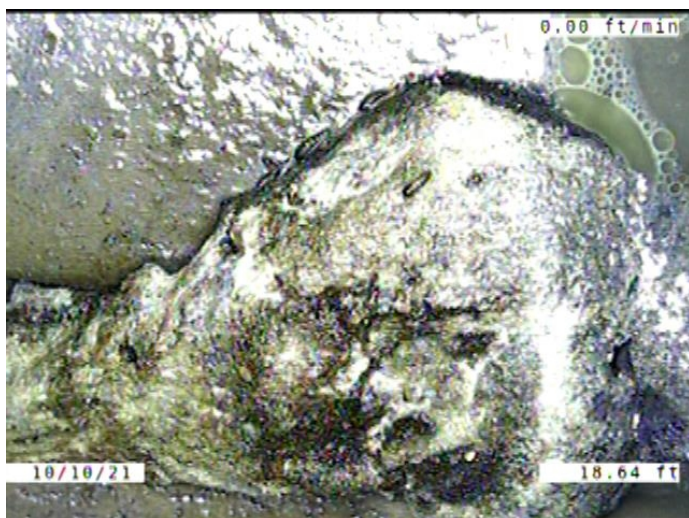
Code: **DAE**
 Description: **Deposits Attached Encrustation**

Distance (ft): **18.6**
 Structural Grade: **0**
 O&M Grade: **2**
 Clock Start/From: **5**
 Clock To: **9**
 1st Value:
 2nd Value:
 Value Percent: **5.000**
 Continuous Index:
 Within 8" of Joint: **YES**
 Remarks:

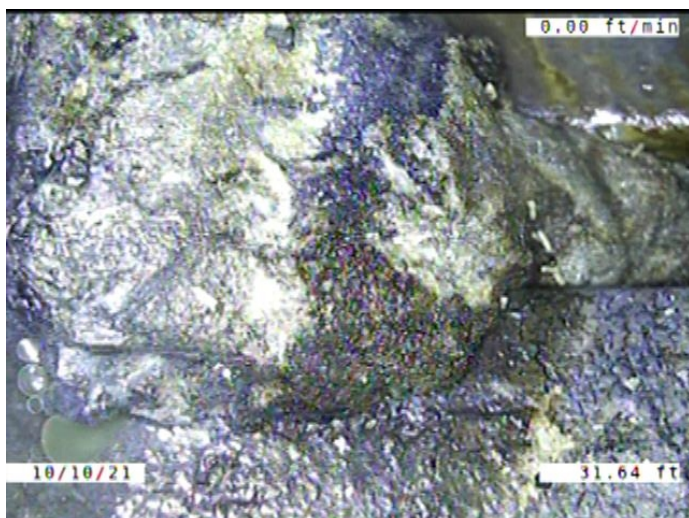
Code: **DAE**
 Description: **Deposits Attached Encrustation**

Distance (ft): **31.6**
 Structural Grade: **0**
 O&M Grade: **2**
 Clock Start/From: **3**
 Clock To: **5**
 1st Value:
 2nd Value:
 Value Percent: **5.000**
 Continuous Index:
 Within 8" of Joint: **YES**
 Remarks:

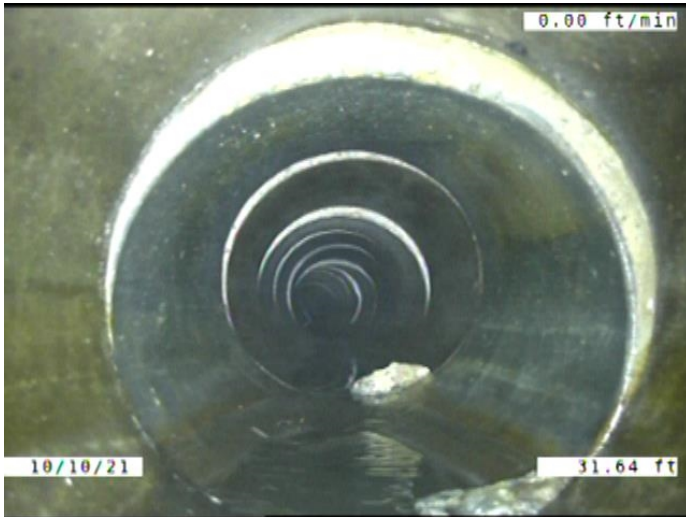
Code: **JOMD**
 Description: **Joint Offset Medium Defective**

Distance (ft): **31.6**
 Structural Grade: **3**
 O&M Grade: **0**
 Clock Start/From:
 Clock To:
 1st Value:
 2nd Value:
 Value Percent:
 Continuous Index: **S01**
 Within 8" of Joint: **NO**
 Remarks:

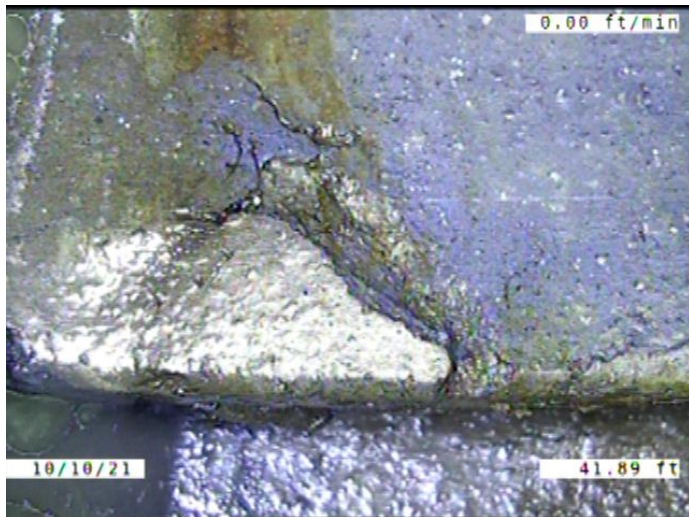
Code: **B**
 Description: **Broken**

Distance (ft): **41.9**
 Structural Grade: **4**
 O&M Grade: **0**
 Clock Start/From: **3**
 Clock To: **4**
 1st Value:
 2nd Value:
 Value Percent:
 Continuous Index:
 Within 8" of Joint: **YES**
 Remarks:

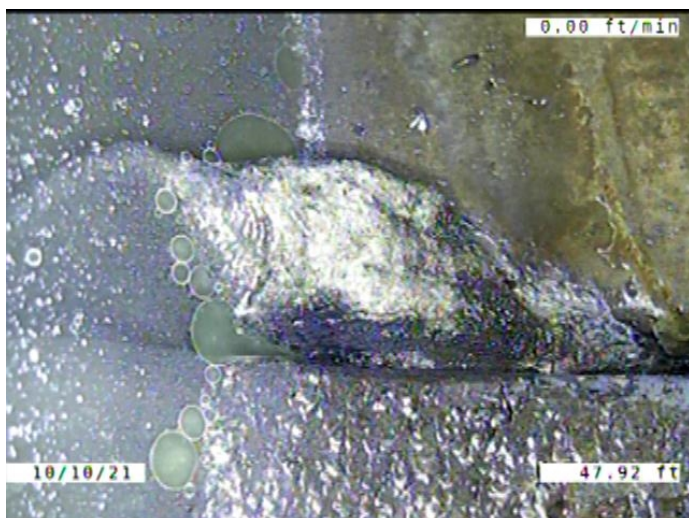
Code: **DAE**
 Description: **Deposits Attached Encrustation**

Distance (ft): **47.9**
 Structural Grade: **0**
 O&M Grade: **2**
 Clock Start/From: **4**
 Clock To:
 1st Value:
 2nd Value:
 Value Percent: **5.000**
 Continuous Index:
 Within 8" of Joint: **YES**
 Remarks:

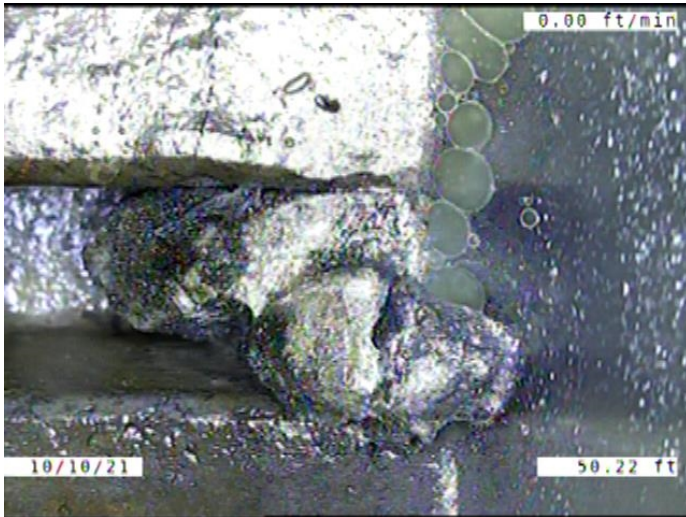
Code: **DAE**
 Description: **Deposits Attached Encrustation**

Distance (ft): **50.2**
 Structural Grade: **0**
 O&M Grade: **2**
 Clock Start/From: **7**
 Clock To:
 1st Value:
 2nd Value:
 Value Percent: **5.000**
 Continuous Index:
 Within 8" of Joint: **YES**
 Remarks:

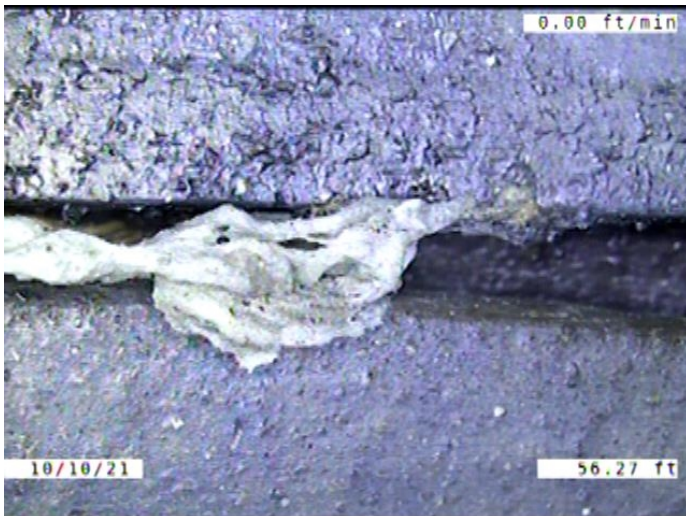
Code: **RFJ**
 Description: **Roots Fine Joint**

Distance (ft): **56.3**
 Structural Grade: **0**
 O&M Grade: **1**
 Clock Start/From: **10**
 Clock To:
 1st Value:
 2nd Value:
 Value Percent:
 Continuous Index:
 Within 8" of Joint: **YES**
 Remarks:

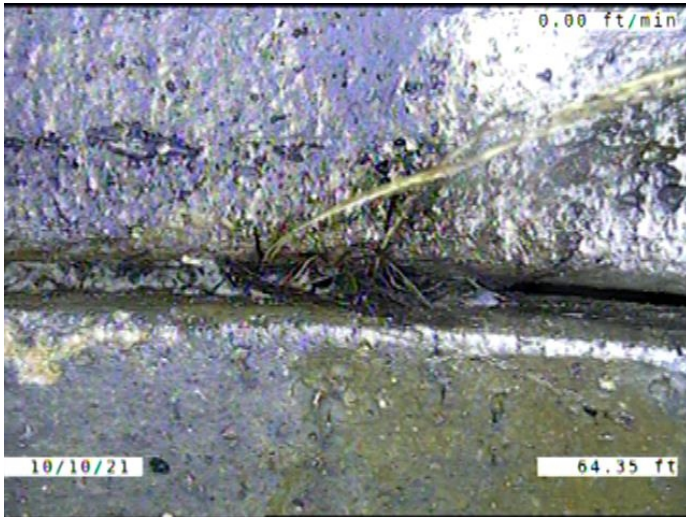
Code: **RFJ**
 Description: **Roots Fine Joint**

Distance (ft): **64.4**
 Structural Grade: **0**
 O&M Grade: **1**
 Clock Start/From: **3**
 Clock To:
 1st Value:
 2nd Value:
 Value Percent:
 Continuous Index:
 Within 8" of Joint: **YES**
 Remarks:

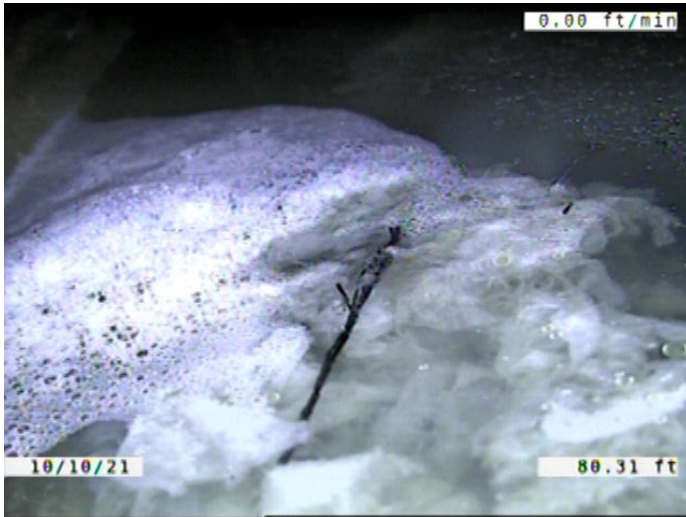
Code: **DSF**
 Description: **Deposits Settled Fine**

Distance (ft): **80.3**
 Structural Grade: **0**
 O&M Grade: **2**
 Clock Start/From: **5**
 Clock To: **7**
 1st Value:
 2nd Value:
 Value Percent: **5.000**
 Continuous Index: **S02**
 Within 8" of Joint: **YES**
 Remarks:

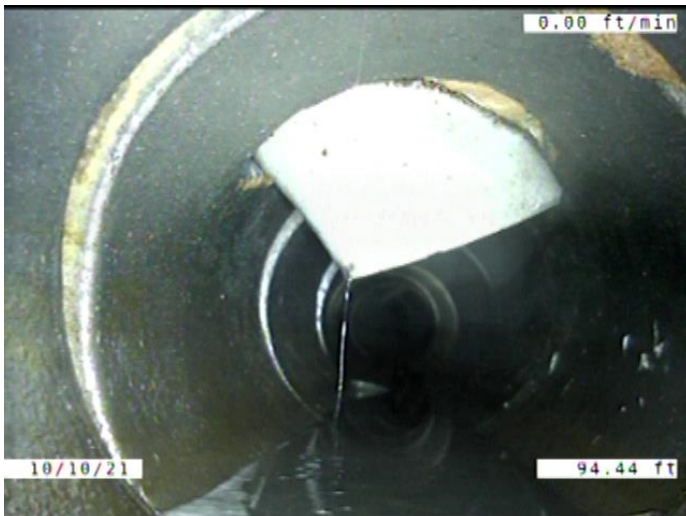
Code: **TBI**
 Description: **Tap Break-in Intruding**

Distance (ft): **94.4**
 Structural Grade: **0**
 O&M Grade: **2**
 Clock Start/From: **11**
 Clock To:
 1st Value: **4.000**
 2nd Value: **4.000**
 Value Percent:
 Continuous Index:
 Within 8" of Joint: **YES**
 Remarks:

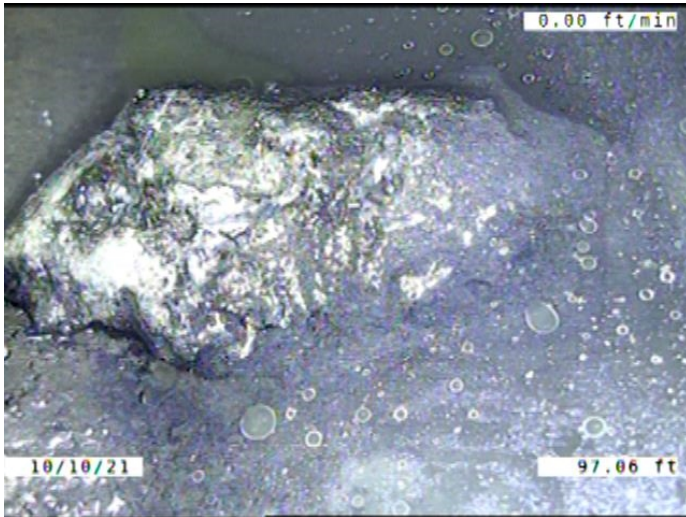
Code: **DAE**
 Description: **Deposits Attached Encrustation**

Distance (ft): **97.1**
 Structural Grade: **0**
 O&M Grade: **2**
 Clock Start/From: **7**
 Clock To:
 1st Value:
 2nd Value:
 Value Percent: **5.000**
 Continuous Index:
 Within 8" of Joint: **YES**
 Remarks:

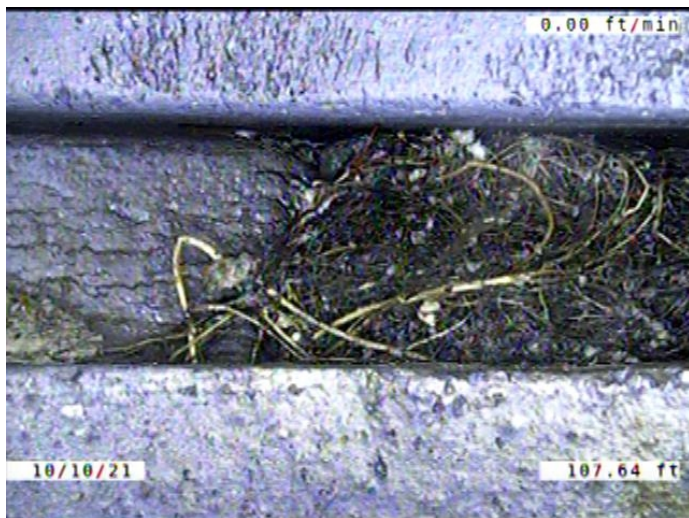
Code:	RFJ
Description:	Roots Fine Joint
Distance (ft):	107.6
Structural Grade:	0
O&M Grade:	1
Clock Start/From:	1
Clock To:	3
1st Value:	
2nd Value:	
Value Percent:	
Continuous Index:	
Within 8" of Joint:	YES
Remarks:

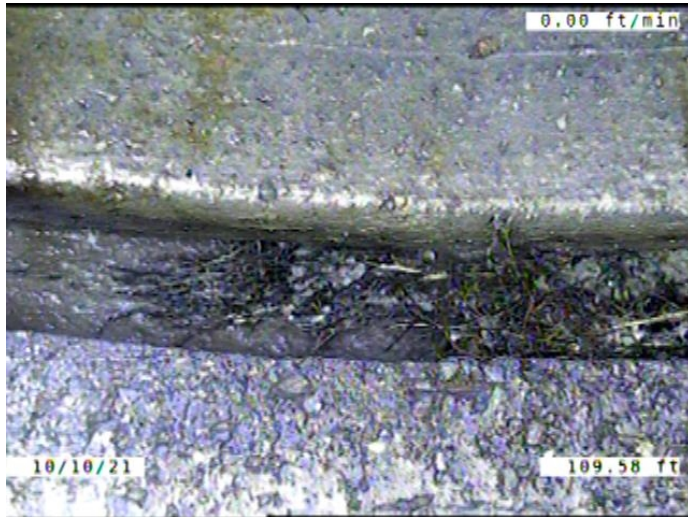
Code: **RFJ**
 Description: **Roots Fine Joint**

Distance (ft): **109.6**
 Structural Grade: **0**
 O&M Grade: **1**
 Clock Start/From: **3**
 Clock To: **4**
 1st Value:
 2nd Value:
 Value Percent:
 Continuous Index:
 Within 8" of Joint: **YES**
 Remarks:

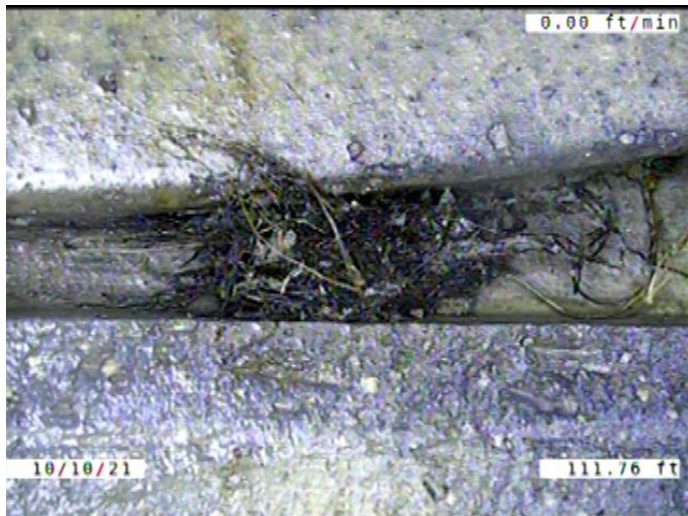
Code: **RFJ**
 Description: **Roots Fine Joint**

Distance (ft): **111.8**
 Structural Grade: **0**
 O&M Grade: **1**
 Clock Start/From: **3**
 Clock To:
 1st Value:
 2nd Value:
 Value Percent:
 Continuous Index:
 Within 8" of Joint: **YES**
 Remarks:

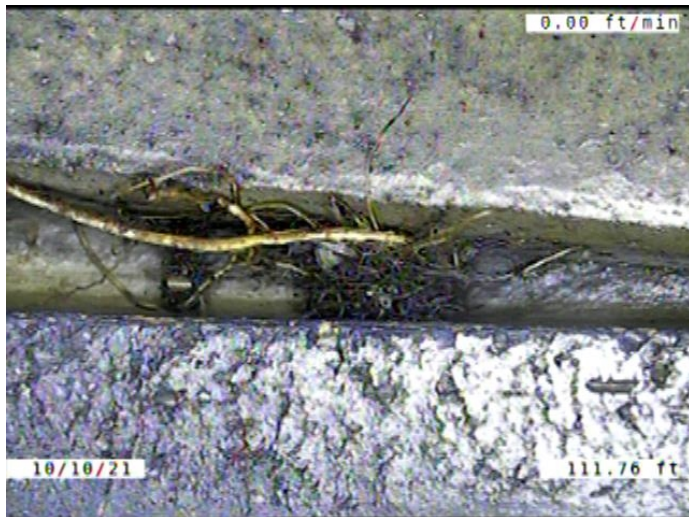
Code: **RFJ**
 Description: **Roots Fine Joint**

Distance (ft): **111.8**
 Structural Grade: **0**
 O&M Grade: **1**
 Clock Start/From: **8**
 Clock To:
 1st Value:
 2nd Value:
 Value Percent:
 Continuous Index:
 Within 8" of Joint: **YES**
 Remarks:

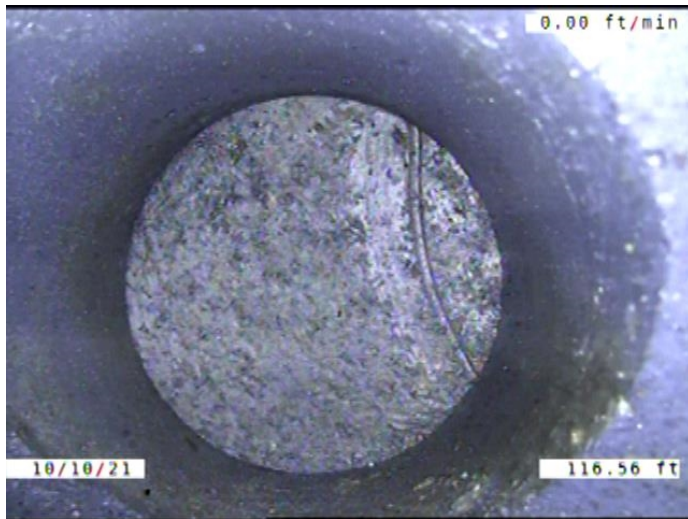
Code: **TFC**
 Description: **Tap Factory Capped**

Distance (ft): **116.6**
 Structural Grade: **0**
 O&M Grade: **0**
 Clock Start/From: **2**
 Clock To:
 1st Value: **4.000**
 2nd Value:
 Value Percent:
 Continuous Index:
 Within 8" of Joint: **YES**
 Remarks:

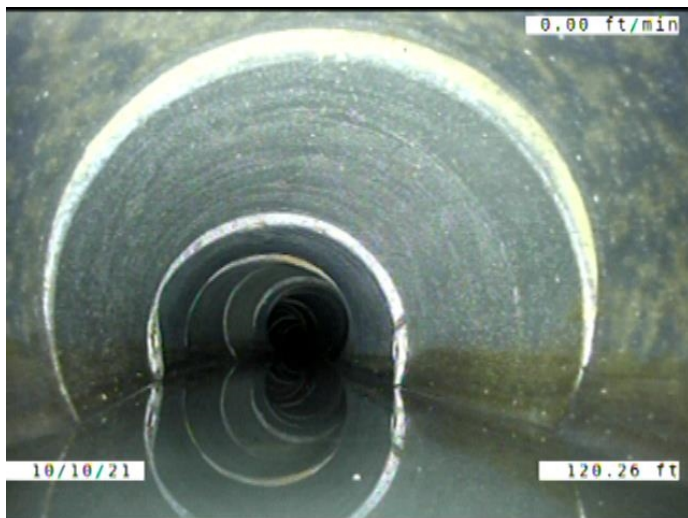
Code: **MWLS**
 Description: **Miscellaneous Water Level Sag**

Distance (ft): **120.3**
 Structural Grade: **2**
 O&M Grade: **0**
 Clock Start/From:
 Clock To:
 1st Value:
 2nd Value:
 Value Percent: **10.000**
 Continuous Index: **S03**
 Within 8" of Joint: **NO**
 Remarks:

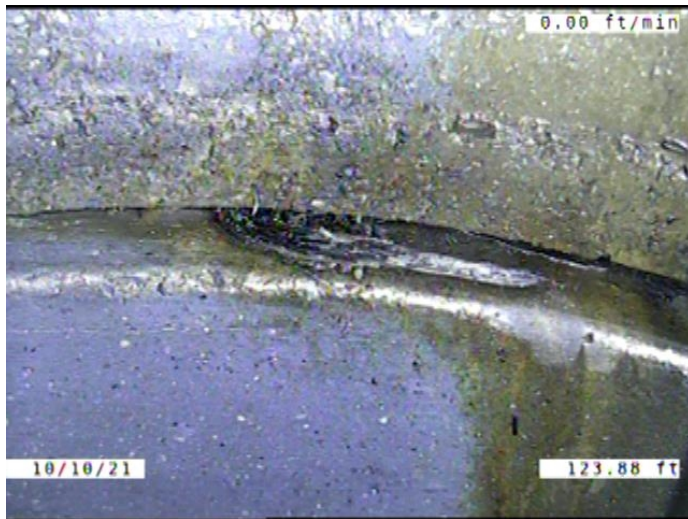
Code: **RFJ**
 Description: **Roots Fine Joint**

Distance (ft): **123.9**
 Structural Grade: **0**
 O&M Grade: **1**
 Clock Start/From: **3**
 Clock To:
 1st Value:
 2nd Value:
 Value Percent:
 Continuous Index:
 Within 8" of Joint: **YES**
 Remarks:

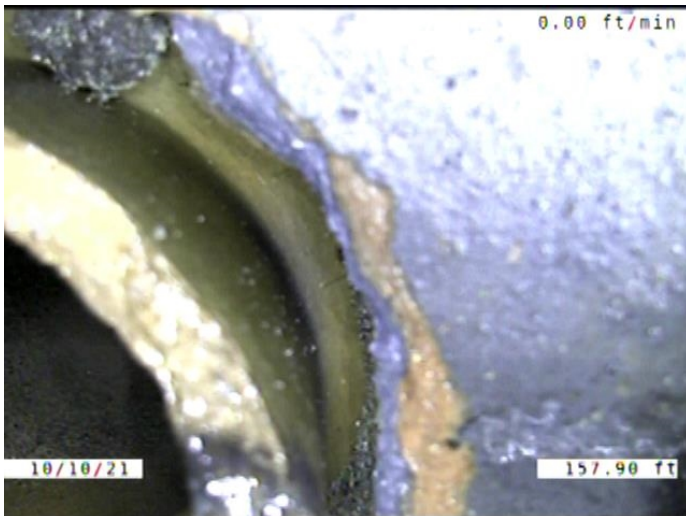
Code: **SSS**
 Description: **Surface Damage Surface Spalling**

Distance (ft): **157.9**
 Structural Grade: **2**
 O&M Grade: **0**
 Clock Start/From: **12**
 Clock To: **2**
 1st Value:
 2nd Value:
 Value Percent:
 Continuous Index:
 Within 8" of Joint: **YES**
 Remarks:

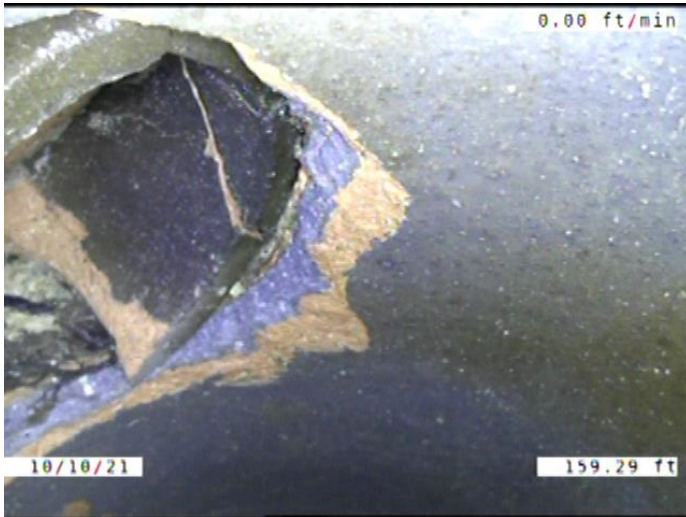
Code: **SSS**
 Description: **Surface Damage Surface Spalling**

Distance (ft): **159.3**
 Structural Grade: **2**
 O&M Grade: **0**
 Clock Start/From: **9**
 Clock To: **12**
 1st Value:
 2nd Value:
 Value Percent:
 Continuous Index:
 Within 8" of Joint: **YES**
 Remarks:

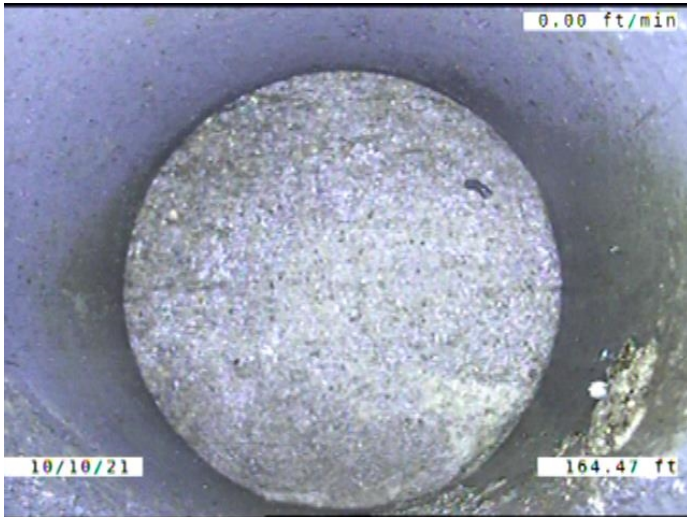
Code: **TFC**
 Description: **Tap Factory Capped**

Distance (ft): **164.5**
 Structural Grade: **0**
 O&M Grade: **0**
 Clock Start/From: **2**
 Clock To:
 1st Value: **4.000**
 2nd Value:
 Value Percent:
 Continuous Index:
 Within 8" of Joint: **YES**
 Remarks:

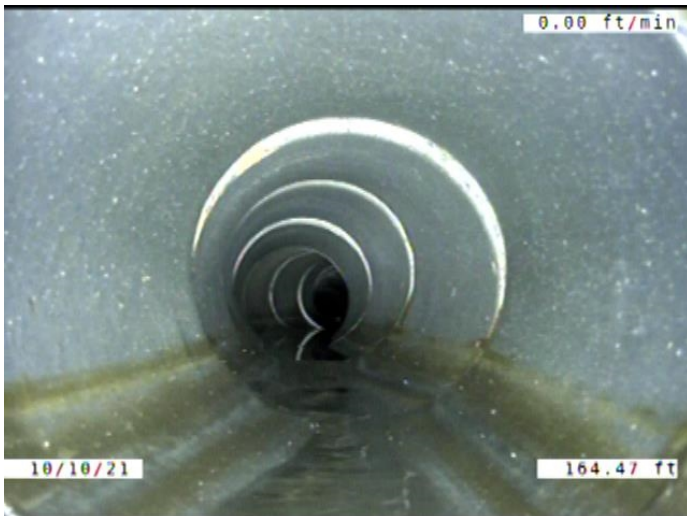
Code: **MWLS**
 Description: **Miscellaneous Water Level Sag**

Distance (ft): **164.5**
 Structural Grade: **2**
 O&M Grade: **0**
 Clock Start/From:
 Clock To:
 1st Value:
 2nd Value:
 Value Percent: **10.000**
 Continuous Index: **F03**
 Within 8" of Joint: **NO**
 Remarks:

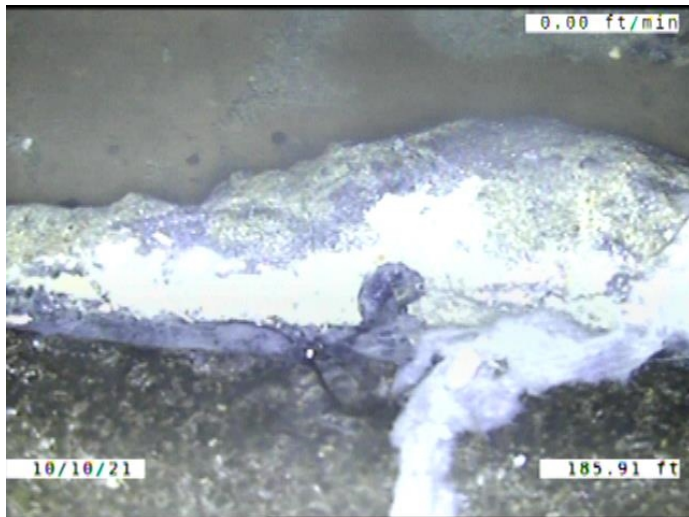
Code: **DAE**
 Description: **Deposits Attached Encrustation**

Distance (ft): **185.9**
 Structural Grade: **0**
 O&M Grade: **2**
 Clock Start/From: **4**
 Clock To: **7**
 1st Value:
 2nd Value:
 Value Percent: **5.000**
 Continuous Index:
 Within 8" of Joint: **YES**
 Remarks:

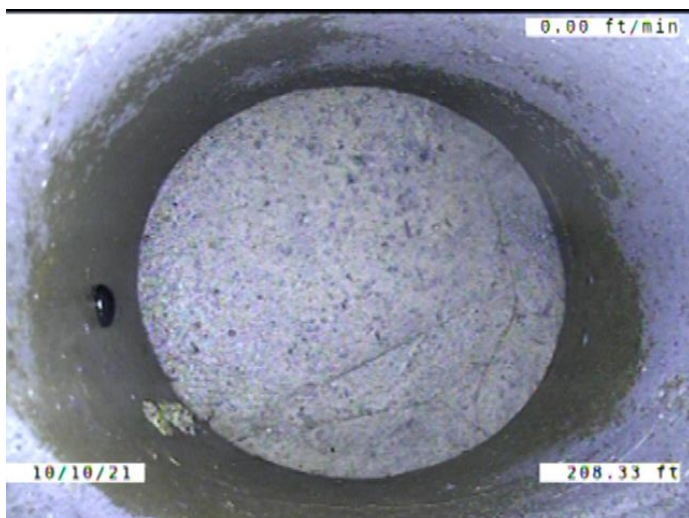
Code: **TFC**
 Description: **Tap Factory Capped**

Distance (ft): **208.3**
 Structural Grade: **0**
 O&M Grade: **0**
 Clock Start/From: **10**
 Clock To:
 1st Value: **4.000**
 2nd Value:
 Value Percent:
 Continuous Index:
 Within 8" of Joint: **YES**
 Remarks:

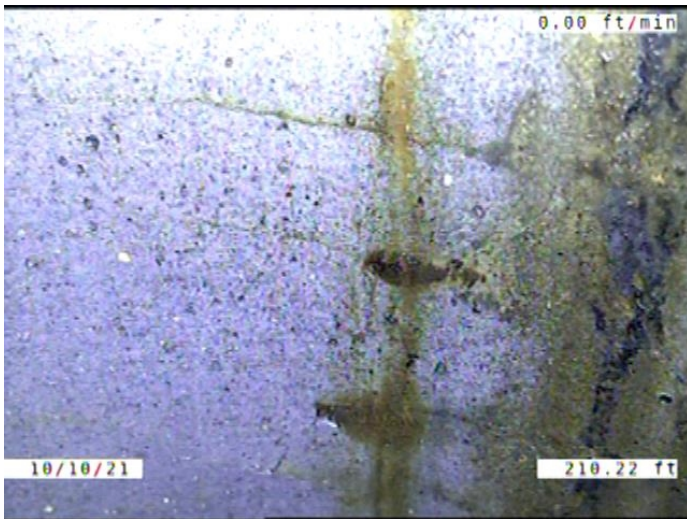
Code: **ISB**
Description: **Infiltration Stain Barrel**

Distance (ft): **210.2**
Structural Grade: **0**
O&M Grade: **1**
Clock Start/From: **3**
Clock To: **4**
1st Value:
2nd Value:
Value Percent:
Continuous Index:
Within 8" of Joint: **NO**
Remarks:

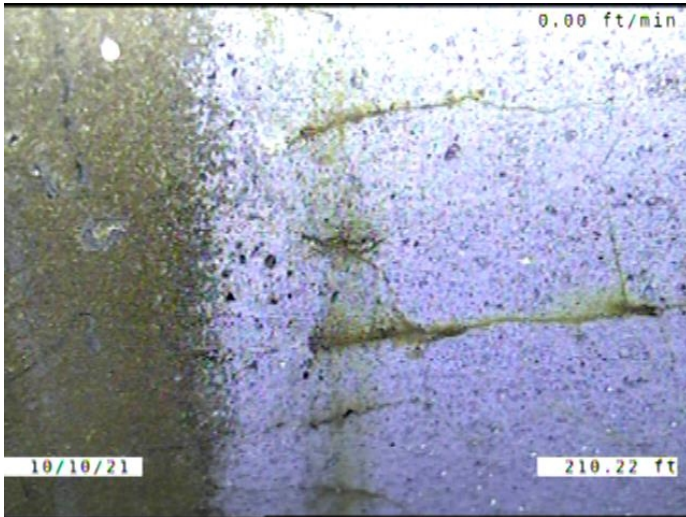
Code: **ISB**
 Description: **Infiltration Stain Barrel**

Distance (ft): **210.2**
 Structural Grade: **0**
 O&M Grade: **1**
 Clock Start/From: **3**
 Clock To: **4**
 1st Value:
 2nd Value:
 Value Percent:
 Continuous Index:
 Within 8" of Joint: **NO**
 Remarks:

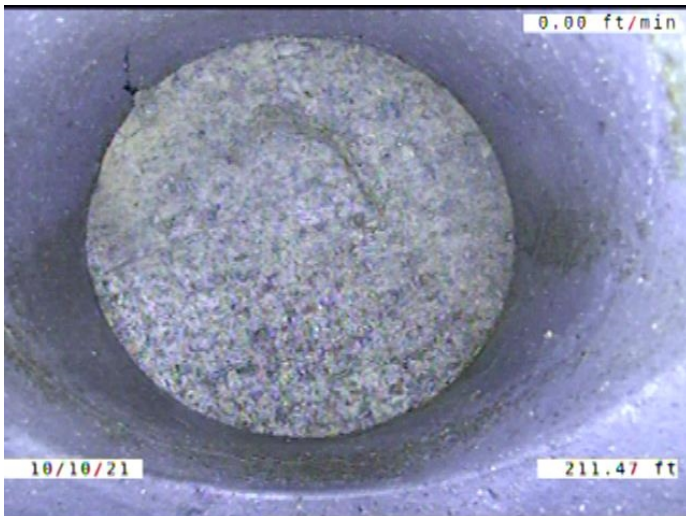
Code: **TFC**
 Description: **Tap Factory Capped**

Distance (ft): **211.5**
 Structural Grade: **0**
 O&M Grade: **0**
 Clock Start/From: **2**
 Clock To:
 1st Value: **4.000**
 2nd Value:
 Value Percent:
 Continuous Index:
 Within 8" of Joint: **YES**
 Remarks:

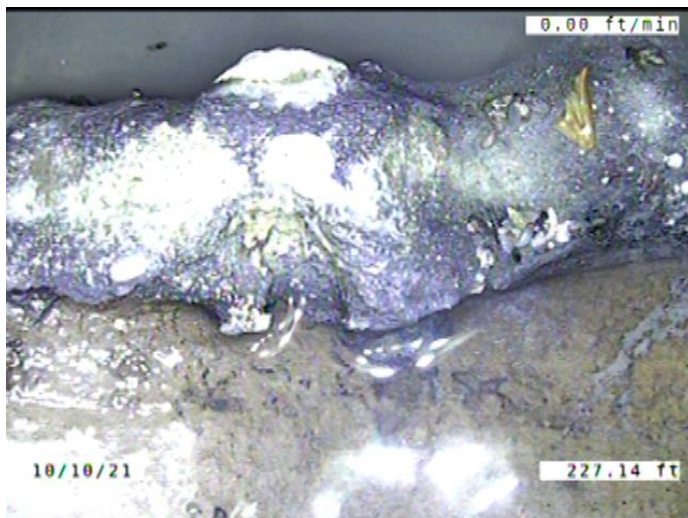
Code: **DAE**
 Description: **Deposits Attached Encrustation**

Distance (ft): **227.1**
 Structural Grade: **0**
 O&M Grade: **2**
 Clock Start/From: **5**
 Clock To: **7**
 1st Value:
 2nd Value:
 Value Percent: **5.000**
 Continuous Index:
 Within 8" of Joint: **YES**
 Remarks:

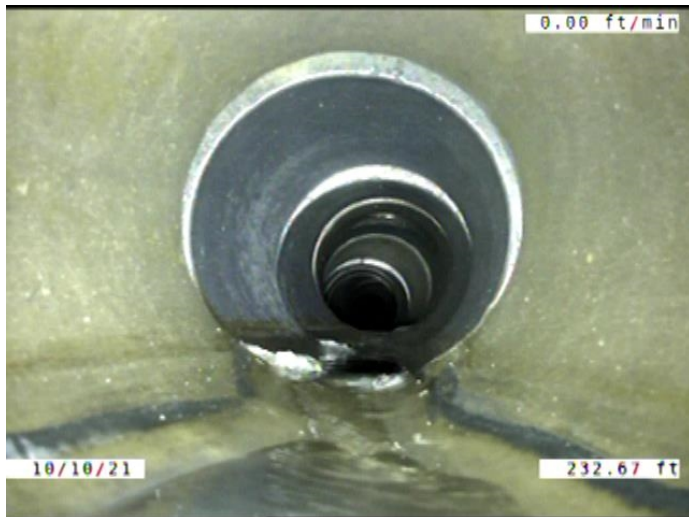
Code: **MWLS**
 Description: **Miscellaneous Water Level Sag**

Distance (ft): **232.7**
 Structural Grade: **2**
 O&M Grade: **0**
 Clock Start/From:
 Clock To:
 1st Value:
 2nd Value:
 Value Percent: **5.000**
 Continuous Index:
 Within 8" of Joint: **NO**
 Remarks:

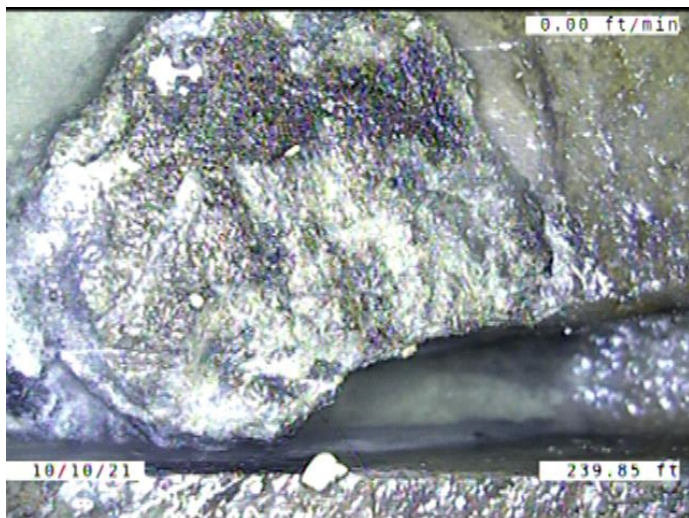
Code: **DAE**
 Description: **Deposits Attached Encrustation**

Distance (ft): **239.8**
 Structural Grade: **0**
 O&M Grade: **2**
 Clock Start/From: **4**
 Clock To: **5**
 1st Value:
 2nd Value:
 Value Percent: **5.000**
 Continuous Index:
 Within 8" of Joint: **YES**
 Remarks:

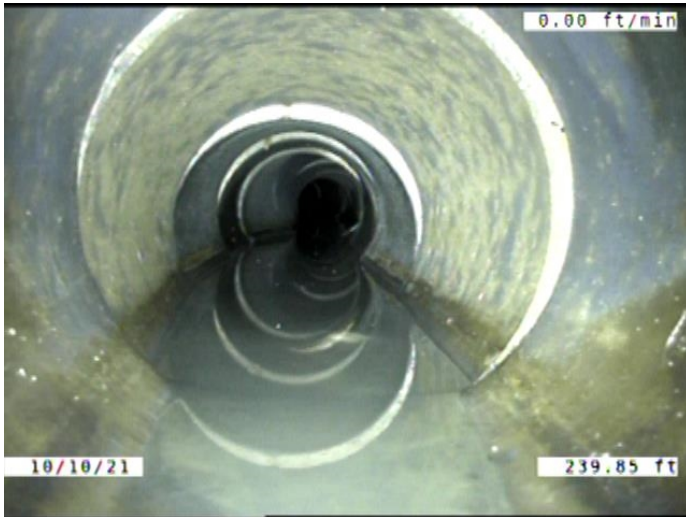
Code: **MWLS**
 Description: **Miscellaneous Water Level Sag**

Distance (ft): **239.9**
 Structural Grade: **2**
 O&M Grade: **0**
 Clock Start/From:
 Clock To:
 1st Value:
 2nd Value:
 Value Percent: **15.000**
 Continuous Index: **S04**
 Within 8" of Joint: **NO**
 Remarks:

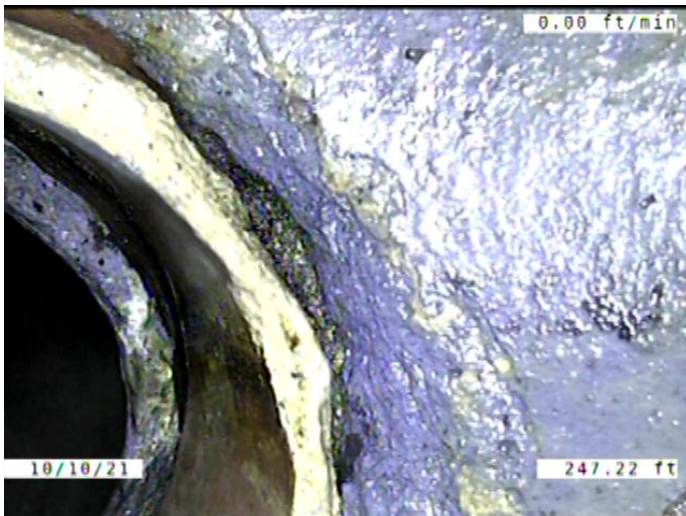
Code: **SSS**
 Description: **Surface Damage Surface Spalling**

Distance (ft): **247.2**
 Structural Grade: **2**
 O&M Grade: **0**
 Clock Start/From: **11**
 Clock To: **2**
 1st Value:
 2nd Value:
 Value Percent:
 Continuous Index:
 Within 8" of Joint: **YES**
 Remarks:

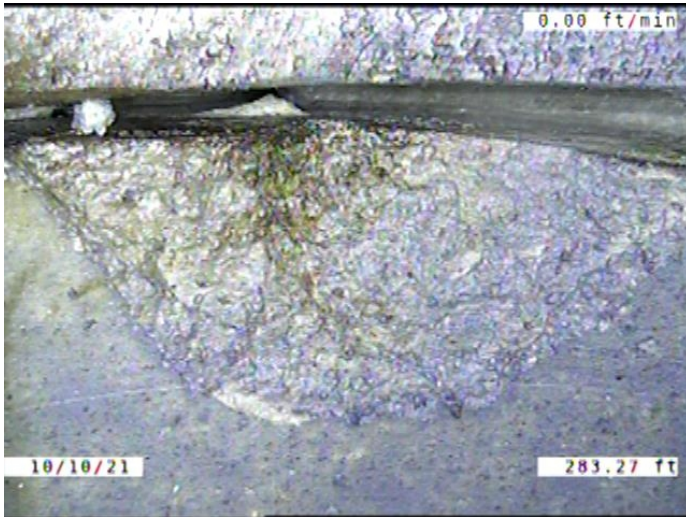
Code:	SZ
Description:	Surface Damage Other
Distance (ft):	277.2
Structural Grade:	0
O&M Grade:	0
Clock Start/From:	12
Clock To:	
1st Value:	
2nd Value:	
Value Percent:	
Continuous Index:	
Within 8" of Joint:	YES
Remarks:	A PIECE CHIPPED AWAY FROM THE JOINT

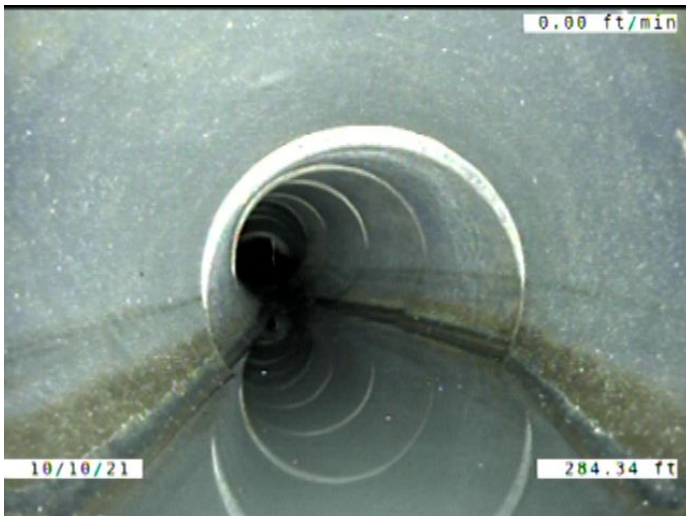
Code: **SZ**
 Description: **Surface Damage Other**

Distance (ft): **283.3**
 Structural Grade: **0**
 O&M Grade: **0**
 Clock Start/From: **8**
 Clock To: **9**
 1st Value:
 2nd Value:
 Value Percent:
 Continuous Index:
 Within 8" of Joint: **YES**
 Remarks: **A PIECE CHIPPED AWAY FROM THE JOINT**

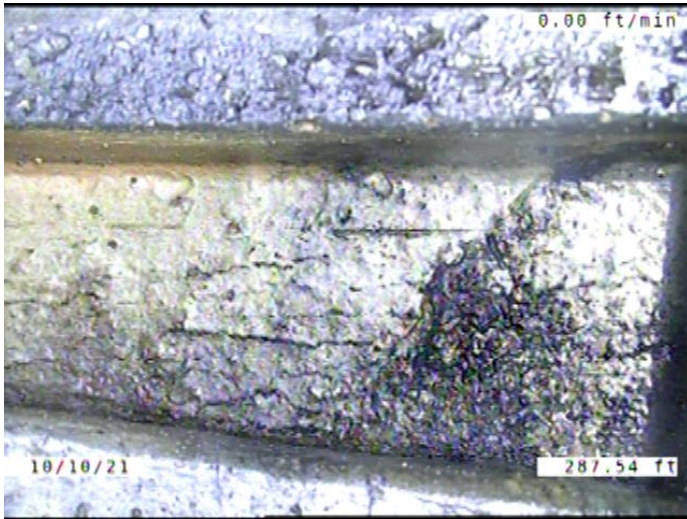
Code: **MWLS**
 Description: **Miscellaneous Water Level Sag**

Distance (ft): **284.3**
 Structural Grade: **2**
 O&M Grade: **0**
 Clock Start/From:
 Clock To:
 1st Value:
 2nd Value:
 Value Percent: **10.000**
 Continuous Index: **S05**
 Within 8" of Joint: **NO**
 Remarks:

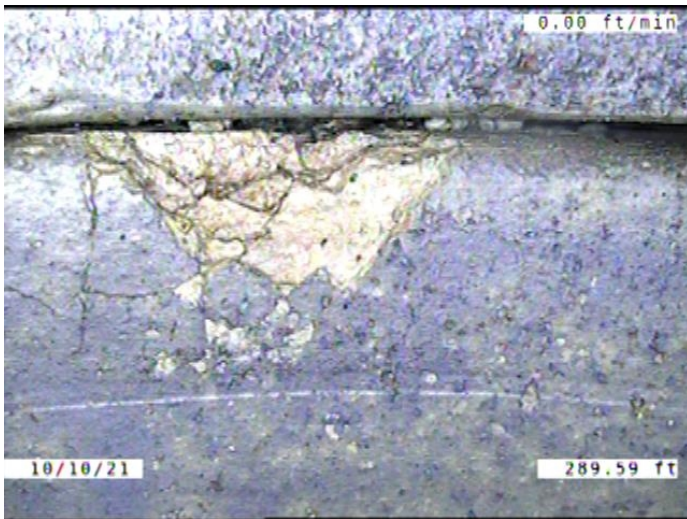
Code: **JAM**
 Description: **Joint Angular Medium**

Distance (ft): **287.5**
 Structural Grade: **3**
 O&M Grade: **0**
 Clock Start/From:
 Clock To:
 1st Value:
 2nd Value:
 Value Percent:
 Continuous Index:
 Within 8" of Joint: **NO**
 Remarks:

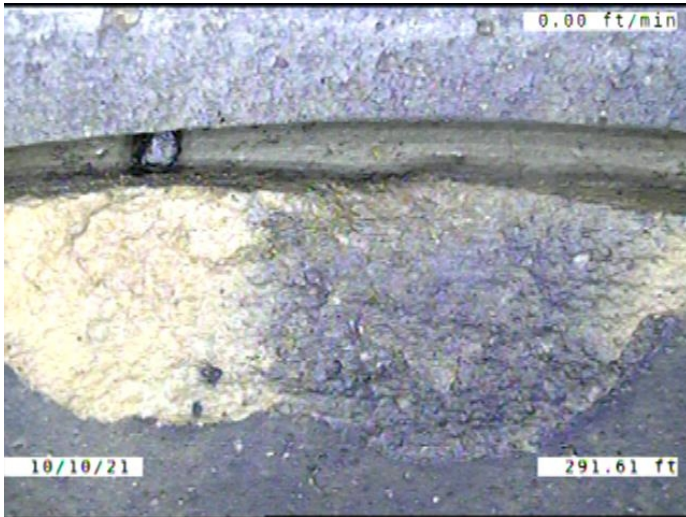
Code: **SZ**
 Description: **Surface Damage Other**

Distance (ft): **289.6**
 Structural Grade: **0**
 O&M Grade: **0**
 Clock Start/From: **10**
 Clock To:
 1st Value:
 2nd Value:
 Value Percent:
 Continuous Index:
 Within 8" of Joint: **YES**
 Remarks: **A PIECE CHIPPED AWAY FROM THE JOINT**

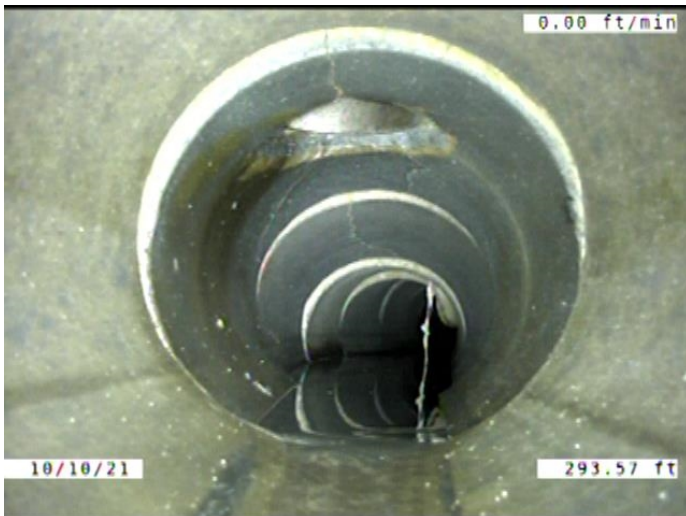
Code: **SZ**
 Description: **Surface Damage Other**

Distance (ft): **291.6**
 Structural Grade: **0**
 O&M Grade: **0**
 Clock Start/From: **10**
 Clock To: **11**
 1st Value:
 2nd Value:
 Value Percent:
 Continuous Index:
 Within 8" of Joint: **YES**
 Remarks: **A PIECE CHIPPED AWAY FROM THE JOINT**

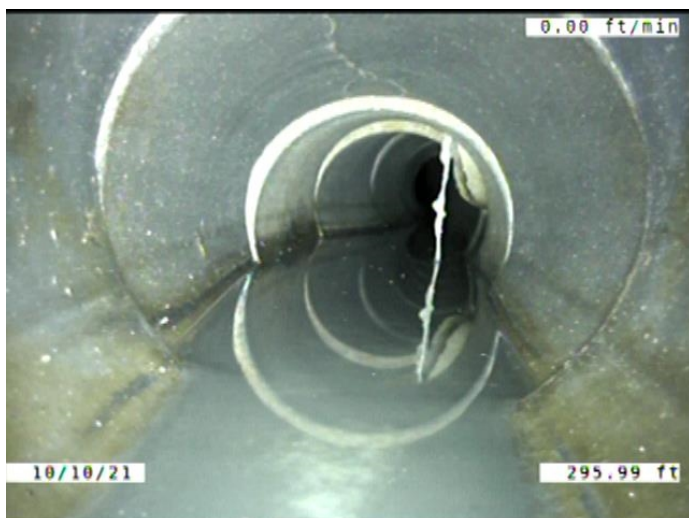
Code: **FM**
 Description: **Fracture Multiple**

Distance (ft): **295.7**
 Structural Grade: **4**
 O&M Grade: **0**
 Clock Start/From: **10**
 Clock To: **3**
 1st Value:
 2nd Value:
 Value Percent:
 Continuous Index:
 Within 8" of Joint: **YES**
 Remarks:

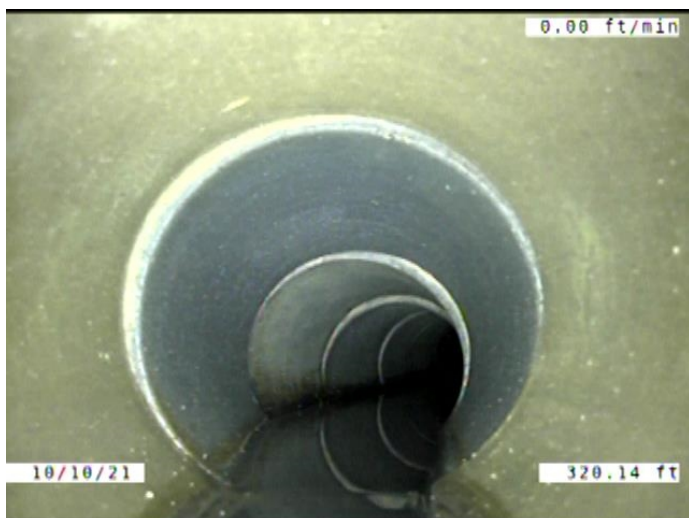
Code: **TFC**
 Description: **Tap Factory Capped**

Distance (ft): **314.9**
 Structural Grade: **0**
 O&M Grade: **0**
 Clock Start/From: **2**
 Clock To:
 1st Value: **4.000**
 2nd Value:
 Value Percent:
 Continuous Index:
 Within 8" of Joint: **YES**
 Remarks:

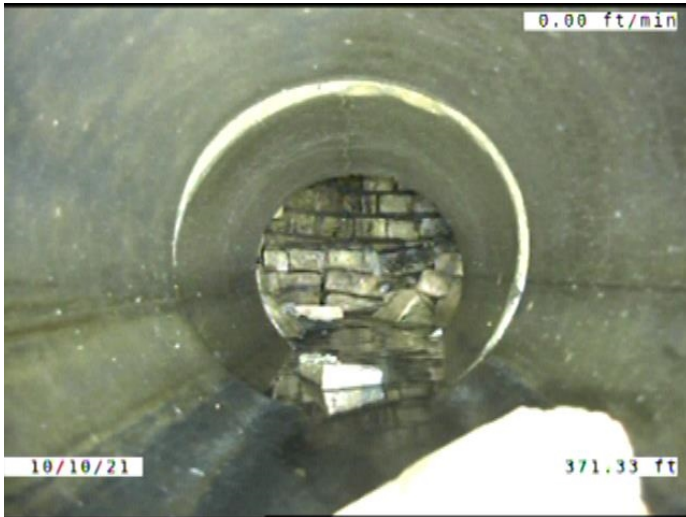
Code: **MWLS**
 Description: **Miscellaneous Water Level Sag**

Distance (ft): **320.1**
 Structural Grade: **2**
 O&M Grade: **0**
 Clock Start/From:
 Clock To:
 1st Value:
 2nd Value:
 Value Percent: **15.000**
 Continuous Index: **S08**
 Within 8" of Joint: **NO**
 Remarks:

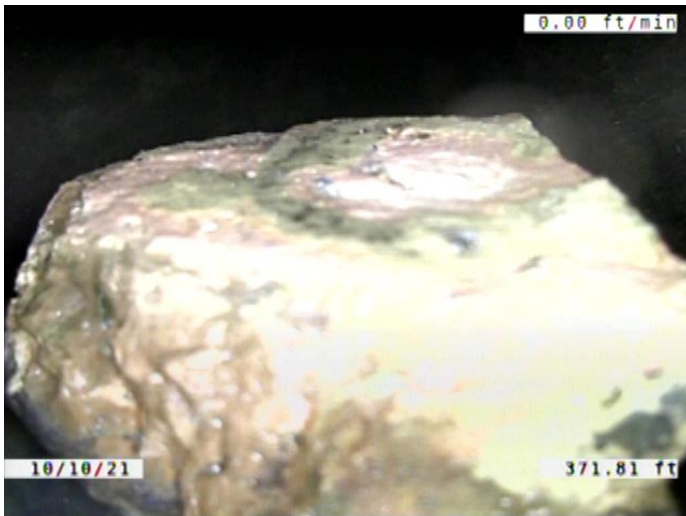
Code: **MWLS**
Description: **Miscellaneous Water Level Sag**

Distance (ft): **371.3**
Structural Grade: **2**
O&M Grade: **0**
Clock Start/From:
Clock To:
1st Value:
2nd Value:
Value Percent: **15.000**
Continuous Index: **F08**
Within 8" of Joint: **NO**
Remarks:

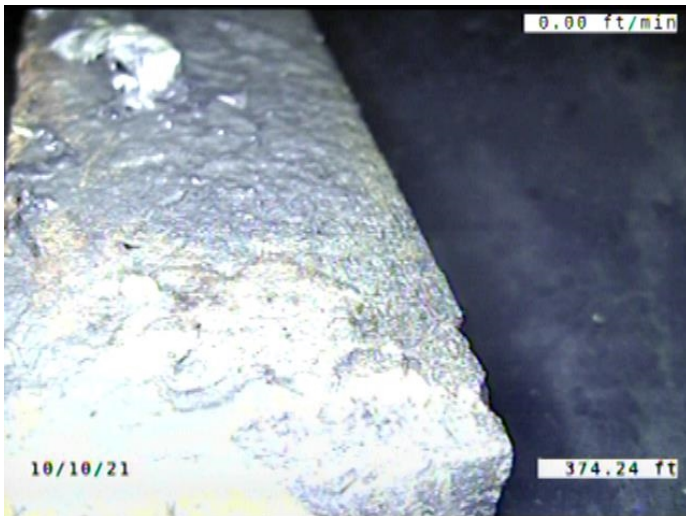
Code:	SZ
Description:	Surface Damage Other
Distance (ft):	374.1
Structural Grade:	0
O&M Grade:	0
Clock Start/From:	12
Clock To:	1
1st Value:	
2nd Value:	
Value Percent:	
Continuous Index:	
Within 8" of Joint:	YES
Remarks:	A FEW PIECES CHIPPED AWAY FROM THE JOINT

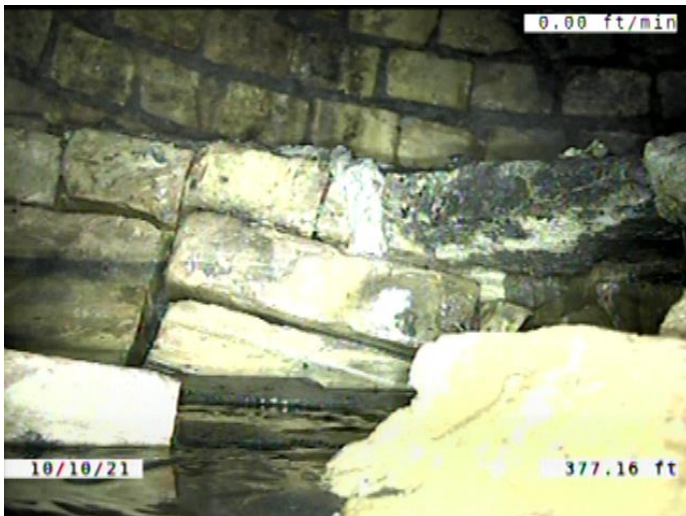
Code: **JOMD**
 Description: **Joint Offset Medium Defective**

Distance (ft): **377.2**
 Structural Grade: **3**
 O&M Grade: **0**
 Clock Start/From:
 Clock To:
 1st Value:
 2nd Value:
 Value Percent:
 Continuous Index: **F01**
 Within 8" of Joint: **NO**
 Remarks:

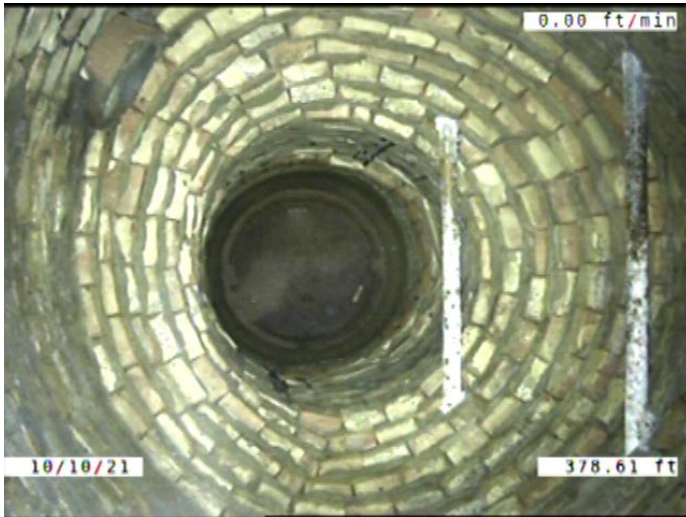
Code: **DSF**
 Description: **Deposits Settled Fine**

Distance (ft): **377.2**
 Structural Grade: **0**
 O&M Grade: **2**
 Clock Start/From: **5**
 Clock To: **7**
 1st Value:
 2nd Value:
 Value Percent: **5.000**
 Continuous Index: **F02**
 Within 8" of Joint: **YES**
 Remarks:
