## Profile/Photo Observation Report

Date:	<b>10/11/2021</b>	Weather:		Coding:	<b>PACP 7.0</b>
Pipe Length (ft):	<b>111.1</b>	Owner:	<b>City of Hobart</b>	Pre Clean:	<b>Heavy Cleaning</b>
P.O.#:	<b>YES502259</b>	Surveyor:	<b>S. Bucklin</b>	PSR:	<b>P-804-014-015</b>
Customer:	<b>City of Hobart</b>	Clean Date:	<b>10/09/2021</b>	Shape:	<b>C</b>

Street:	<b>East Home Avenue</b>	Flow Control:	<b>Not Controlled</b>
City:	<b>Hobart, IN</b>	Year Renewed:	
Location:	<b>Local rural streets with light traffic, t</b>	Tape/Media #:	
Purpose:	<b>Routine Assessment</b>	Dia/Height:	<b>12"</b>
Use:	<b>Sanitary Sewage Pipe</b>	Material:	<b>VCP</b>
Drain Area:		Lining:	
Category:	<b>NA</b>		
Comment:			
Location Details:		Direction of Survey:	<b>Upstream</b>
US MH:	<b>M-804-015</b>	DS MH:	<b>M-804-014</b>
		Total Length Surveyed (ft):	<b>111.1</b>

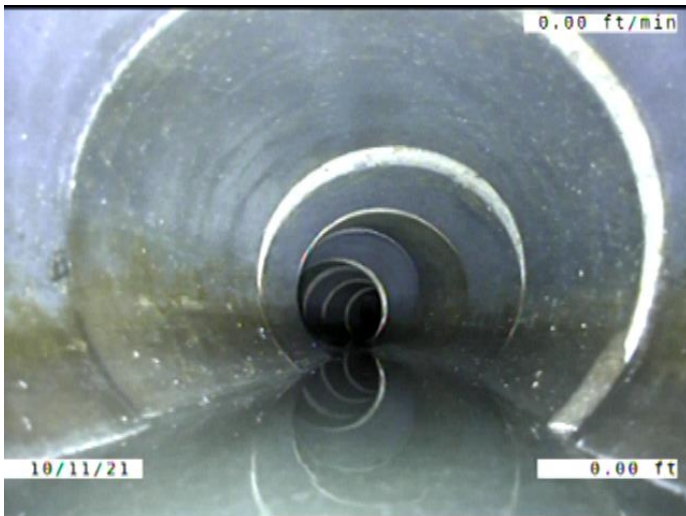
Code: **AMH**  
 Description: **Manhole**

Distance (ft): **.0**  
 Structural Grade: **0**  
 O&M Grade: **0**  
 Clock Start/From:  
 Clock To:  
 1st Value:  
 2nd Value:  
 Value Percent:  
 Continuous Index:  
 Within 8" of Joint: **NO**  
 Remarks: **M-804-014**

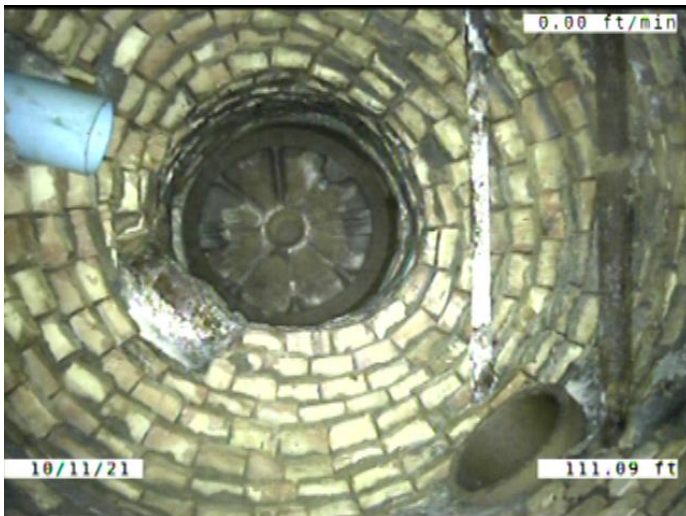
Code: **AMH**  
 Description: **Manhole**

Distance (ft): **111.1**  
 Structural Grade: **0**  
 O&M Grade: **0**  
 Clock Start/From:  
 Clock To:  
 1st Value:  
 2nd Value:  
 Value Percent:  
 Continuous Index:  
 Within 8" of Joint: **NO**  
 Remarks: **M-804-015**
