Profile/Photo Observation Report

Date:	10/23/2021	Weather:		Coding:	PACP 7.0
Pipe Length (ft):	351.0	Owner:	City of Hobart	Pre Clean:	Heavy Cleaning
P.O.#:	YES502259	Surveyor:	S. Bucklin	PSR:	P-804-020-015
Customer:	City of Hobart	Clean Date:	09/15/2021	Shape:	C

Street:	North Illinois Street	Flow Control:	Not Controlled
City:	Hobart, IN	Year Renewed:	
Location:	Alley	Tape/Media #:	
Purpose:	Routine Assessment	Dia/Height:	8"
Use:	Sanitary Sewage Pipe	Material:	VCP
Drain Area:		Lining:	None
Category:	NA		
Comment:			
Location Details:		Direction of Survey:	Upstream
US MH:	M-804-020	DS MH:	M-804-015
		Total Length Surveyed (ft):	237.3

O&M Index:	2.46	O&M Quick:	433B	O&M Rating:	96.00
Structural Index:	2.72	Structural Quick:	5242	Structural Rating:	136.00
Overall Index:	2.61	Overall Quick:	5245	Overall Rating:	232.00

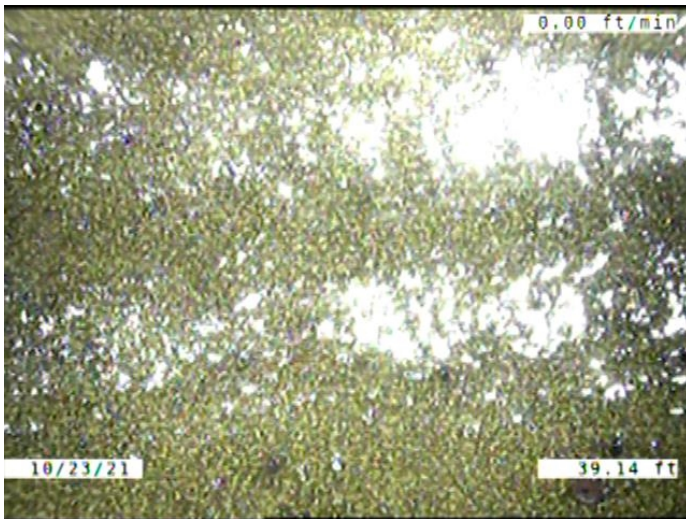
Code: **CL**
 Description: **Crack Longitudinal**

Distance (ft): **36.8**
 Structural Grade: **2**
 O&M Grade: **0**
 Clock Start/From: **1**
 Clock To:
 1st Value:
 2nd Value:
 Value Percent:
 Continuous Index:
 Within 8" of Joint: **YES**
 Remarks:

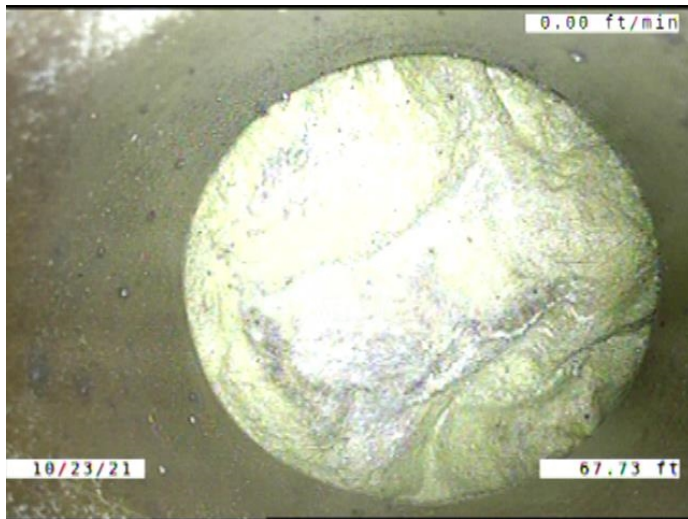
Code: **HSV**
 Description: **Hole Soil Visible**

Distance (ft): **67.2**
 Structural Grade: **5**
 O&M Grade: **0**
 Clock Start/From: **6**
 Clock To:
 1st Value:
 2nd Value:
 Value Percent:
 Continuous Index:
 Within 8" of Joint: **YES**
 Remarks:

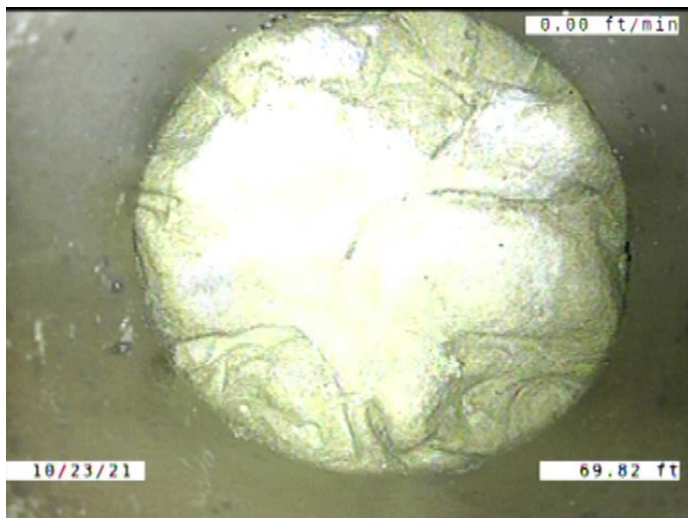
Code: **TFC**
Description: **Tap Factory Capped**

Distance (ft): **67.7**
Structural Grade: **0**
O&M Grade: **0**
Clock Start/From: **1**
Clock To:
1st Value: **4.000**
2nd Value:
Value Percent:
Continuous Index:
Within 8" of Joint: **YES**
Remarks:

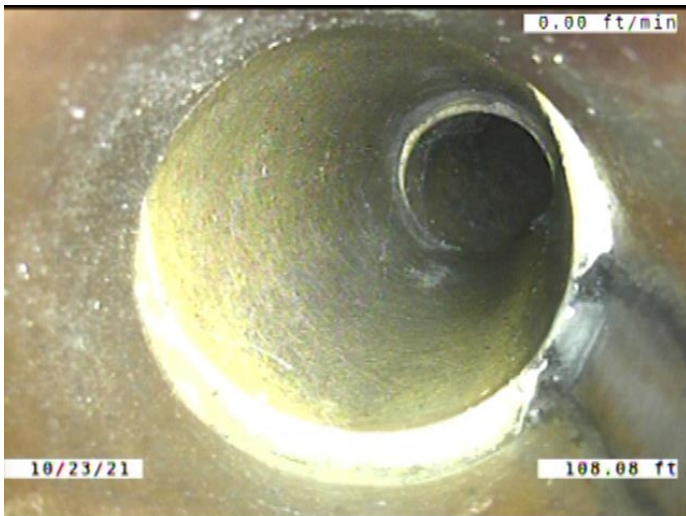
Code: **B**
 Description: **Broken**

Distance (ft): **104.8**
 Structural Grade: **4**
 O&M Grade: **0**
 Clock Start/From: **2**
 Clock To: **5**
 1st Value:
 2nd Value:
 Value Percent:
 Continuous Index:
 Within 8" of Joint: **YES**
 Remarks:

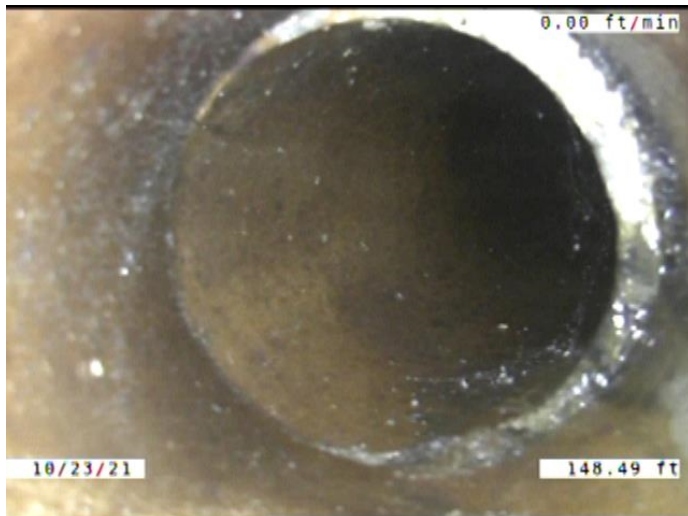
Code: **RFJ**
 Description: **Roots Fine Joint**

Distance (ft): **137.4**
 Structural Grade: **0**
 O&M Grade: **1**
 Clock Start/From: **8**
 Clock To: **4**
 1st Value:
 2nd Value:
 Value Percent:
 Continuous Index: **S02**
 Within 8" of Joint: **YES**
 Remarks:
