# Profile/Photo Observation Report

Date:	10/18/2021	Weather:		Coding:	PACP 7.0
Pipe Length (ft):	288.5	Owner:	City of Hobart	Pre Clean:	Heavy Cleaning
P.O.#:	YES502259	Surveyor:	S. Bucklin	PSR:	P-804-023-024
Customer:	City of Hobart	Clean Date:	10/15/2021	Shape:	C

Street:	North Kelly Street	Flow Control:	Not Controlled
City:	Hobart, IN	Year Renewed:	
Location:	Local rural streets with light traffic, t	Tape/Media #:	
Purpose:	Routine Assessment	Dia/Height:	12"
Use:	Sanitary Sewage Pipe	Material:	VCP
Drain Area:		Lining:	
Category:	NA		
Comment:			
Location Details:		Direction of Survey:	Upstream
US MH:	M-804-024	DS MH:	M-804-023
		Total Length Surveyed (ft):	288.5

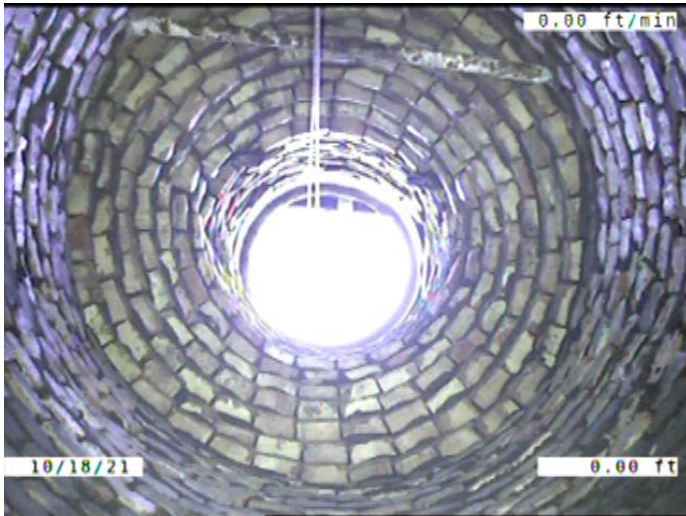
Code: **AMH**  
Description: **Manhole**

Distance (ft): **.0**  
Structural Grade: **0**  
O&M Grade: **0**  
Clock Start/From:  
Clock To:  
1st Value:  
2nd Value:  
Value Percent:  
Continuous Index:  
Within 8" of Joint: **NO**  
Remarks: **M-804-023**

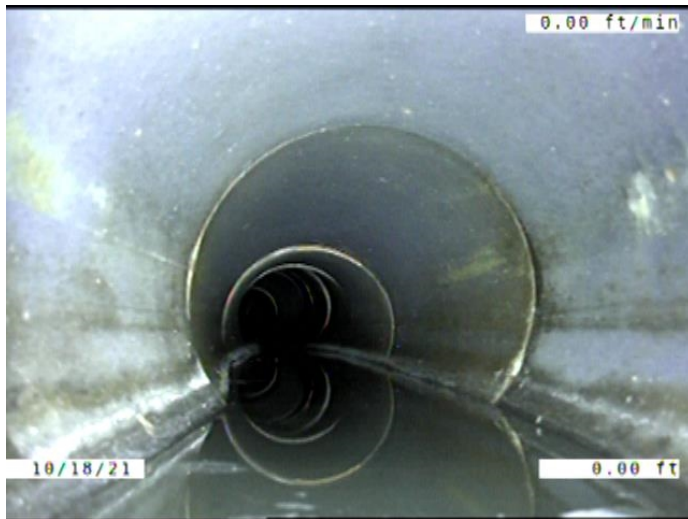
Code: **MWL**  
 Description: **Miscellaneous Water Level**

Distance (ft): **.0**  
 Structural Grade: **0**  
 O&M Grade: **0**  
 Clock Start/From:  
 Clock To:  
 1st Value:  
 2nd Value:  
 Value Percent: **5.000**  
 Continuous Index:  
 Within 8" of Joint: **NO**  
 Remarks:

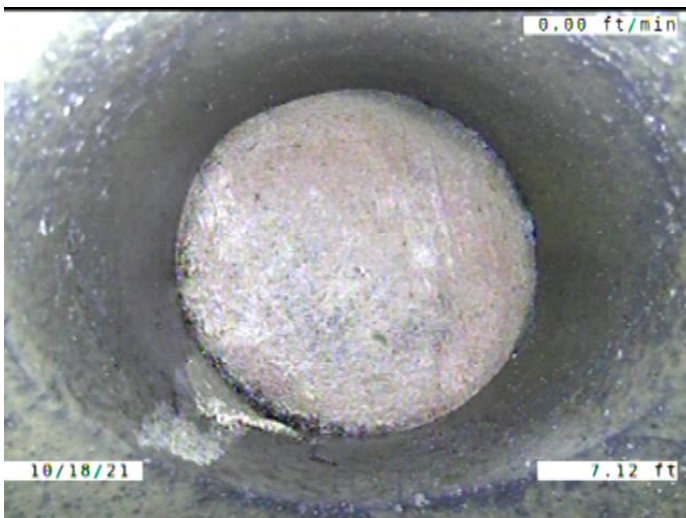
Code: **TFC**  
Description: **Tap Factory Capped**

Distance (ft): **7.1**  
Structural Grade: **0**  
O&M Grade: **0**  
Clock Start/From: **11**  
Clock To:  
1st Value: **4.000**  
2nd Value:  
Value Percent:  
Continuous Index:  
Within 8" of Joint: **YES**  
Remarks:

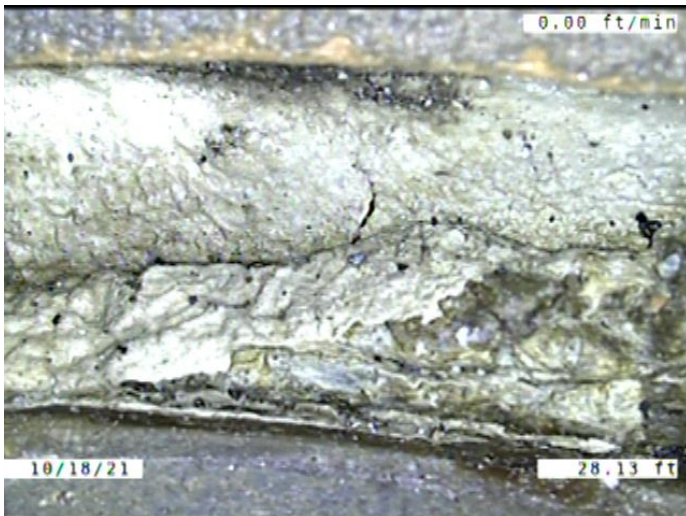
Code: **JAL**  
Description: **Joint Angular Large**

Distance (ft): **28.1**  
Structural Grade: **4**  
O&M Grade: **0**  
Clock Start/From:  
Clock To:  
1st Value:  
2nd Value:  
Value Percent:  
Continuous Index:  
Within 8" of Joint: **NO**  
Remarks:

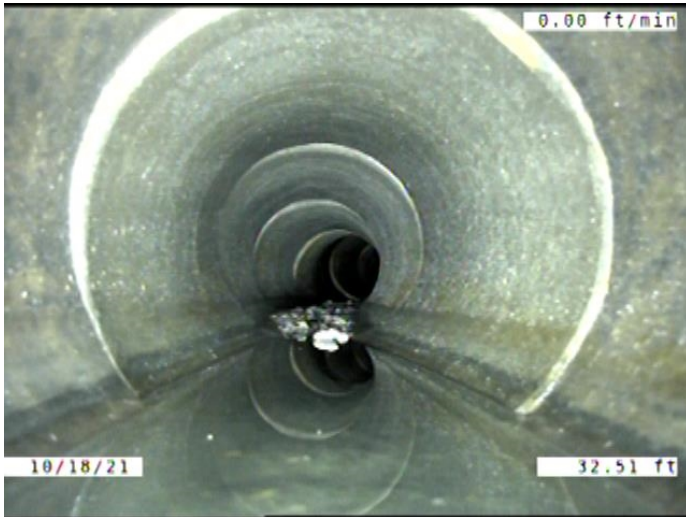
Code: **MWLS**  
 Description: **Miscellaneous Water Level Sag**

Distance (ft): **32.5**  
 Structural Grade: **2**  
 O&M Grade: **0**  
 Clock Start/From:  
 Clock To:  
 1st Value:  
 2nd Value:  
 Value Percent: **10.000**  
 Continuous Index:  
 Within 8" of Joint: **NO**  
 Remarks:

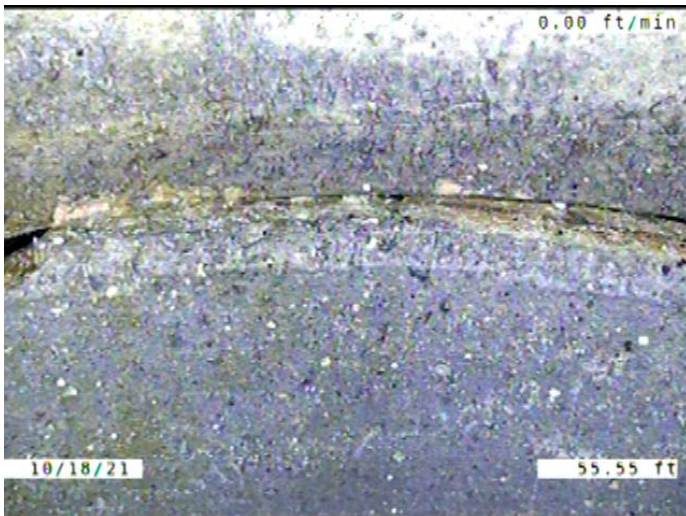
Code: **JAM**  
Description: **Joint Angular Medium**

Distance (ft): **55.6**  
Structural Grade: **3**  
O&M Grade: **0**  
Clock Start/From:  
Clock To:  
1st Value:  
2nd Value:  
Value Percent:  
Continuous Index:  
Within 8" of Joint: **NO**  
Remarks:

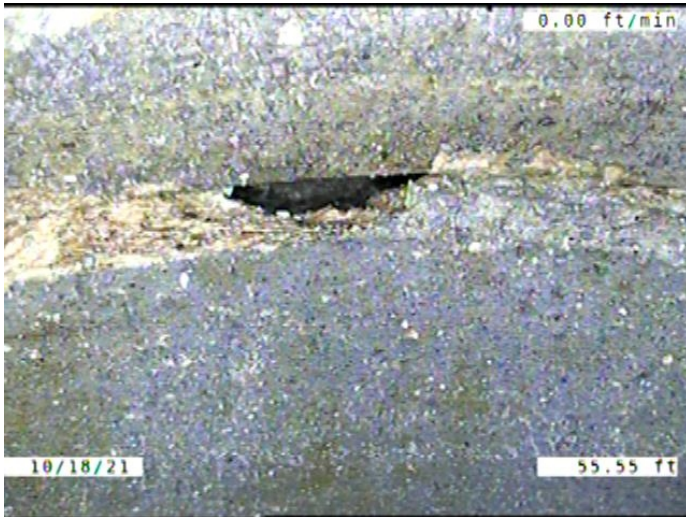
Code: **HSV**  
 Description: **Hole Soil Visible**

Distance (ft): **55.6**  
 Structural Grade: **5**  
 O&M Grade: **0**  
 Clock Start/From: **8**  
 Clock To: **11**  
 1st Value:  
 2nd Value:  
 Value Percent:  
 Continuous Index:  
 Within 8" of Joint: **YES**  
 Remarks:

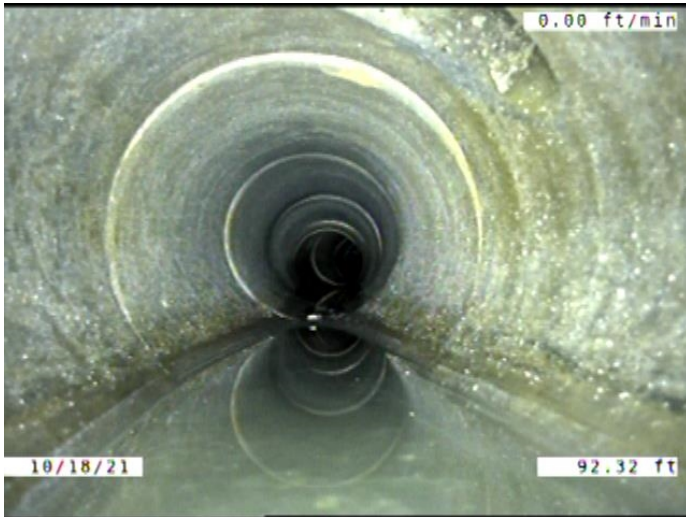
Code: **MWLS**  
 Description: **Miscellaneous Water Level Sag**

Distance (ft): **92.3**  
 Structural Grade: **2**  
 O&M Grade: **0**  
 Clock Start/From:  
 Clock To:  
 1st Value:  
 2nd Value:  
 Value Percent: **5.000**  
 Continuous Index:  
 Within 8" of Joint: **NO**  
 Remarks:

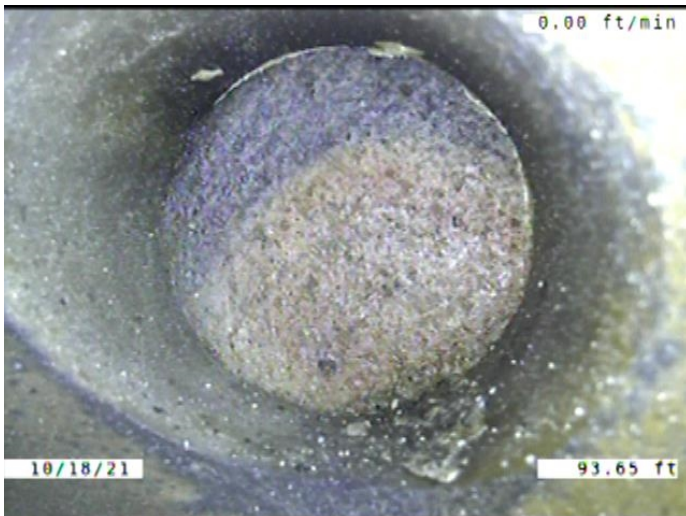
Code: **TFC**  
 Description: **Tap Factory Capped**

Distance (ft): **93.6**  
 Structural Grade: **0**  
 O&M Grade: **0**  
 Clock Start/From: **1**  
 Clock To:  
 1st Value: **4.000**  
 2nd Value:  
 Value Percent:  
 Continuous Index:  
 Within 8" of Joint: **YES**  
 Remarks:

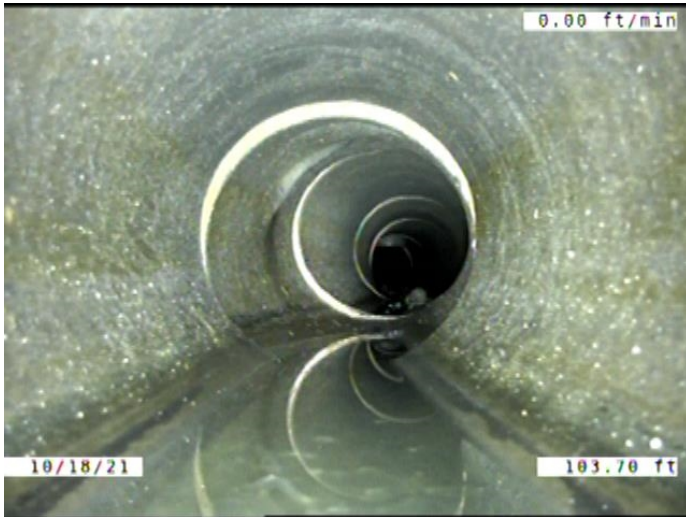
Code: **DSF**  
Description: **Deposits Settled Fine**

Distance (ft): **103.7**  
Structural Grade: **0**  
O&M Grade: **2**  
Clock Start/From: **5**  
Clock To: **7**  
1st Value:  
2nd Value:  
Value Percent: **5.000**  
Continuous Index: **S04**  
Within 8" of Joint: **YES**  
Remarks:

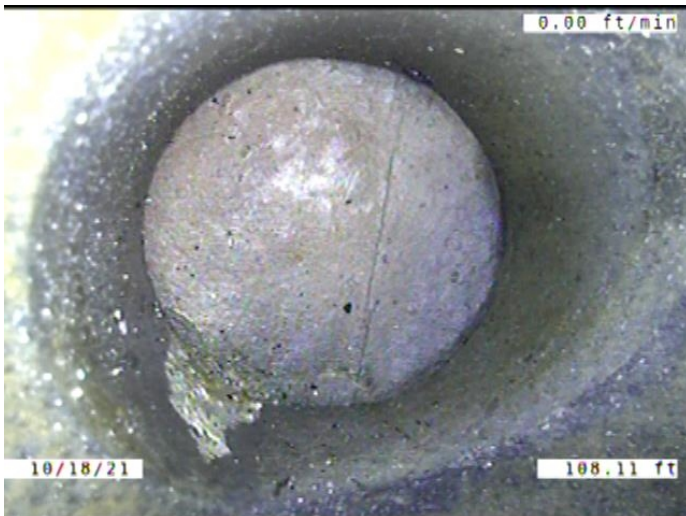
Code: **TFC**  
Description: **Tap Factory Capped**

Distance (ft): **108.1**  
Structural Grade: **0**  
O&M Grade: **0**  
Clock Start/From: **11**  
Clock To:  
1st Value: **4.000**  
2nd Value:  
Value Percent:  
Continuous Index:  
Within 8" of Joint: **YES**  
Remarks: **ENCrustation AROUND THE CAP**

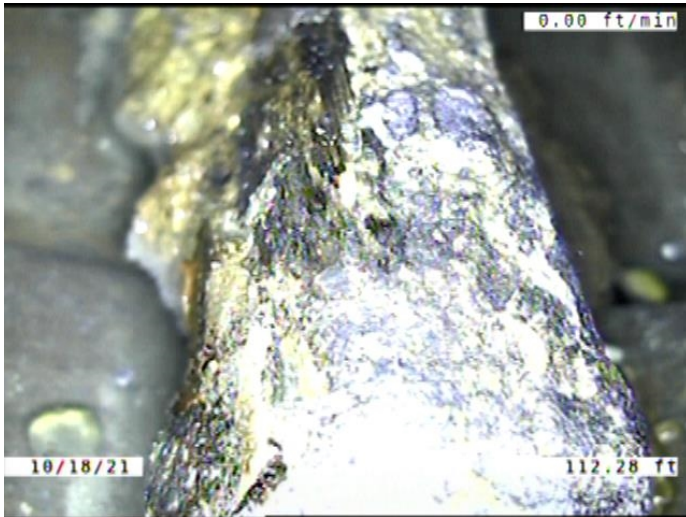
Code: **OBZ**  
Description: **Obstruction Other**

Distance (ft): **112.3**  
Structural Grade: **0**  
O&M Grade: **2**  
Clock Start/From: **5**  
Clock To: **6**  
1st Value:  
2nd Value:  
Value Percent: **5.000**  
Continuous Index:  
Within 8" of Joint: **NO**  
Remarks: **STICK**

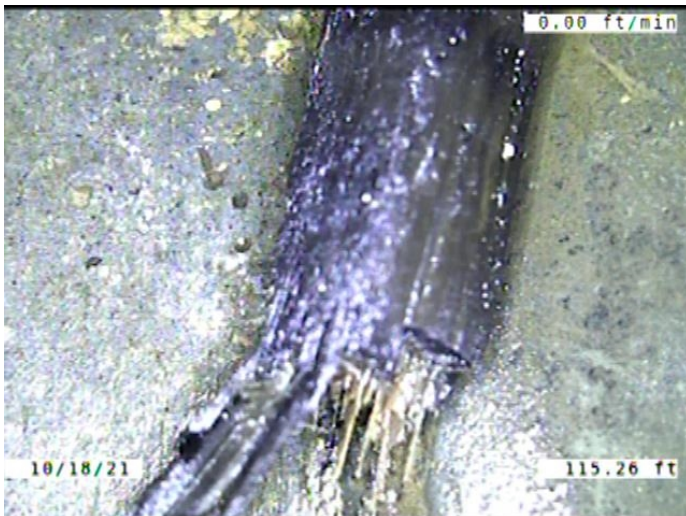
Code: **OBZ**  
Description: **Obstruction Other**

Distance (ft): **115.3**  
Structural Grade: **0**  
O&M Grade: **2**  
Clock Start/From: **7**  
Clock To: **8**  
1st Value:  
2nd Value:  
Value Percent: **5.000**  
Continuous Index:  
Within 8" of Joint: **YES**  
Remarks: **STICK**

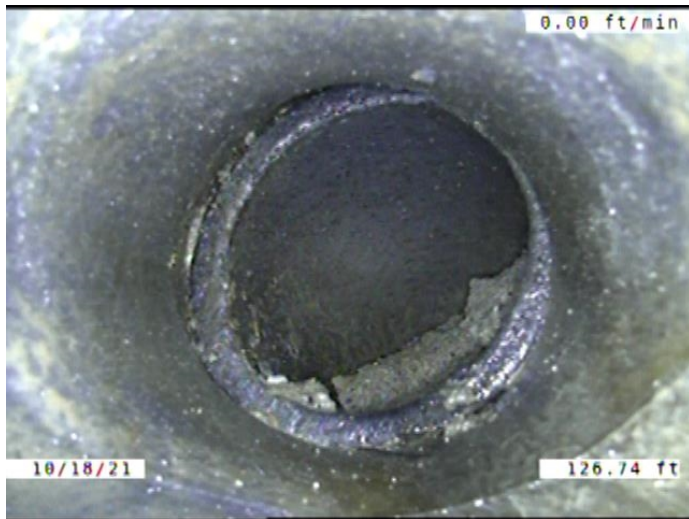
Code: **TF**  
 Description: **Tap Factory**

Distance (ft): **126.7**  
 Structural Grade: **0**  
 O&M Grade: **0**  
 Clock Start/From: **1**  
 Clock To:  
 1st Value: **4.000**  
 2nd Value:  
 Value Percent:  
 Continuous Index:  
 Within 8" of Joint: **YES**  
 Remarks:

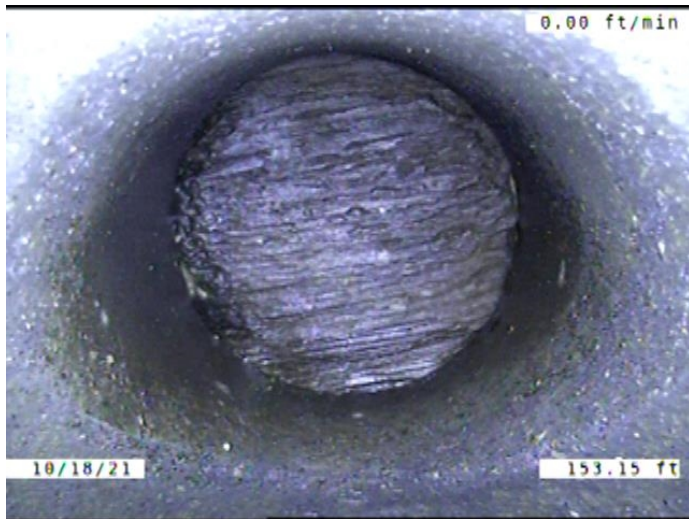
Code: **TFC**  
Description: **Tap Factory Capped**

Distance (ft): **153.1**  
Structural Grade: **0**  
O&M Grade: **0**  
Clock Start/From: **11**  
Clock To:  
1st Value: **4.000**  
2nd Value:  
Value Percent:  
Continuous Index:  
Within 8" of Joint: **YES**  
Remarks:

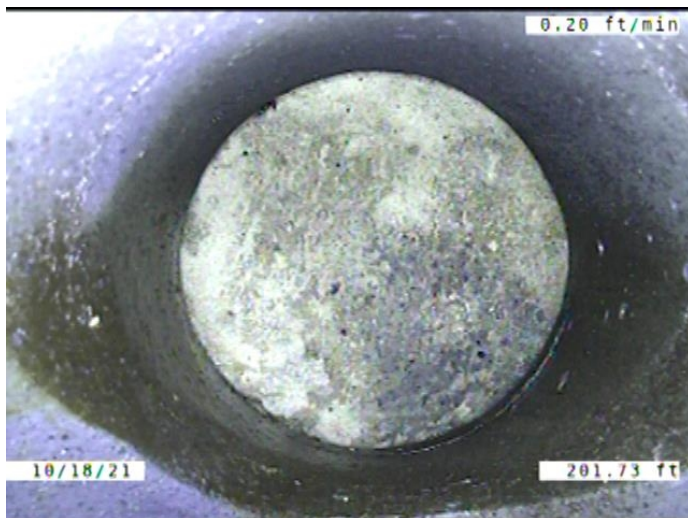
Code: **TFC**  
 Description: **Tap Factory Capped**

Distance (ft): **201.7**  
 Structural Grade: **0**  
 O&M Grade: **0**  
 Clock Start/From: **11**  
 Clock To:  
 1st Value: **4.000**  
 2nd Value:  
 Value Percent:  
 Continuous Index:  
 Within 8" of Joint: **YES**  
 Remarks:

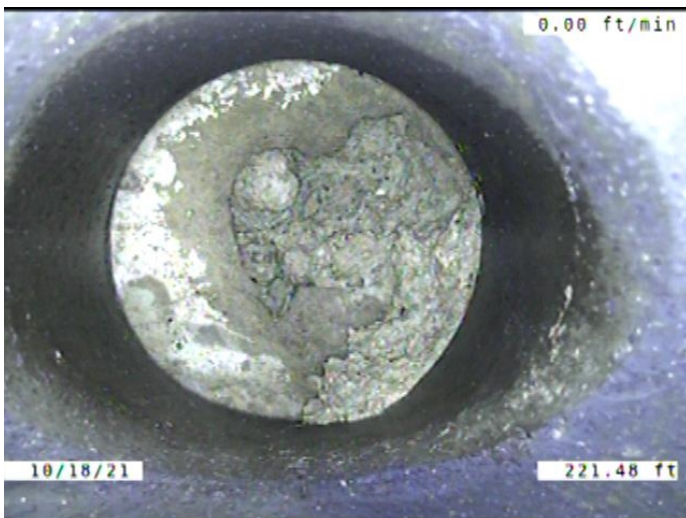
Code: **TFC**  
Description: **Tap Factory Capped**

Distance (ft): **221.5**  
Structural Grade: **0**  
O&M Grade: **0**  
Clock Start/From: **1**  
Clock To:  
1st Value: **4.000**  
2nd Value:  
Value Percent:  
Continuous Index:  
Within 8" of Joint: **YES**  
Remarks:

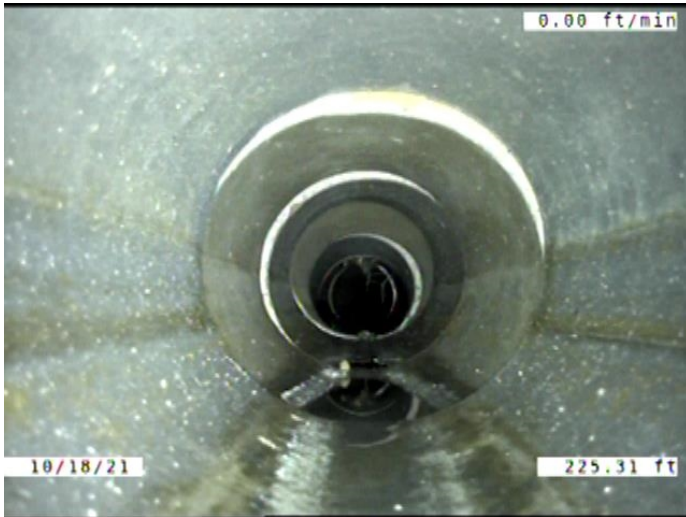
Code: **MWLS**  
Description: **Miscellaneous Water Level Sag**

Distance (ft): **225.3**  
Structural Grade: **2**  
O&M Grade: **0**  
Clock Start/From:  
Clock To:  
1st Value:  
2nd Value:  
Value Percent: **10.000**  
Continuous Index: **F05**  
Within 8" of Joint: **NO**  
Remarks:

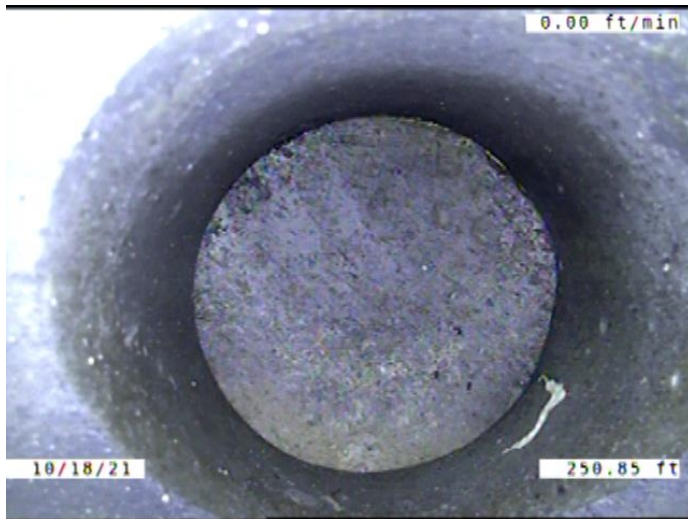
Code: **TFC**  
 Description: **Tap Factory Capped**

Distance (ft): **250.8**  
 Structural Grade: **0**  
 O&M Grade: **0**  
 Clock Start/From: **11**  
 Clock To:  
 1st Value: **4.000**  
 2nd Value:  
 Value Percent:  
 Continuous Index:  
 Within 8" of Joint: **YES**  
 Remarks:

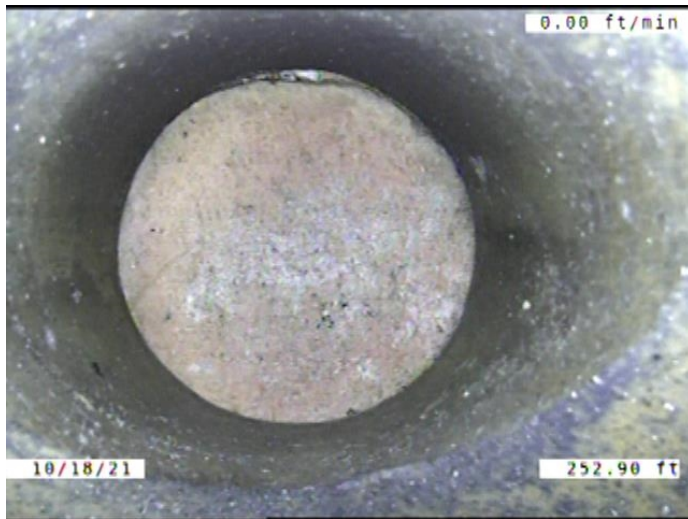
Code:	<b>TFC</b>
Description:	<b>Tap Factory Capped</b>
Distance (ft):	<b>252.9</b>
Structural Grade:	<b>0</b>
O&M Grade:	<b>0</b>
Clock Start/From:	<b>1</b>
Clock To:	
1st Value:	<b>4.000</b>
2nd Value:	
Value Percent:	
Continuous Index:	
Within 8" of Joint:	<b>YES</b>
Remarks:

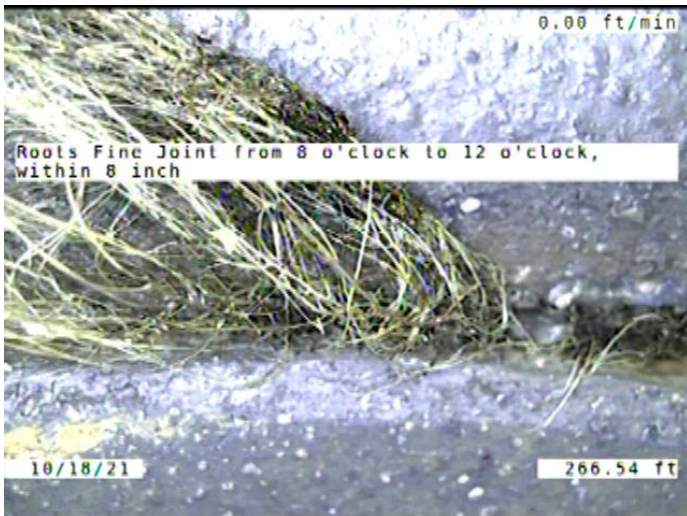
Code: **RFJ**  
 Description: **Roots Fine Joint**

Distance (ft): **266.5**  
 Structural Grade: **0**  
 O&M Grade: **1**  
 Clock Start/From: **8**  
 Clock To: **3**  
 1st Value:  
 2nd Value:  
 Value Percent:  
 Continuous Index:  
 Within 8" of Joint: **YES**  
 Remarks:

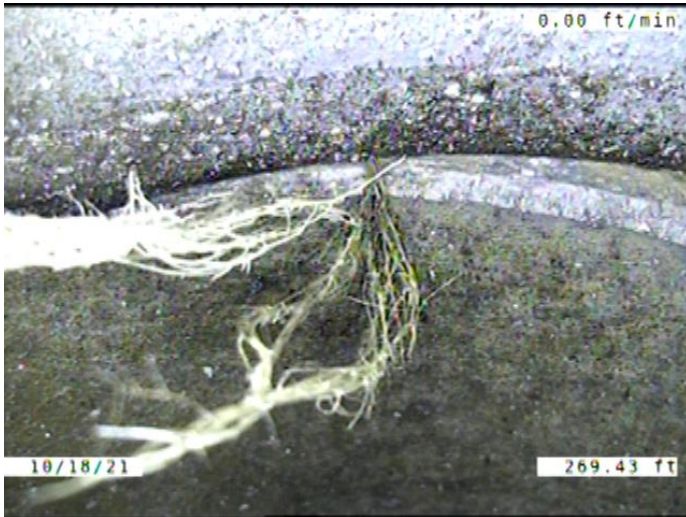
Code: **RFJ**  
 Description: **Roots Fine Joint**

Distance (ft): **269.4**  
 Structural Grade: **0**  
 O&M Grade: **1**  
 Clock Start/From: **9**  
 Clock To: **10**  
 1st Value:  
 2nd Value:  
 Value Percent:  
 Continuous Index:  
 Within 8" of Joint: **YES**  
 Remarks:

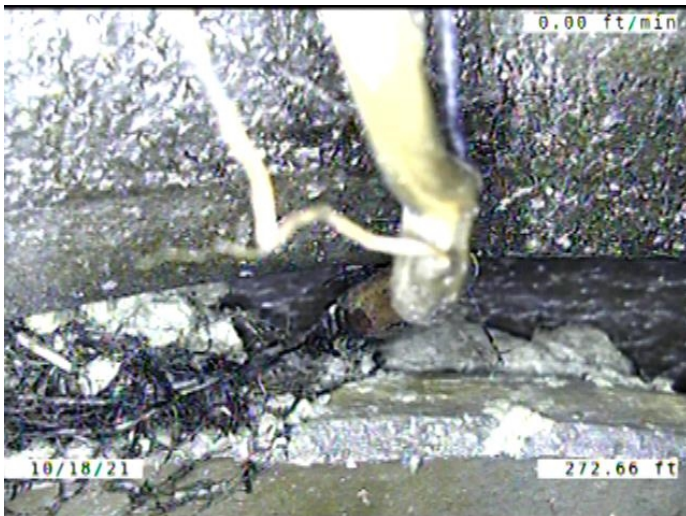
Code: **RTJ**  
 Description: **Roots Tap Joint**

Distance (ft): **272.7**  
 Structural Grade: **0**  
 O&M Grade: **2**  
 Clock Start/From: **7**  
 Clock To: **10**  
 1st Value:  
 2nd Value:  
 Value Percent: **5.000**  
 Continuous Index:  
 Within 8" of Joint: **YES**  
 Remarks:

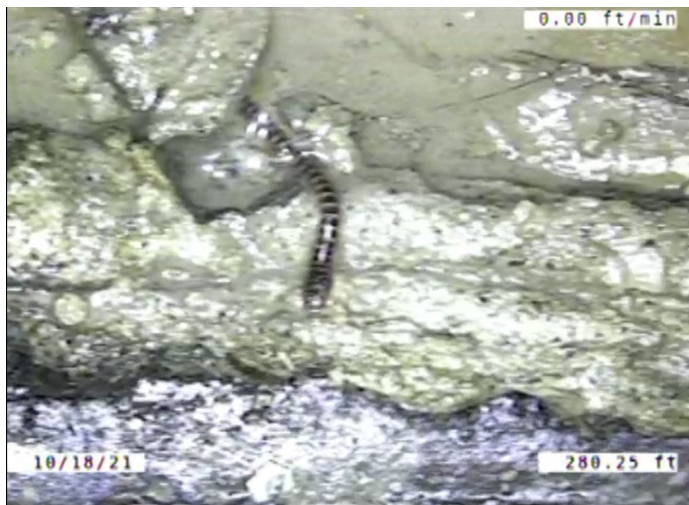
Code: **VZ**  
 Description: **Vermin Other**

Distance (ft): **280.3**  
 Structural Grade: **0**  
 O&M Grade: **1**  
 Clock Start/From:  
 Clock To:  
 1st Value: **1.000**  
 2nd Value:  
 Value Percent:  
 Continuous Index:  
 Within 8" of Joint: **NO**  
 Remarks: **Snake**

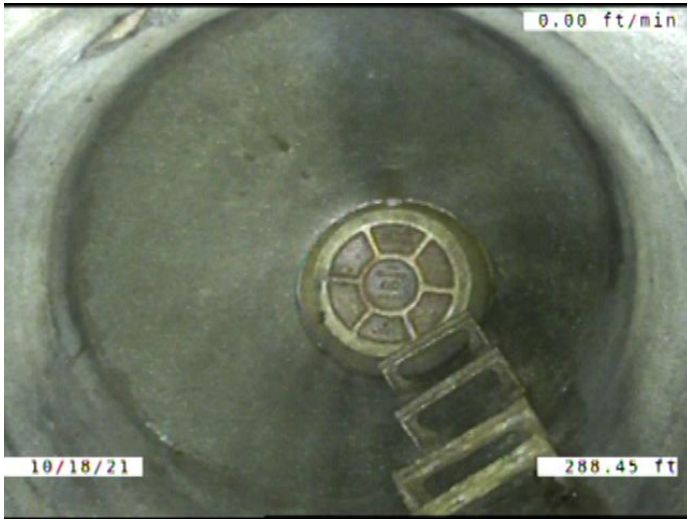
Code:	<b>AMH</b>
Description:	<b>Manhole</b>
Distance (ft):	<b>288.5</b>
Structural Grade:	<b>0</b>
O&M Grade:	<b>0</b>
Clock Start/From:	
Clock To:	
1st Value:	
2nd Value:	
Value Percent:	
Continuous Index:	
Within 8" of Joint:	<b>NO</b>
Remarks:	<b>M-804-024</b>
