Profile/Photo Observation Report

Date:	10/18/2021	Weather:		Coding:	PACP 7.0
Pipe Length (ft):	288.5	Owner:	City of Hobart	Pre Clean:	Heavy Cleaning
P.O.#:	YES502259	Surveyor:	S. Bucklin	PSR:	P-804-023-024
Customer:	City of Hobart	Clean Date:	10/15/2021	Shape:	C

Street:	North Kelly Street	Flow Control:	Not Controlled
City:	Hobart, IN	Year Renewed:	
Location:	Local rural streets with light traffic, t	Tape/Media #:	
Purpose:	Routine Assessment	Dia/Height:	12"
Use:	Sanitary Sewage Pipe	Material:	VCP
Drain Area:		Lining:	
Category:	NA		
Comment:			
Location Details:		Direction of Survey:	Upstream
US MH:	M-804-024	DS MH:	M-804-023
		Total Length Surveyed (ft):	288.5

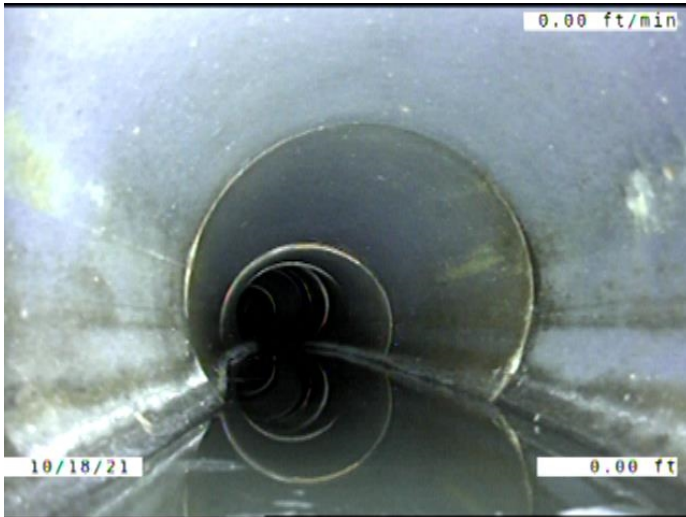
Code: **MWL**
 Description: **Miscellaneous Water Level**

Distance (ft): **.0**
 Structural Grade: **0**
 O&M Grade: **0**
 Clock Start/From:
 Clock To:
 1st Value:
 2nd Value:
 Value Percent: **5.000**
 Continuous Index:
 Within 8" of Joint: **NO**
 Remarks:

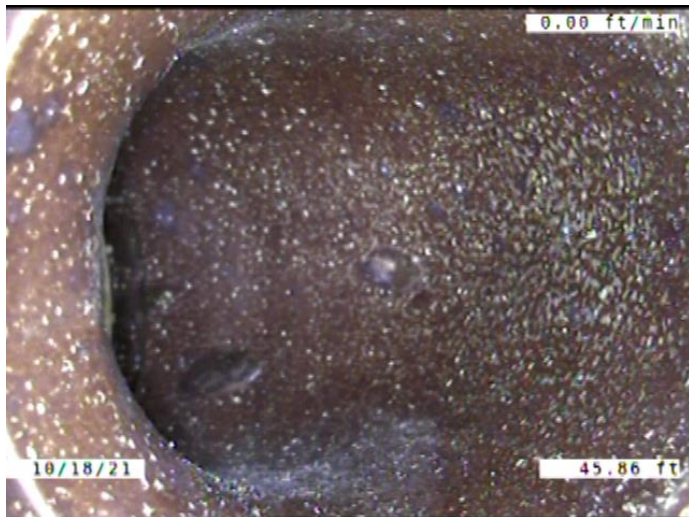
Code: **TBI**
 Description: **Tap Break-in Intruding**

Distance (ft): **45.9**
 Structural Grade: **0**
 O&M Grade: **2**
 Clock Start/From: **12**
 Clock To:
 1st Value: **4.000**
 2nd Value: **1.000**
 Value Percent:
 Continuous Index:
 Within 8" of Joint: **YES**
 Remarks:

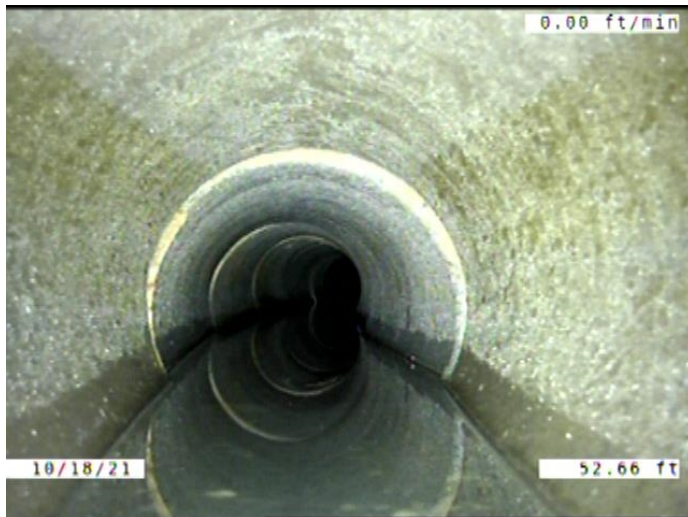
Code: **MWLS**
 Description: **Miscellaneous Water Level Sag**

Distance (ft): **52.7**
 Structural Grade: **2**
 O&M Grade: **0**
 Clock Start/From:
 Clock To:
 1st Value:
 2nd Value:
 Value Percent: **10.000**
 Continuous Index: **S03**
 Within 8" of Joint: **NO**
 Remarks:

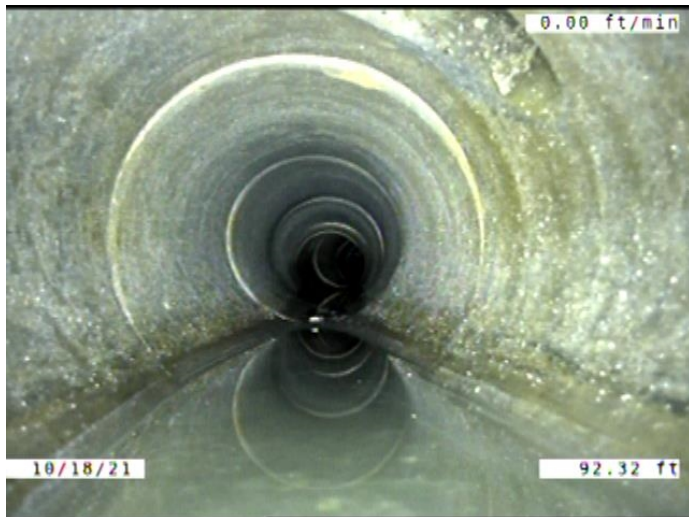
Code: **MWLS**
 Description: **Miscellaneous Water Level Sag**

Distance (ft): **92.3**
 Structural Grade: **2**
 O&M Grade: **0**
 Clock Start/From:
 Clock To:
 1st Value:
 2nd Value:
 Value Percent: **5.000**
 Continuous Index:
 Within 8" of Joint: **NO**
 Remarks:

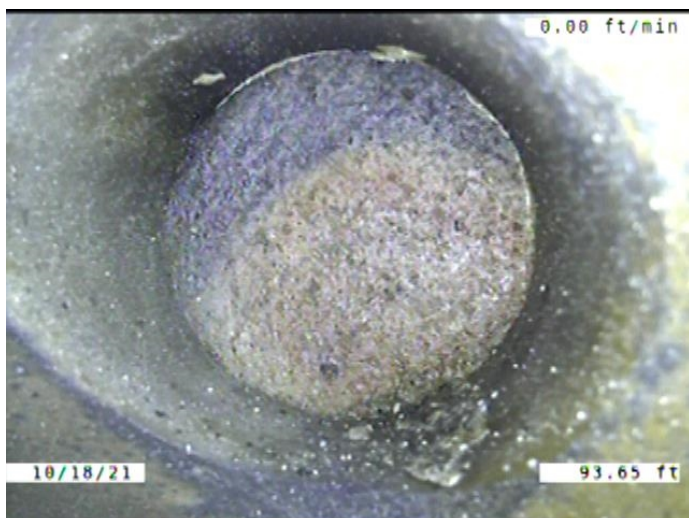
Code: **TFC**
 Description: **Tap Factory Capped**

Distance (ft): **93.6**
 Structural Grade: **0**
 O&M Grade: **0**
 Clock Start/From: **1**
 Clock To:
 1st Value: **4.000**
 2nd Value:
 Value Percent:
 Continuous Index:
 Within 8" of Joint: **YES**
 Remarks:

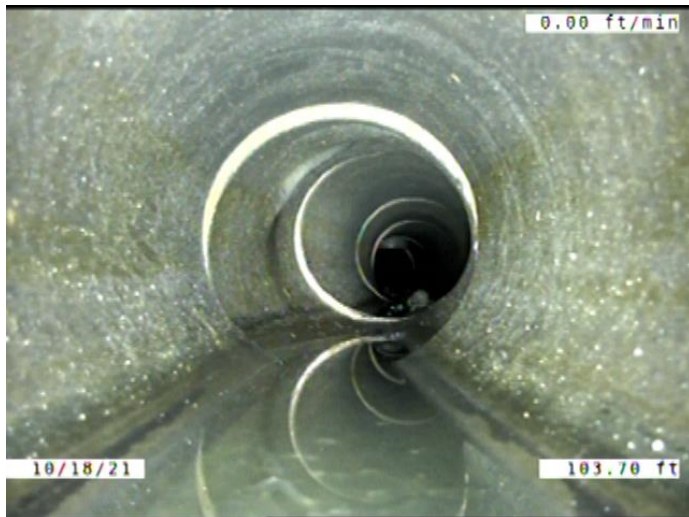
Code: **DSF**
 Description: **Deposits Settled Fine**

Distance (ft): **103.7**
 Structural Grade: **0**
 O&M Grade: **2**
 Clock Start/From: **5**
 Clock To: **7**
 1st Value:
 2nd Value:
 Value Percent: **5.000**
 Continuous Index: **S04**
 Within 8" of Joint: **YES**
 Remarks:

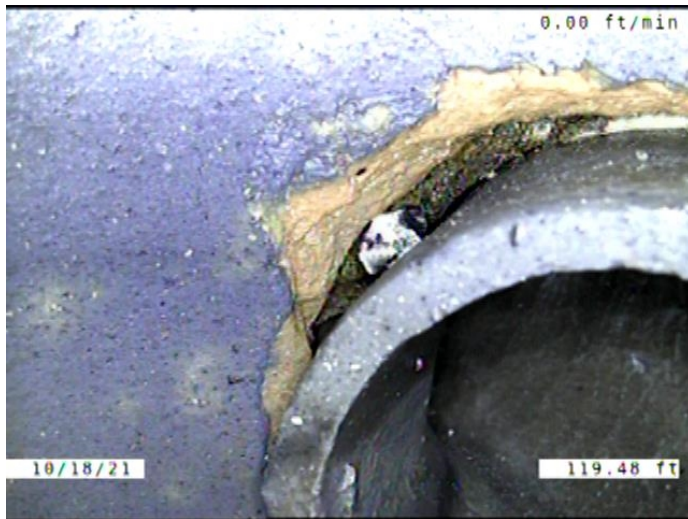
Code: **SSS**
 Description: **Surface Damage Surface Spalling**

Distance (ft): **119.5**
 Structural Grade: **2**
 O&M Grade: **0**
 Clock Start/From: **11**
 Clock To: **1**
 1st Value:
 2nd Value:
 Value Percent:
 Continuous Index:
 Within 8" of Joint: **NO**
 Remarks:

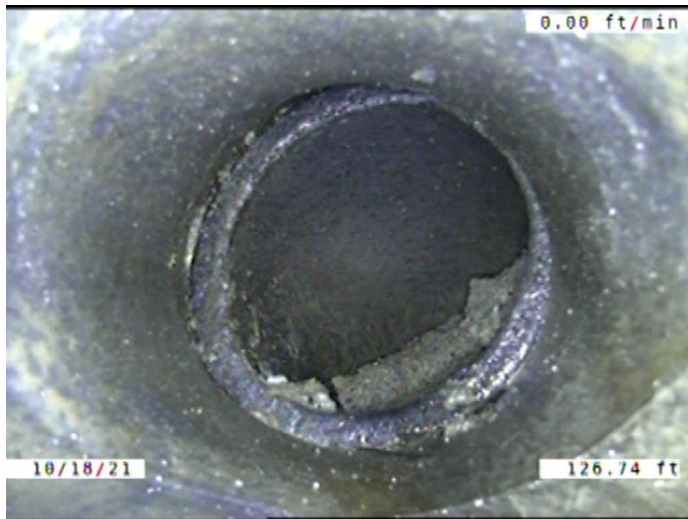
Code: **TF**
 Description: **Tap Factory**

Distance (ft): **126.7**
 Structural Grade: **0**
 O&M Grade: **0**
 Clock Start/From: **1**
 Clock To:
 1st Value: **4.000**
 2nd Value:
 Value Percent:
 Continuous Index:
 Within 8" of Joint: **YES**
 Remarks:

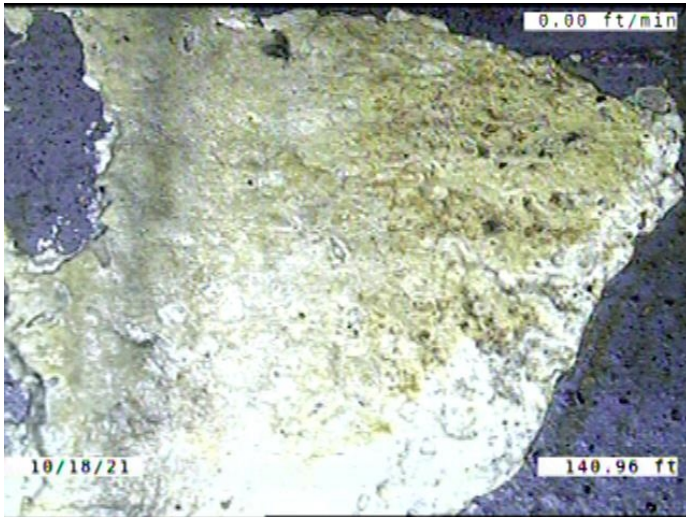
Code: **DAE**
 Description: **Deposits Attached Encrustation**

Distance (ft): **141.0**
 Structural Grade: **0**
 O&M Grade: **2**
 Clock Start/From: **3**
 Clock To: **4**
 1st Value:
 2nd Value:
 Value Percent: **5.000**
 Continuous Index:
 Within 8" of Joint: **YES**
 Remarks:

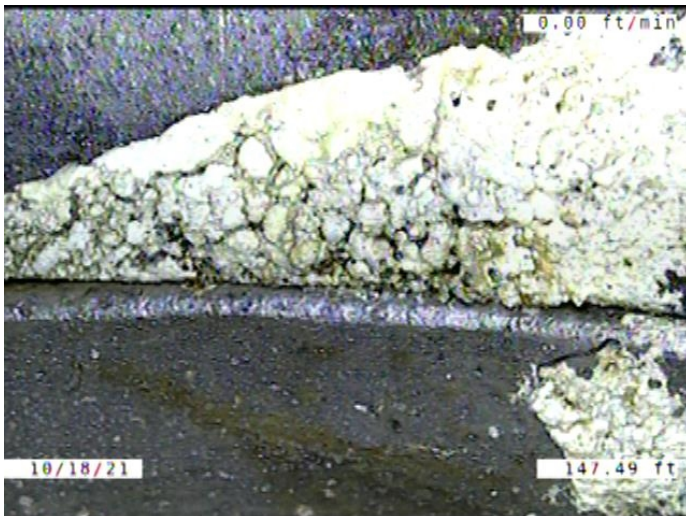
Code: **DAE**
 Description: **Deposits Attached Encrustation**

Distance (ft): **147.5**
 Structural Grade: **0**
 O&M Grade: **2**
 Clock Start/From: **2**
 Clock To: **4**
 1st Value:
 2nd Value:
 Value Percent: **5.000**
 Continuous Index:
 Within 8" of Joint: **YES**
 Remarks:

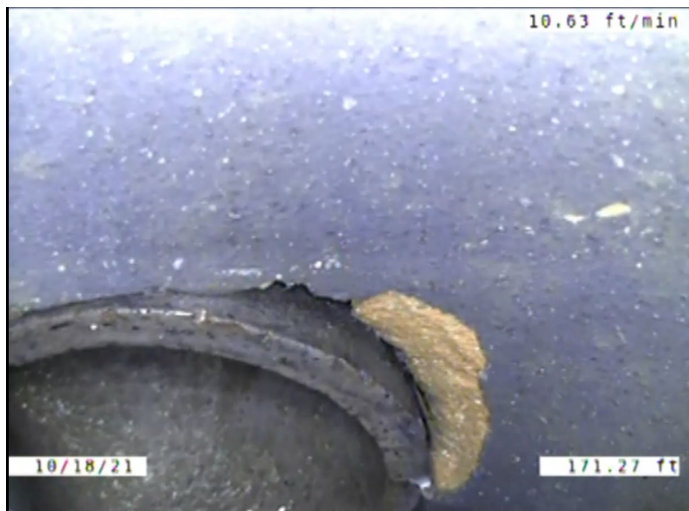
Code: **SSS**
 Description: **Surface Damage Surface Spalling**

Distance (ft): **171.3**
 Structural Grade: **2**
 O&M Grade: **0**
 Clock Start/From: **2**
 Clock To:
 1st Value:
 2nd Value:
 Value Percent:
 Continuous Index:
 Within 8" of Joint: **NO**
 Remarks:

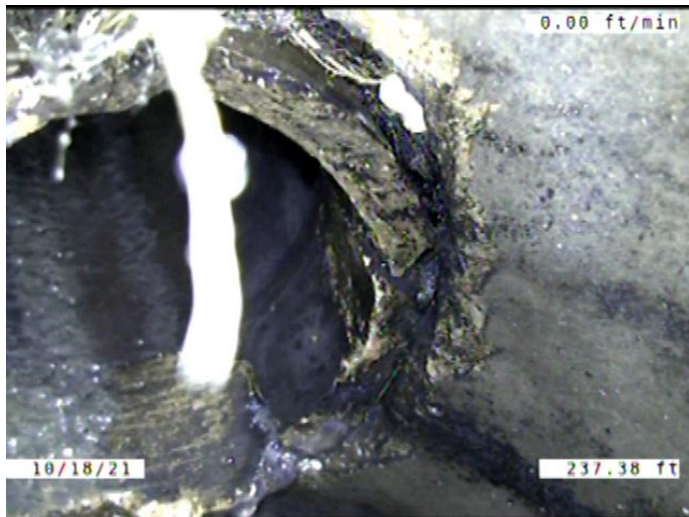
Code: **SSS**
 Description: **Surface Damage Surface Spalling**

Distance (ft): **237.4**
 Structural Grade: **2**
 O&M Grade: **0**
 Clock Start/From: **11**
 Clock To: **1**
 1st Value:
 2nd Value:
 Value Percent:
 Continuous Index:
 Within 8" of Joint: **YES**
 Remarks:

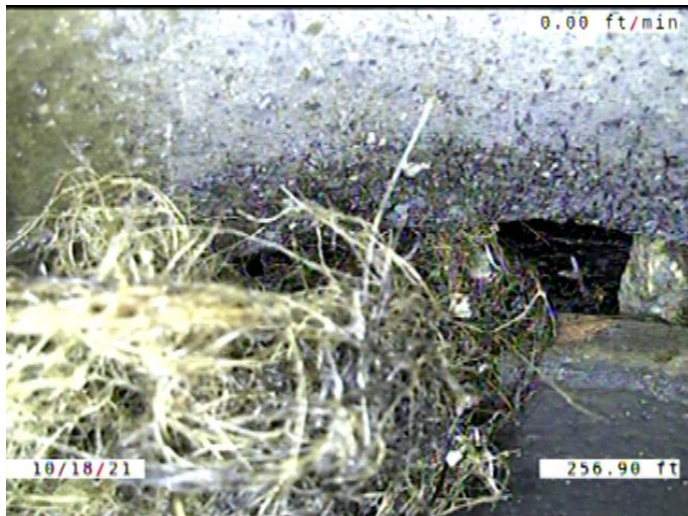
Code: **RMJ**
 Description: **Roots Medium Joint**

Distance (ft): **256.9**
 Structural Grade: **0**
 O&M Grade: **3**
 Clock Start/From: **7**
 Clock To: **10**
 1st Value:
 2nd Value:
 Value Percent: **10.000**
 Continuous Index:
 Within 8" of Joint: **YES**
 Remarks:

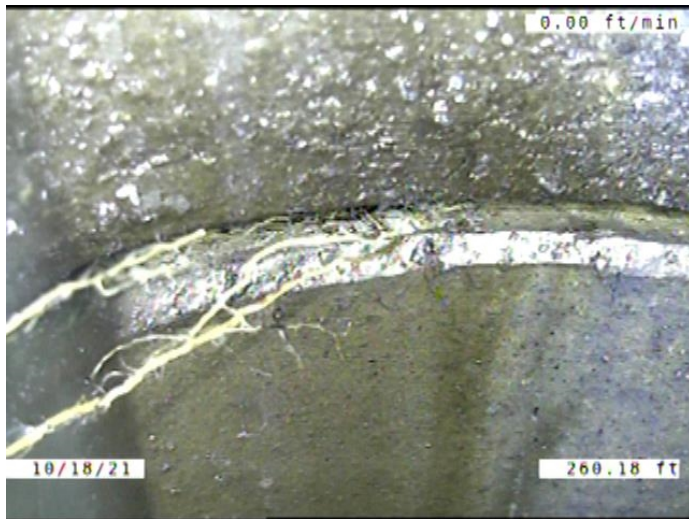
Code: **RFJ**
 Description: **Roots Fine Joint**

Distance (ft): **260.2**
 Structural Grade: **0**
 O&M Grade: **1**
 Clock Start/From: **9**
 Clock To:
 1st Value:
 2nd Value:
 Value Percent:
 Continuous Index:
 Within 8" of Joint: **YES**
 Remarks:

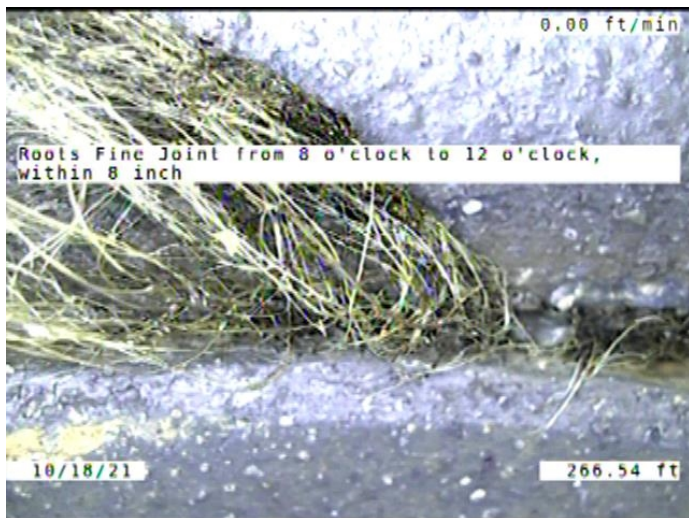
Code: **RFJ**
 Description: **Roots Fine Joint**

Distance (ft): **266.5**
 Structural Grade: **0**
 O&M Grade: **1**
 Clock Start/From: **8**
 Clock To: **3**
 1st Value:
 2nd Value:
 Value Percent:
 Continuous Index:
 Within 8" of Joint: **YES**
 Remarks:

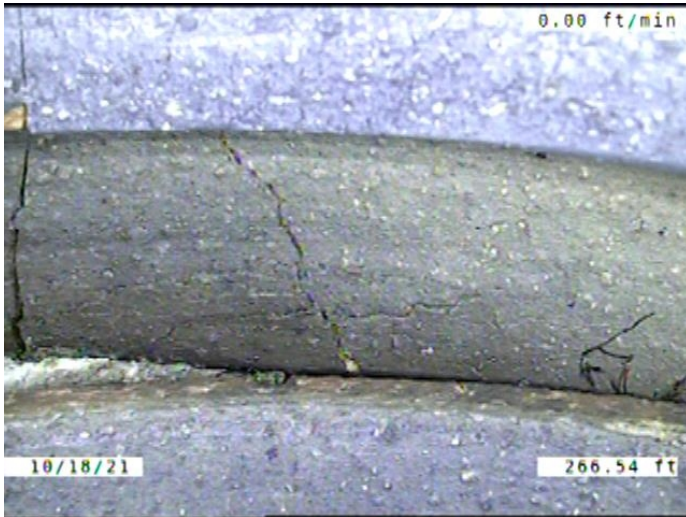
Code: **JAL**
Description: **Joint Angular Large**

Distance (ft): **266.5**
Structural Grade: **4**
O&M Grade: **0**
Clock Start/From:
Clock To:
1st Value:
2nd Value:
Value Percent:
Continuous Index:
Within 8" of Joint: **NO**
Remarks:

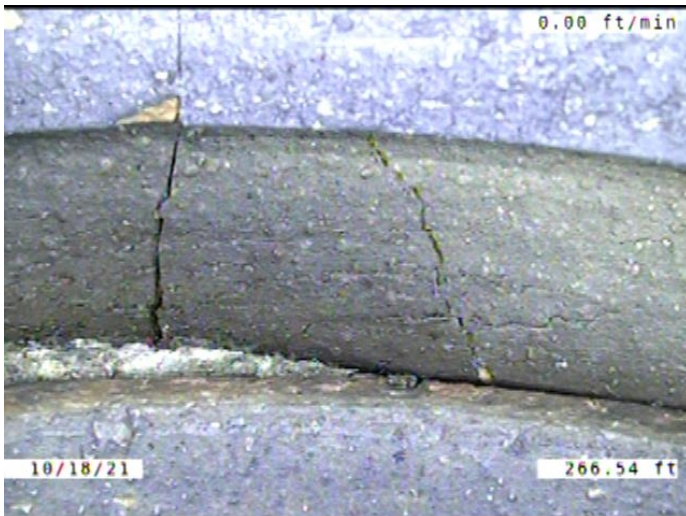
Code: **FM**
Description: **Fracture Multiple**

Distance (ft): **266.5**
Structural Grade: **4**
O&M Grade: **0**
Clock Start/From: **12**
Clock To: **2**
1st Value:
2nd Value:
Value Percent:
Continuous Index:
Within 8" of Joint: **YES**
Remarks:

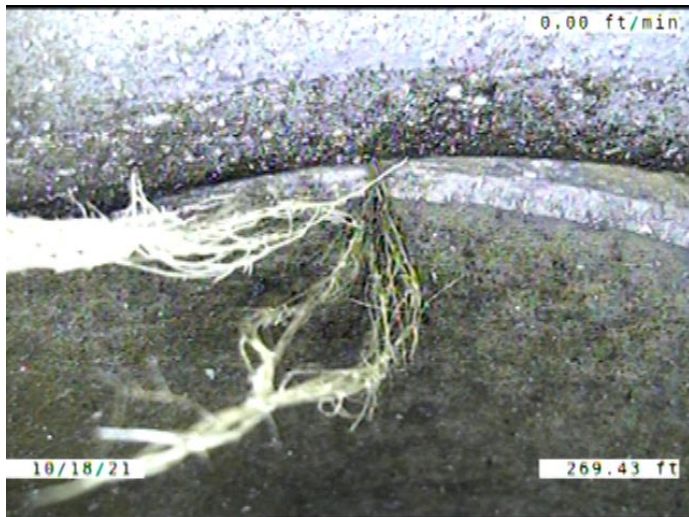
Code: **RFJ**
 Description: **Roots Fine Joint**

Distance (ft): **269.4**
 Structural Grade: **0**
 O&M Grade: **1**
 Clock Start/From: **9**
 Clock To: **10**
 1st Value:
 2nd Value:
 Value Percent:
 Continuous Index:
 Within 8" of Joint: **YES**
 Remarks:

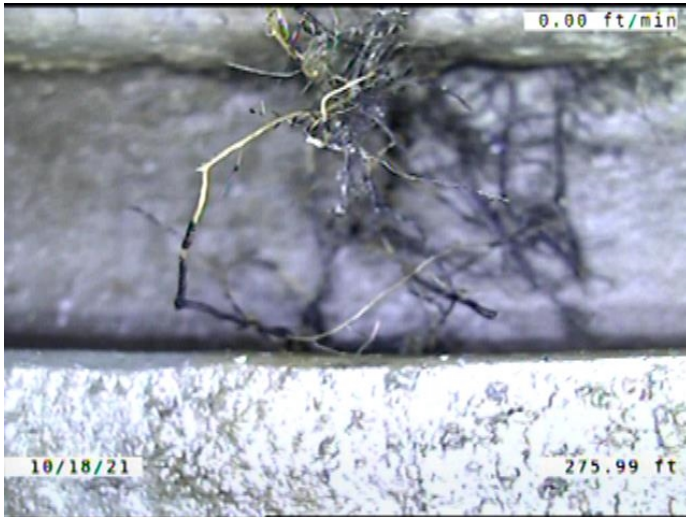
Code: **RTJ**
 Description: **Roots Tap Joint**

Distance (ft): **272.7**
 Structural Grade: **0**
 O&M Grade: **2**
 Clock Start/From: **7**
 Clock To: **10**
 1st Value:
 2nd Value:
 Value Percent: **5.000**
 Continuous Index:
 Within 8" of Joint: **YES**
 Remarks:

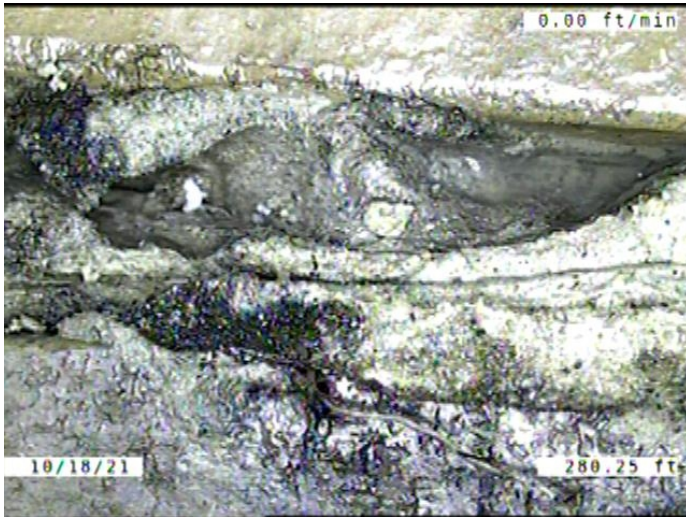
Code: **FM**
 Description: **Fracture Multiple**

Distance (ft): **278.0**
 Structural Grade: **4**
 O&M Grade: **0**
 Clock Start/From: **12**
 Clock To: **12**
 1st Value:
 2nd Value:
 Value Percent:
 Continuous Index:
 Within 8" of Joint: **YES**
 Remarks:

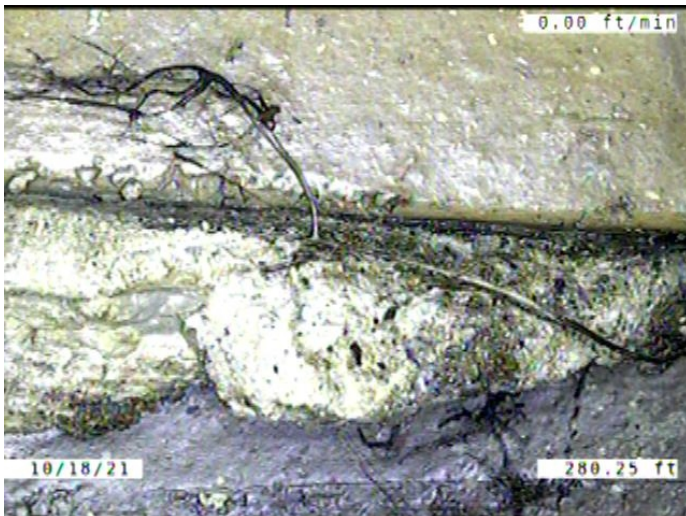
Code: **RFJ**
 Description: **Roots Fine Joint**

Distance (ft): **280.2**
 Structural Grade: **0**
 O&M Grade: **1**
 Clock Start/From: **4**
 Clock To: **8**
 1st Value:
 2nd Value:
 Value Percent:
 Continuous Index:
 Within 8" of Joint: **YES**
 Remarks:

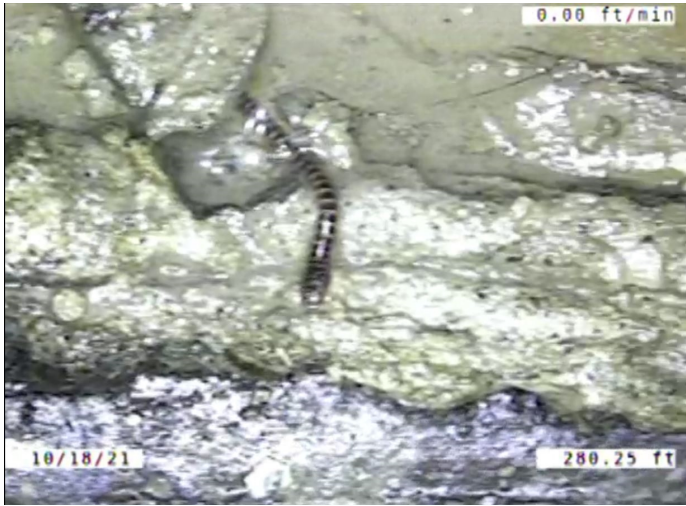
Code: **DAE**
 Description: **Deposits Attached Encrustation**

Distance (ft): **280.2**
 Structural Grade: **0**
 O&M Grade: **2**
 Clock Start/From: **2**
 Clock To: **10**
 1st Value:
 2nd Value:
 Value Percent: **5.000**
 Continuous Index:
 Within 8" of Joint: **YES**
 Remarks:

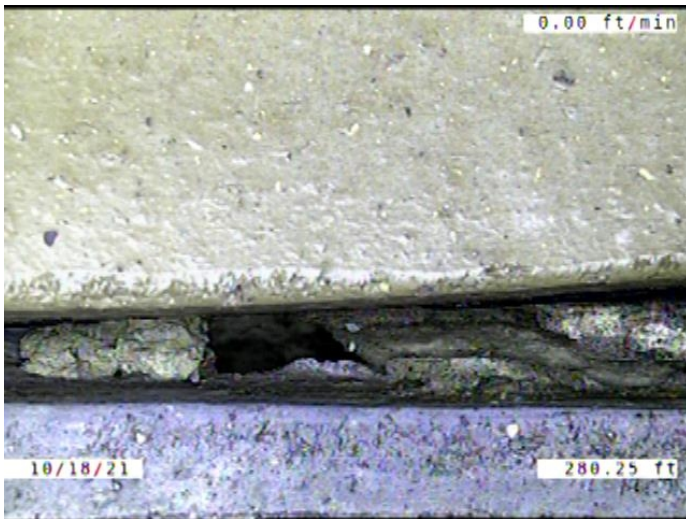
Code: **VZ**
Description: **Vermin Other**

Distance (ft): **280.3**
Structural Grade: **0**
O&M Grade: **1**
Clock Start/From:
Clock To:
1st Value: **1.000**
2nd Value:
Value Percent:
Continuous Index:
Within 8" of Joint: **NO**
Remarks: **Snake**
