## Profile/Photo Observation Report

Date:	<b>04/07/2018</b>	Weather:		Coding:	<b>PACP 6.0</b>
Pipe Length (ft):	<b>276.5</b>	Owner:	<b>NA</b>	Pre Clean:	<b>Not Known</b>
P.O.#:		Surveyor:	<b>Mark Ruby</b>	PSR:	<b>P-804-048-047</b>
Customer:		Clean Date:	<b>01/01/1900</b>	Shape:	<b>C</b>

Street:	<b>N OHIO ST</b>	Flow Control:	<b>Not Controlled</b>
City:	<b>Hobart, IN</b>	Year Renewed:	
Location:	<b>Other</b>	Tape/Media #:	
Purpose:	<b>Not Known</b>	Dia/Height:	<b>10"</b>
Use:	<b>Sanitary</b>	Material:	<b>VCP</b>
Drain Area:	<b>NA</b>	Lining:	
Category:	<b>NA</b>		
Comment:			
Location Details:		Direction of Survey:	<b>Upstream</b>
US MH:	<b>M-804-047</b>	DS MH:	<b>M-804-048</b>
		Total Length Surveyed (ft):	<b>254.8</b>

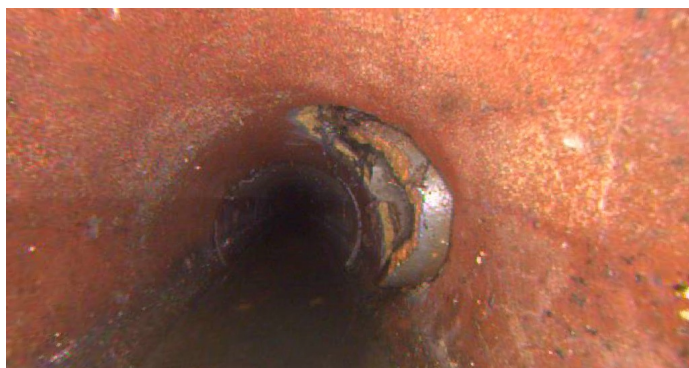
Code: **AMH**  
Description: **Manhole**

Distance (ft): **.0**  
Structural Grade: **0**  
O&M Grade: **0**  
Clock Start/From:  
Clock To:  
1st Value:  
2nd Value:  
Value Percent:  
Continuous Index:  
Within 8" of Joint: **NO**  
Remarks: **M-804-048**

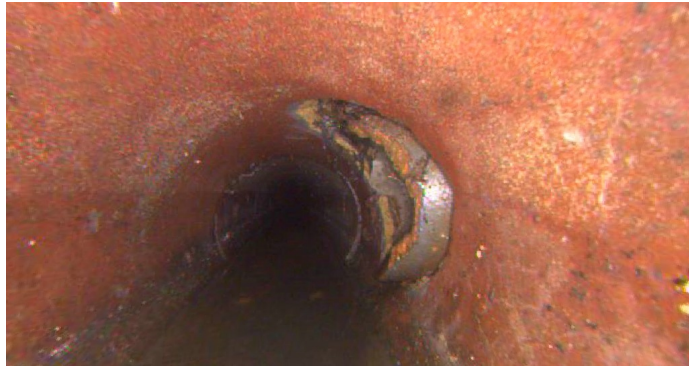
Code: **MWL**  
Description: **Water Level**

Distance (ft): **.0**  
Structural Grade: **0**  
O&M Grade: **0**  
Clock Start/From:  
Clock To:  
1st Value:  
2nd Value:  
Value Percent: **10.000**  
Continuous Index:  
Within 8" of Joint: **NO**  
Remarks:

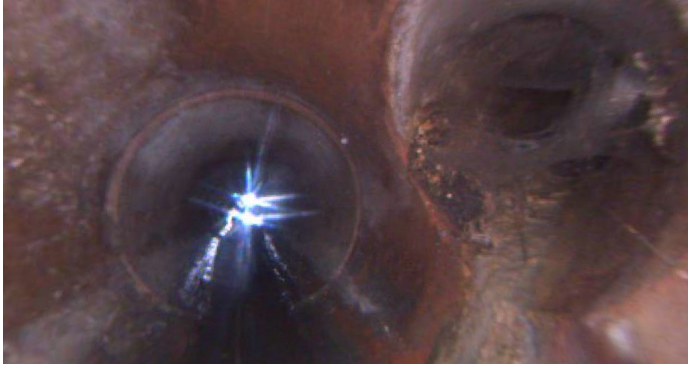
Code: **TF**  
Description: **Tap Factory**

Distance (ft): **12.9**  
Structural Grade: **0**  
O&M Grade: **0**  
Clock Start/From: **9**  
Clock To:  
1st Value: **4.000**  
2nd Value:  
Value Percent:  
Continuous Index:  
Within 8" of Joint:  
Remarks:

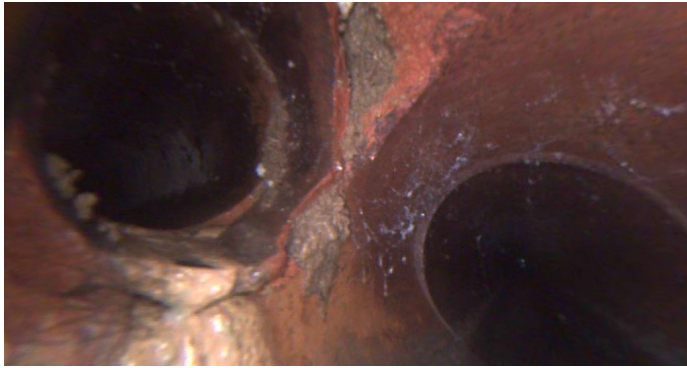
Code: **TB**  
Description: **Tap Break-in**

Distance (ft): **80.5**  
Structural Grade: **0**  
O&M Grade: **0**  
Clock Start/From: **3**  
Clock To:  
1st Value: **4.000**  
2nd Value:  
Value Percent:  
Continuous Index:  
Within 8" of Joint:  
Remarks: **Photo taken from rear camera.**

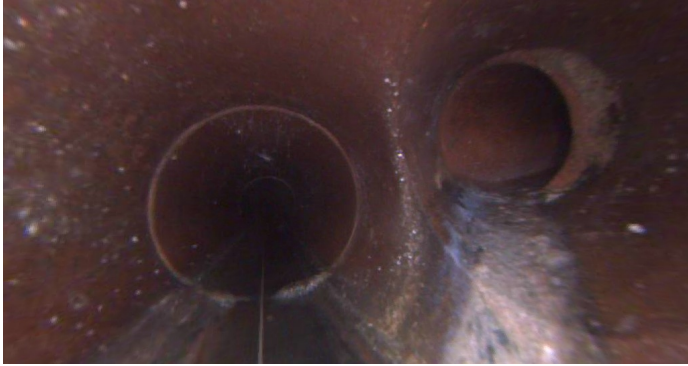
Code: **TF**  
Description: **Tap Factory**

Distance (ft): **164.1**  
Structural Grade: **0**  
O&M Grade: **0**  
Clock Start/From: **9**  
Clock To:  
1st Value: **4.000**  
2nd Value:  
Value Percent:  
Continuous Index:  
Within 8" of Joint:  
Remarks: **Photo taken from rear camera.**
