Profile/Photo Observation Report

Street:	N OHIO ST	Flow Control:	Not Controlled
City:	Hobart, IN	Year Renewed:	
Location:	Other	Tape/Media #:	
Purpose:	Not Known	Dia/Height:	10"
Use:	Sanitary	Material:	VCP
Drain Area:	NA	Lining:	
Category:	NA		
Comment:

Location Details:		Direction of Survey:	Downstream
US MH:	M-804-049	DS MH:	M-804-050
		Total Length Surveyed (ft):	5.2

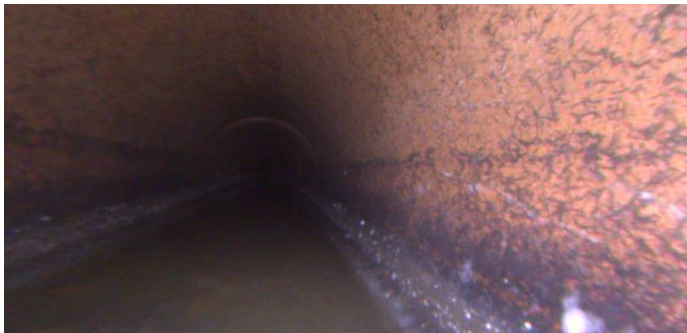
Code:	MWL
Description:	Water Level

Distance (ft):	.0
Structural Grade:	0
O&M Grade:	0
Clock Start/From:	
Clock To:	
1st Value:	
2nd Value:	
Value Percent:	10.000
Continuous Index:	
Within 8" of Joint:	NO
Remarks:
