## Profile/Photo Observation Report

Date:	<b>10/18/2021</b>	Weather:		Coding:	<b>PACP 7.0</b>
Pipe Length (ft):	<b>213.4</b>	Owner:	<b>City of Hobart</b>	Pre Clean:	<b>Heavy Cleaning</b>
P.O.#:	<b>YES502259</b>	Surveyor:	<b>S. Bucklin</b>	PSR:	<b>P-804-052-023</b>
Customer:	<b>City of Hobart</b>	Clean Date:	<b>10/15/2021</b>	Shape:	<b>C</b>

Street:	<b>North Kelly Street</b>	Flow Control:	<b>Not Controlled</b>
City:	<b>Hobart, IN</b>	Year Renewed:	
Location:	<b>Local rural streets with light traffic, t</b>	Tape/Media #:	
Purpose:	<b>Routine Assessment</b>	Dia/Height:	<b>12"</b>
Use:	<b>Sanitary Sewage Pipe</b>	Material:	<b>VCP</b>
Drain Area:		Lining:	
Category:	<b>NA</b>		
Comment:			
Location Details:		Direction of Survey:	<b>Downstream</b>
US MH:	<b>M-804-052</b>	DS MH:	<b>M-804-023</b>
		Total Length Surveyed (ft):	<b>213.4</b>

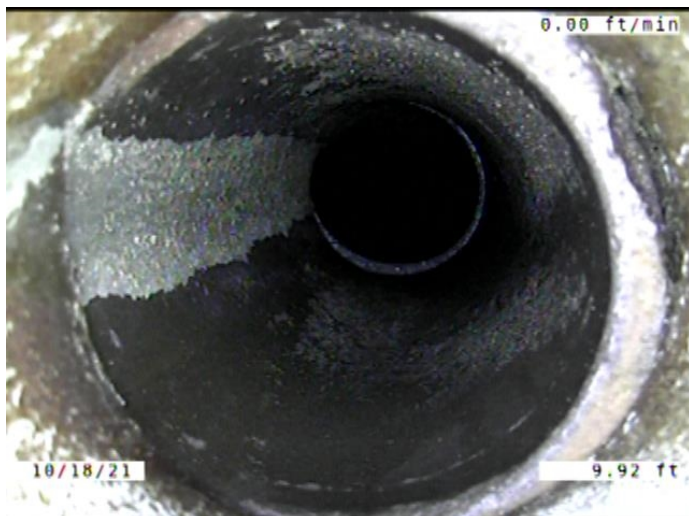
Code: **TF**  
 Description: **Tap Factory**

Distance (ft): **9.9**  
 Structural Grade: **0**  
 O&M Grade: **0**  
 Clock Start/From: **11**  
 Clock To:  
 1st Value: **4.000**  
 2nd Value:  
 Value Percent:  
 Continuous Index:  
 Within 8" of Joint: **YES**  
 Remarks:

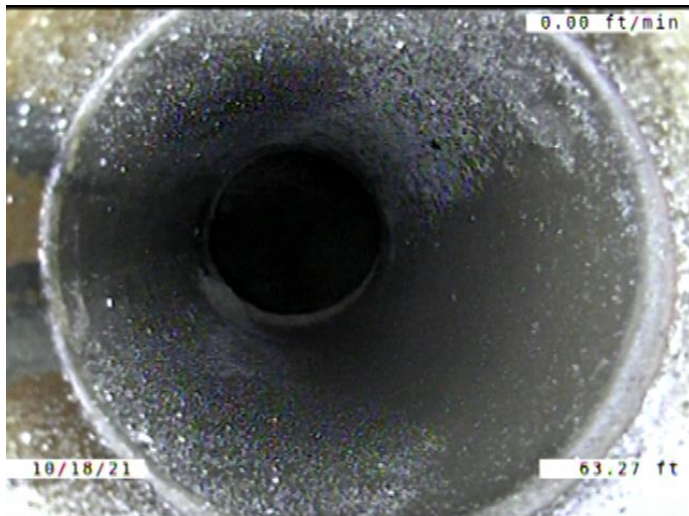
Code: **TF**  
 Description: **Tap Factory**

Distance (ft): **63.3**  
 Structural Grade: **0**  
 O&M Grade: **0**  
 Clock Start/From: **11**  
 Clock To:  
 1st Value: **4.000**  
 2nd Value:  
 Value Percent:  
 Continuous Index:  
 Within 8" of Joint: **YES**  
 Remarks:

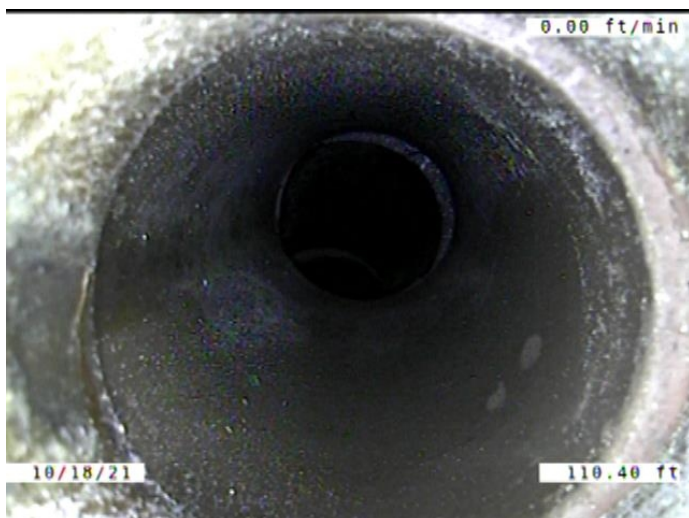
Code: **TF**  
Description: **Tap Factory**

Distance (ft): **110.4**  
Structural Grade: **0**  
O&M Grade: **0**  
Clock Start/From: **11**  
Clock To:  
1st Value: **4.000**  
2nd Value:  
Value Percent:  
Continuous Index:  
Within 8" of Joint: **YES**  
Remarks:

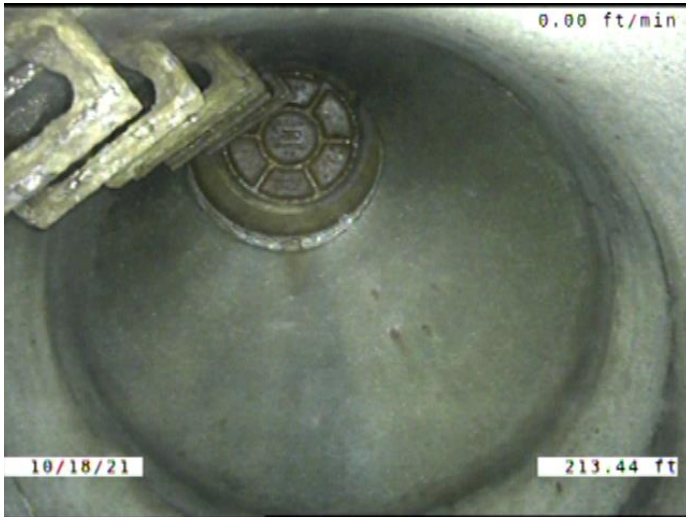
Code:	<b>AMH</b>
Description:	<b>Manhole</b>
Distance (ft):	<b>213.4</b>
Structural Grade:	<b>0</b>
O&M Grade:	<b>0</b>
Clock Start/From:	
Clock To:	
1st Value:	
2nd Value:	
Value Percent:	
Continuous Index:	
Within 8" of Joint:	<b>NO</b>
Remarks:	<b>M-804-023</b>
