Profile/Photo Observation Report

Street:	N KELLY ST	Flow Control:	Not Controlled
City:	Hobart, IN	Year Renewed:	
Location:	Other	Tape/Media #:	
Purpose:	Not Known	Dia/Height:	12"
Use:	Sanitary	Material:	VCP
Drain Area:	NA	Lining:	
Category:	NA		
Comment:	NULL - CNA DC at MH-M-804-023

Location Details:		Direction of Survey:	Downstream
US MH:	M-804-056	DS MH:	M-804-055
		Total Length Surveyed (ft):	9.6

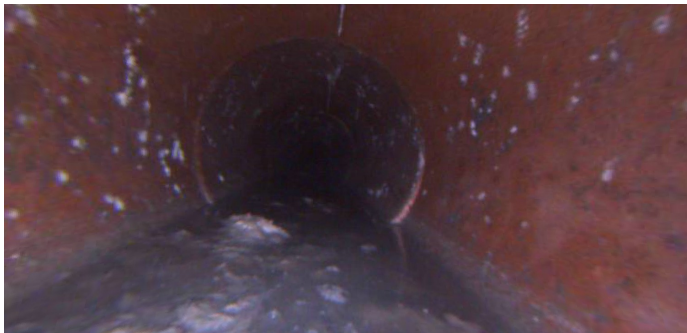
Position	Code	Observation	Video (sec)	Grade
.0	AMH	Manhole	10	NA
.0	MWL	Water Level	21	NA
3.9	CM	Crack Multiple	40	S 3
6.3	FM	Fracture Multiple	56	S 4
8.7	TF	Tap Factory	72	NA
9.6	MSA	Abandoned Survey	84	NA
