## Profile/Photo Observation Report

Date:	<b>10/11/2021</b>	Weather:		Coding:	<b>PACP 7.0</b>
Pipe Length (ft):	<b>84.8</b>	Owner:	<b>City of Hobart</b>	Pre Clean:	<b>Heavy Cleaning</b>
P.O.#:	<b>YES502259</b>	Surveyor:	<b>S. Bucklin</b>	PSR:	<b>P-804-016-077</b>
Customer:	<b>City of Hobart</b>	Clean Date:	<b>10/09/2021</b>	Shape:	<b>C</b>

Street:	<b>East Home Avenue</b>	Flow Control:	<b>Not Controlled</b>
City:	<b>Hobart, IN</b>	Year Renewed:	
Location:	<b>Local rural streets with light traffic, t</b>	Tape/Media #:	
Purpose:	<b>Routine Assessment</b>	Dia/Height:	<b>12"</b>
Use:	<b>Sanitary Sewage Pipe</b>	Material:	<b>VCP</b>
Drain Area:		Lining:	
Category:	<b>NA</b>		
Comment:			
Location Details:		Direction of Survey:	<b>Downstream</b>
US MH:	<b>M-804-077</b>	DS MH:	<b>M-804-016</b>
		Total Length Surveyed (ft):	<b>84.8</b>

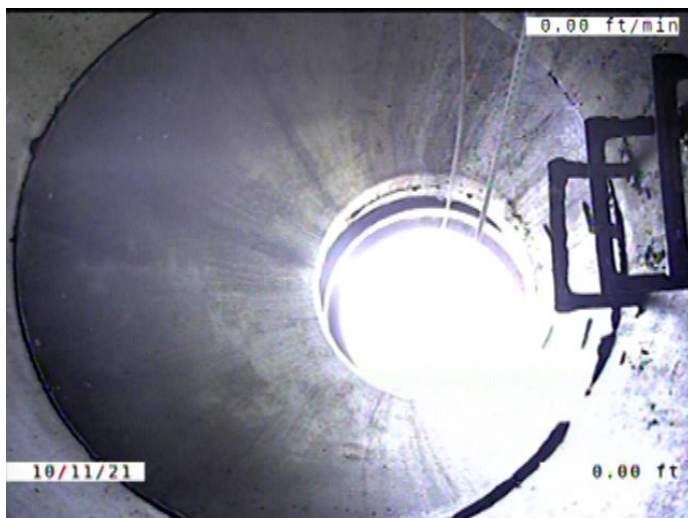
Code: **AMH**  
 Description: **Manhole**

Distance (ft): **.0**  
 Structural Grade: **0**  
 O&M Grade: **0**  
 Clock Start/From:  
 Clock To:  
 1st Value:  
 2nd Value:  
 Value Percent:  
 Continuous Index:  
 Within 8" of Joint: **NO**  
 Remarks: **M-804-077**

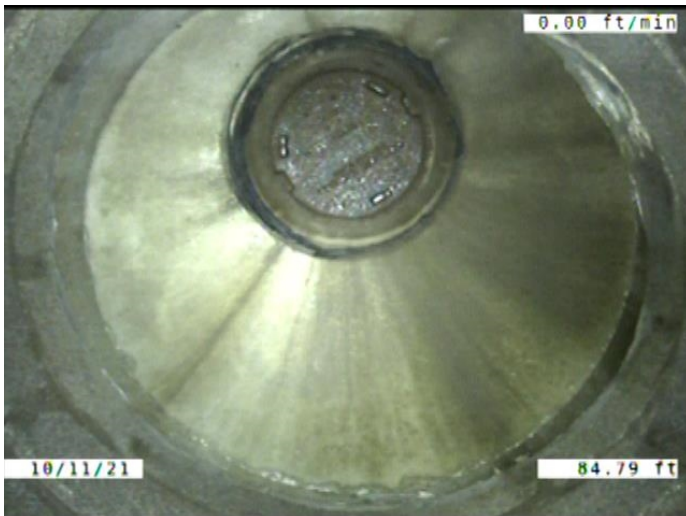
Code: **AMH**  
 Description: **Manhole**

Distance (ft): **84.8**  
 Structural Grade: **0**  
 O&M Grade: **0**  
 Clock Start/From:  
 Clock To:  
 1st Value:  
 2nd Value:  
 Value Percent:  
 Continuous Index:  
 Within 8" of Joint: **NO**  
 Remarks: **M-804-016**
