Profile/Photo Observation Report

Date:	04/22/2018	Weather:		Coding:	PACP 6.0
Pipe Length (ft):	162.9	Owner:	NA	Pre Clean:	Not Known
P.O.#:		Surveyor:	Mark Ruby	PSR:	P-805-014-013
Customer:		Clean Date:	01/01/1900	Shape:	C

Location Details:		Direction of Survey:	Upstream
US MH:	M-805-013	DS MH:	M-805-014
		Total Length Surveyed (ft):	154.4

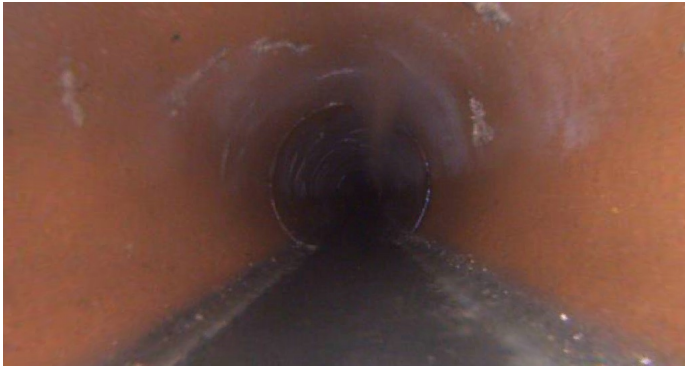
Code:	MWL
Description:	Water Level

Distance (ft):	.0
Structural Grade:	0
O&M Grade:	0
Clock Start/From:	
Clock To:	
1st Value:	
2nd Value:	
Value Percent:	10.000
Continuous Index:	
Within 8" of Joint:	NO
Remarks:
