## Profile/Photo Observation Report

Date:	<b>09/13/2022</b>	Weather:		Coding:	<b>PACP 7.0</b>
Pipe Length (ft):	<b>194.0</b>	Owner:	<b>City of Hobart</b>	Pre Clean:	<b>Heavy Cleaning</b>
P.O.#:	<b>YES502259</b>	Surveyor:	<b>S. Bucklin</b>	PSR:	<b>P-805-015-014</b>
Customer:	<b>City of Hobart</b>	Clean Date:	<b>08/26/2022</b>	Shape:	<b>C</b>

Street:	<b>South Liberty Street</b>	Flow Control:	<b>Not Controlled</b>
City:	<b>Hobart, IN</b>	Year Renewed:	
Location:	<b>Alley</b>	Tape/Media #:	
Purpose:	<b>Routine Assessment</b>	Dia/Height:	<b>10"</b>
Use:	<b>Sanitary Sewage Pipe</b>	Material:	<b>VCP</b>
Drain Area:		Lining:	<b>None</b>
Category:	<b>NA</b>		
Comment:

Location Details:		Direction of Survey:	<b>Downstream</b>
US MH:	<b>M-805-014</b>	DS MH:	<b>M-805-015</b>
		Total Length Surveyed (ft):	<b>196.1</b>

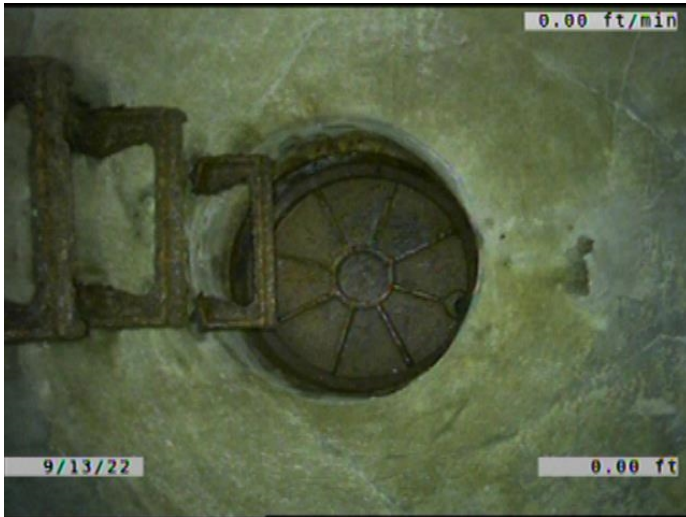
Code: **AMH**  
Description: **Manhole**

Distance (ft): **.0**  
Structural Grade: **0**  
O&M Grade: **0**  
Clock Start/From:  
Clock To:  
1st Value:  
2nd Value:  
Value Percent:  
Continuous Index:  
Within 8" of Joint: **NO**  
Remarks: **M-805-014**

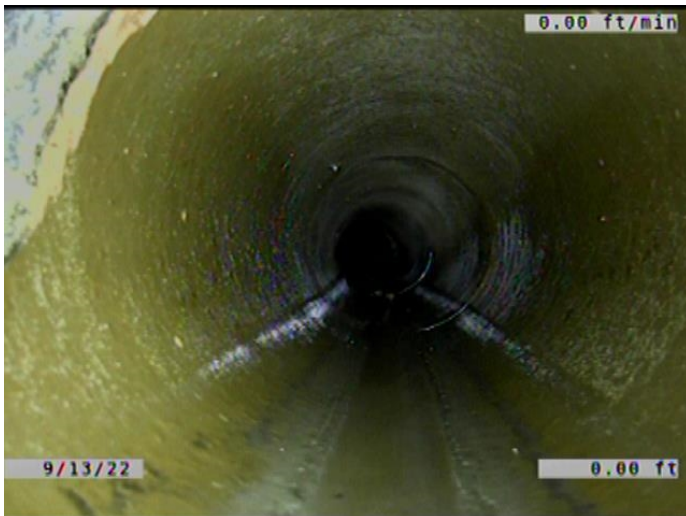
Code: **MWL**  
Description: **Miscellaneous Water Level**

Distance (ft): **.0**  
Structural Grade: **0**  
O&M Grade: **0**  
Clock Start/From:  
Clock To:  
1st Value:  
2nd Value:  
Value Percent: **5.000**  
Continuous Index:  
Within 8" of Joint: **NO**  
Remarks:

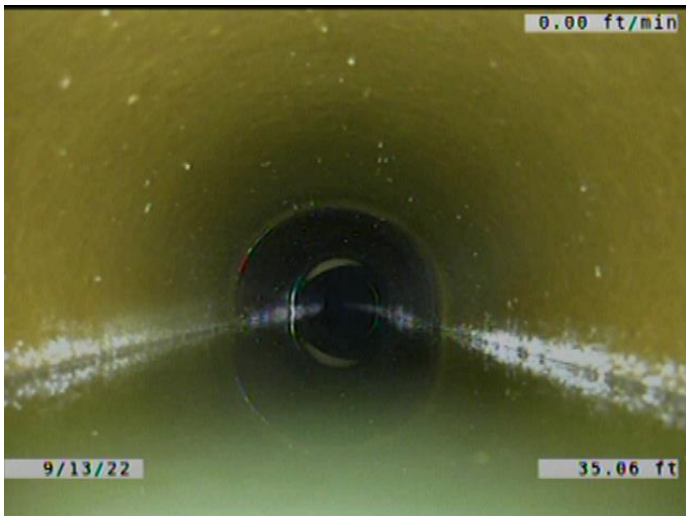
Code: **MWL**  
Description: **Miscellaneous Water Level**

Distance (ft): **35.1**  
Structural Grade: **0**  
O&M Grade: **0**  
Clock Start/From:  
Clock To:  
1st Value:  
2nd Value:  
Value Percent: **25.000**  
Continuous Index:  
Within 8" of Joint: **NO**  
Remarks:

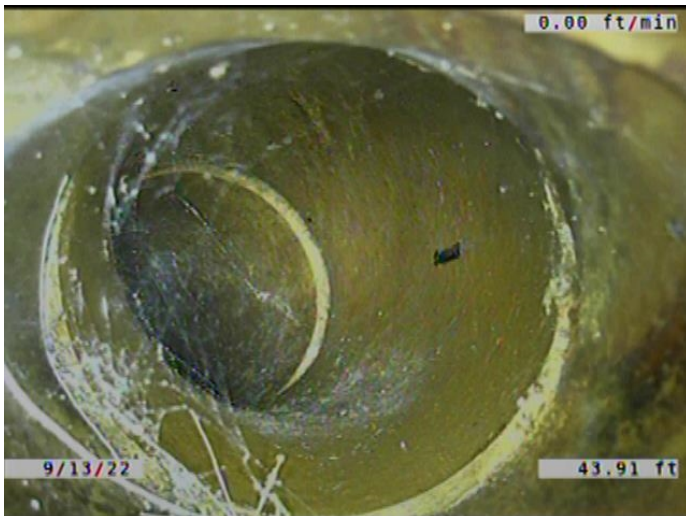
Code: **TF**  
 Description: **Tap Factory**

Distance (ft): **43.9**  
 Structural Grade: **0**  
 O&M Grade: **0**  
 Clock Start/From: **11**  
 Clock To:  
 1st Value: **6.000**  
 2nd Value:  
 Value Percent:  
 Continuous Index:  
 Within 8" of Joint: **YES**  
 Remarks:

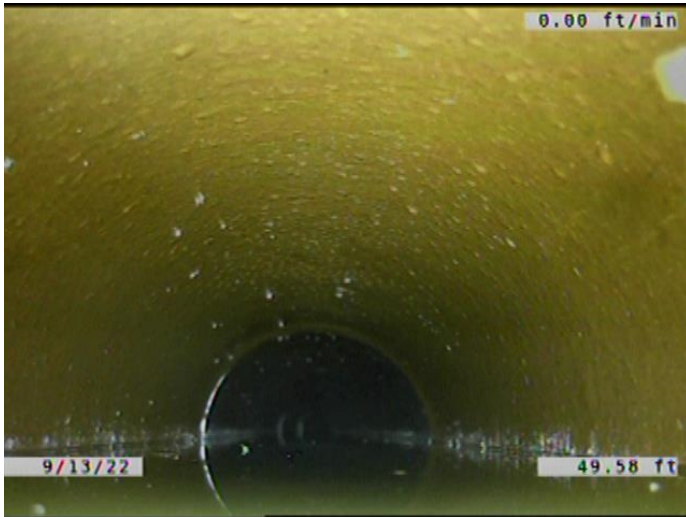
Code:	<b>MWL</b>
Description:	<b>Miscellaneous Water Level</b>
Distance (ft):	<b>49.6</b>
Structural Grade:	<b>0</b>
O&M Grade:	<b>0</b>
Clock Start/From:	
Clock To:	
1st Value:	
2nd Value:	
Value Percent:	<b>40.000</b>
Continuous Index:	
Within 8" of Joint:	<b>NO</b>
Remarks:

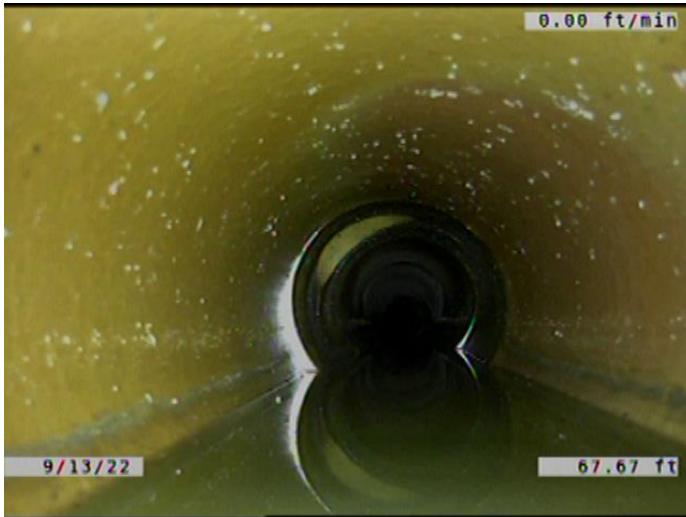
Code: **MWL**  
 Description: **Miscellaneous Water Level**

Distance (ft): **67.7**  
 Structural Grade: **0**  
 O&M Grade: **0**  
 Clock Start/From:  
 Clock To:  
 1st Value:  
 2nd Value:  
 Value Percent: **15.000**  
 Continuous Index:  
 Within 8" of Joint: **NO**  
 Remarks:

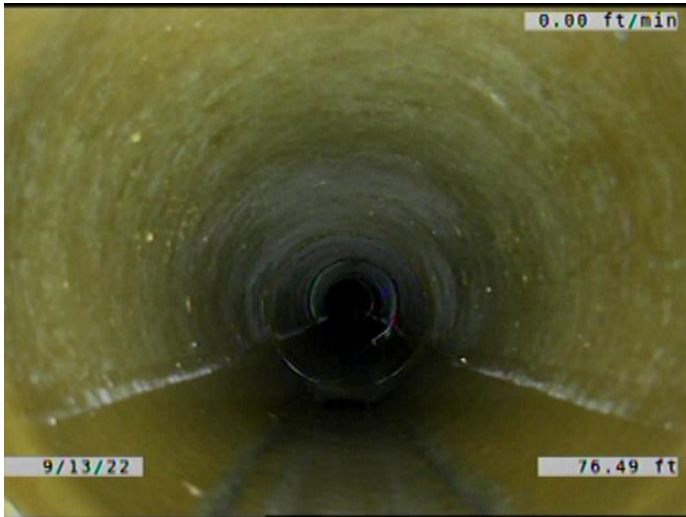
Code: **MWL**  
 Description: **Miscellaneous Water Level**

Distance (ft): **76.5**  
 Structural Grade: **0**  
 O&M Grade: **0**  
 Clock Start/From:  
 Clock To:  
 1st Value:  
 2nd Value:  
 Value Percent: **5.000**  
 Continuous Index:  
 Within 8" of Joint: **NO**  
 Remarks:

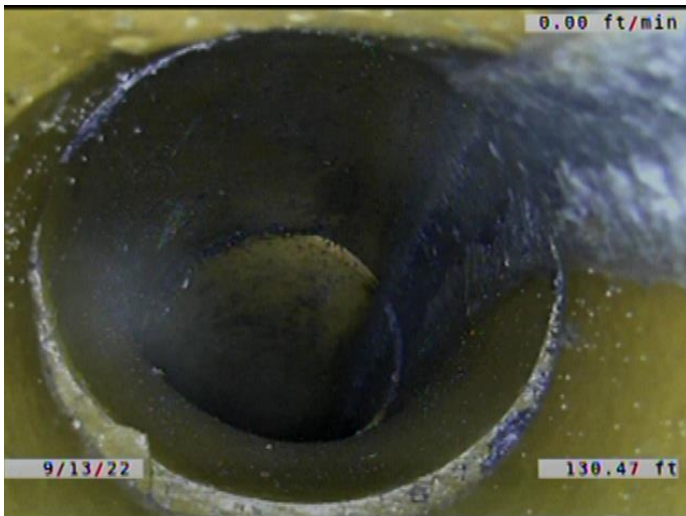
Code: **TF**  
 Description: **Tap Factory**

Distance (ft): **130.5**  
 Structural Grade: **0**  
 O&M Grade: **0**  
 Clock Start/From: **1**  
 Clock To:  
 1st Value: **6.000**  
 2nd Value:  
 Value Percent:  
 Continuous Index:  
 Within 8" of Joint: **YES**  
 Remarks:

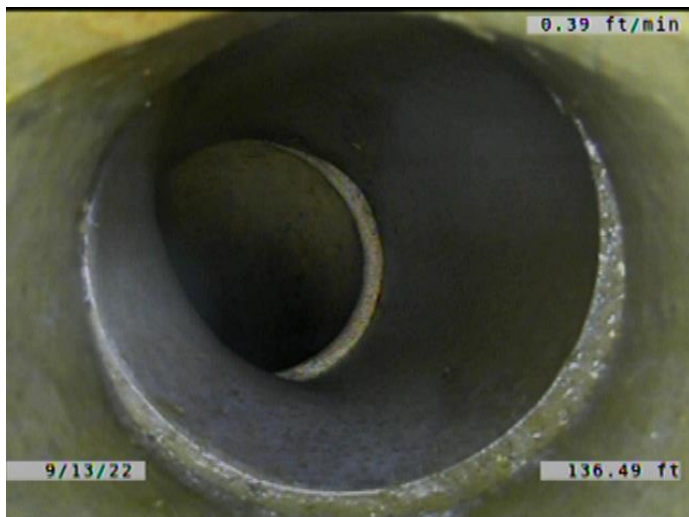
Code: **TF**  
 Description: **Tap Factory**

Distance (ft): **136.5**  
 Structural Grade: **0**  
 O&M Grade: **0**  
 Clock Start/From: **11**  
 Clock To:  
 1st Value: **6.000**  
 2nd Value:  
 Value Percent:  
 Continuous Index:  
 Within 8" of Joint: **YES**  
 Remarks:

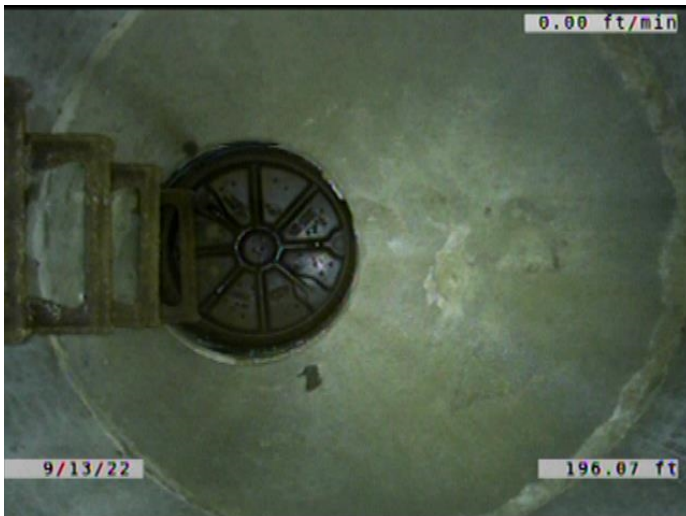
Code: **AMH**  
 Description: **Manhole**

Distance (ft): **196.1**  
 Structural Grade: **0**  
 O&M Grade: **0**  
 Clock Start/From:  
 Clock To:  
 1st Value:  
 2nd Value:  
 Value Percent:  
 Continuous Index:  
 Within 8" of Joint: **NO**  
 Remarks: **M-805-015**
