## Profile/Photo Observation Report

Date:	<b>04/22/2018</b>	Weather:		Coding:	<b>PACP 6.0</b>
Pipe Length (ft):	<b>202.3</b>	Owner:	<b>NA</b>	Pre Clean:	<b>Not Known</b>
P.O.#:		Surveyor:	<b>Jen Costello</b>	PSR:	<b>P-805-016-015</b>
Customer:		Clean Date:	<b>01/01/1900</b>	Shape:	<b>C</b>

Street:	<b>Capitol</b>	Flow Control:	<b>Not Controlled</b>
City:	<b>Hobart, IN</b>	Year Renewed:	
Location:	<b>Alley</b>	Tape/Media #:	
Purpose:	<b>Maintenance Related</b>	Dia/Height:	<b>10"</b>
Use:	<b>Sanitary</b>	Material:	<b>VCP</b>
Drain Area:	<b>NA</b>	Lining:	<b>Cured in Place</b>
Category:	<b>NA</b>		
Comment:	<b>flow incorrect. Roots at 5'.</b>		
Location Details:		Direction of Survey:	<b>Upstream</b>
US MH:	<b>M-805-015</b>	DS MH:	<b>M-805-016</b>
		Total Length Surveyed (ft):	<b>6.5</b>

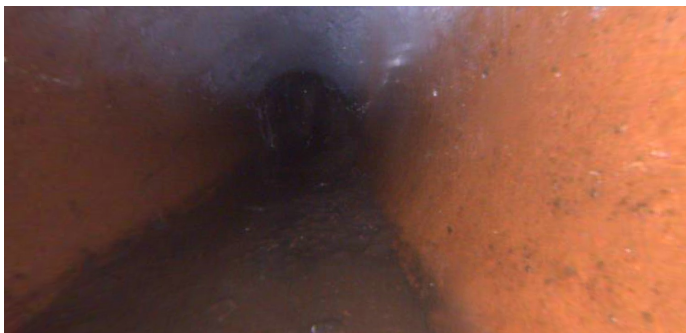
Code: **AMH**  
Description: **Manhole**

Distance (ft): **.0**  
Structural Grade: **0**  
O&M Grade: **0**  
Clock Start/From:  
Clock To:  
1st Value:  
2nd Value:  
Value Percent:  
Continuous Index:  
Within 8" of Joint: **NO**  
Remarks: **M-805-016**
