# Profile/Photo Observation Report

| Customer: | <b>City of Hobart</b> | Clean Date: | <b>09/01/2022</b> | Shape: | <b>C</b> |

| Street: | <b>E 5TH ST</b> | Flow Control: | <b>Not Controlled</b> |
| US MH: | <b>M-805-018</b> | DS MH: | <b>M-805-013</b> |

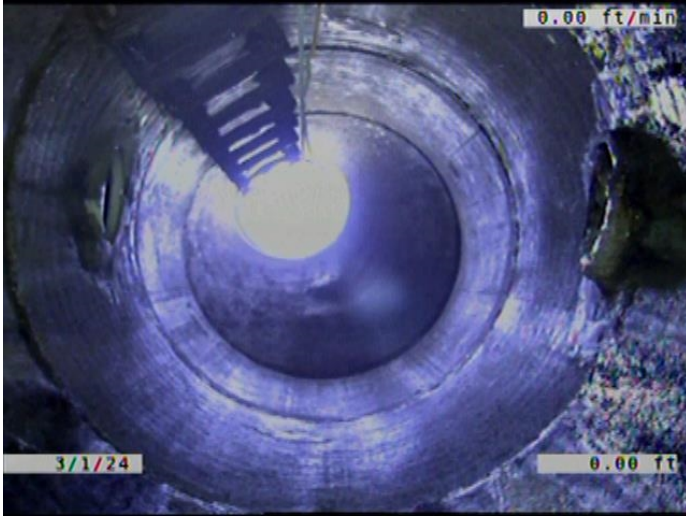
Code: **AMH**  
Description: **Manhole**

Distance (ft): **.0**  
Structural Grade: **0**  
O&M Grade: **0**  
Clock Start/From:  
Clock To:  
1st Value:  
2nd Value:  
Value Percent:  
Continuous Index:  
Within 8" of Joint: **NO**  
Remarks: **M-805-018**

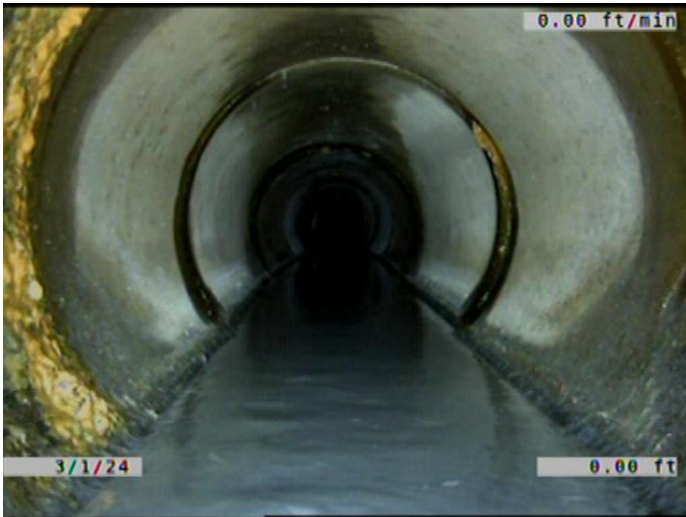
Code: **MWL**  
Description: **Miscellaneous Water Level**

Distance (ft): **.0**  
Structural Grade: **0**  
O&M Grade: **0**  
Clock Start/From:  
Clock To:  
1st Value:  
2nd Value:  
Value Percent: **15.000**  
Continuous Index:  
Within 8" of Joint: **NO**  
Remarks:
