Profile/Photo Observation Report

Date:	04/22/2018	Weather:		Coding:	PACP 6.0
Pipe Length (ft):	214.5	Owner:	NA	Pre Clean:	Not Known
P.O.#:		Surveyor:	Mark Ruby	PSR:	P-805-021-020
Customer:		Clean Date:	01/01/1900	Shape:	C

Street:	Capitol	Flow Control:	Not Controlled
City:	Hobart, IN	Year Renewed:	
Location:	Alley	Tape/Media #:	
Purpose:	Maintenance Related	Dia/Height:	10"
Use:	Sanitary	Material:	VCP
Drain Area:	NA	Lining:	Cured in Place
Category:	NA		
Comment:	heavy debris at 144'-flow reversed.		
Location Details:		Direction of Survey:	Upstream
US MH:	M-805-020	DS MH:	M-805-021
		Total Length Surveyed (ft):	145.3

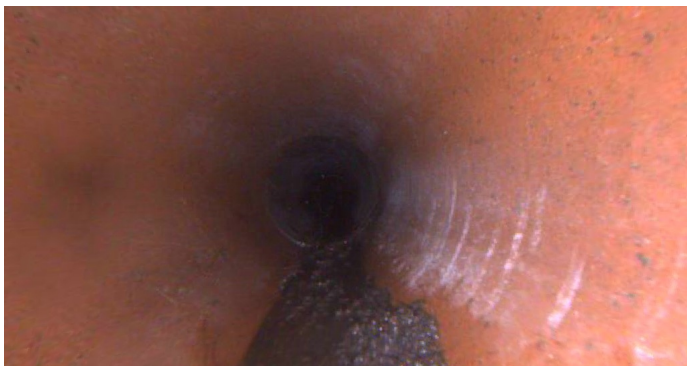
Code:	MWL
Description:	Water Level

Distance (ft):	.0
Structural Grade:	0
O&M Grade:	0
Clock Start/From:	
Clock To:	
1st Value:	
2nd Value:	
Value Percent:	10.000
Continuous Index:	
Within 8" of Joint:	NO
Remarks:
