Profile/Photo Observation Report

Date:	04/21/2018	Weather:		Coding:	PACP 6.0
Pipe Length (ft):	280.6	Owner:	NA	Pre Clean:	Not Known
P.O.#:		Surveyor:	Mark Ruby	PSR:	P-805-024-023
Customer:		Clean Date:	01/01/1900	Shape:	C

Street:	Capitol	Flow Control:	Not Controlled
City:	Hobart, IN	Year Renewed:	
Location:	Alley	Tape/Media #:	
Purpose:	Maintenance Related	Dia/Height:	10"
Use:	Sanitary	Material:	PVC
Drain Area:	NA	Lining:	Cured in Place
Category:	NA		
Comment:	unknown near tap at 124'.		
Location Details:		Direction of Survey:	Upstream
US MH:	M-805-023	DS MH:	M-805-024
		Total Length Surveyed (ft):	125.3

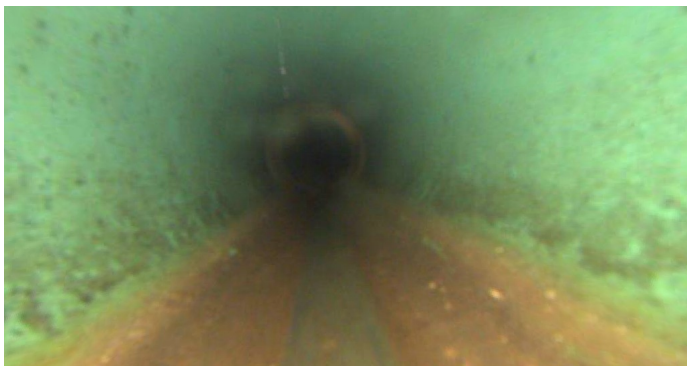
Position	Code	Observation	Video (sec)	Grade
.0	AMH	Manhole	10	NA
.0	MWL	Water Level	21	NA
4.2	TF	Tap Factory	43	NA
14.3	TF	Tap Factory	76	NA
44.4	TF	Tap Factory	148	NA
57.2	TF	Tap Factory	185	NA
122.6	TF	Tap Factory	330	NA
125.3	MSA	Abandoned Survey	351	NA
