Profile/Photo Observation Report

Date:	03/01/2024	Weather:		Coding:	PACP 7.0
Pipe Length (ft):	327.0	Owner:	City of Hobart	Pre Clean:	Heavy Cleaning
P.O.#:		Surveyor:	S. Bucklin	PSR:	P-805-023-027
Customer:	City of Hobart	Clean Date:	09/09/2022	Shape:	C

Street:	E 5TH ST	Flow Control:	Not Controlled
City:	Hobart, IN	Year Renewed:	
Location:	Local rural streets with light traffic, t	Tape/Media #:	
Purpose:	Sewer System Evaluation Survey (SS	Dia/Height:	21"
Use:	Sanitary Sewage Pipe	Material:	PE
Drain Area:		Lining:	None
Category:	NA		
Comment:			
Location Details:		Direction of Survey:	Downstream
US MH:	M-805-027	DS MH:	M-805-023
		Total Length Surveyed (ft):	333.1

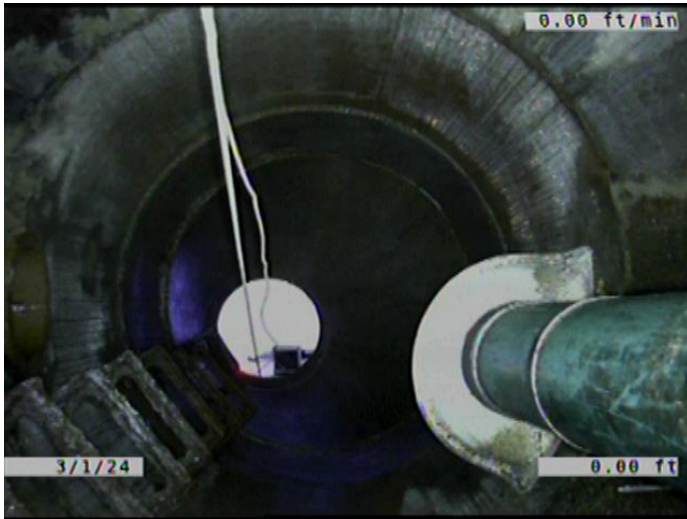
Code: **AMH**
Description: **Manhole**

Distance (ft): **.0**
Structural Grade: **0**
O&M Grade: **0**
Clock Start/From:
Clock To:
1st Value:
2nd Value:
Value Percent:
Continuous Index:
Within 8" of Joint: **NO**
Remarks: **M-805-027**

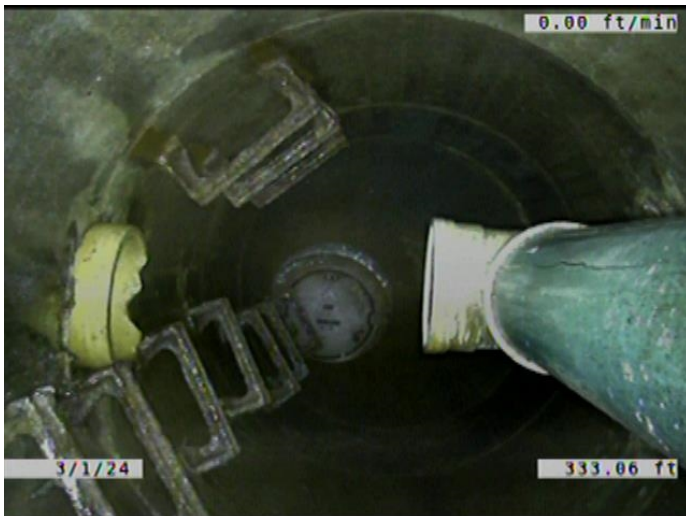
Code: **AMH**
 Description: **Manhole**

Distance (ft): **333.1**
 Structural Grade: **0**
 O&M Grade: **0**
 Clock Start/From:
 Clock To:
 1st Value:
 2nd Value:
 Value Percent:
 Continuous Index:
 Within 8" of Joint: **NO**
 Remarks: **M-805-023**
