## Profile/Photo Observation Report

Date:	<b>04/20/2018</b>	Weather:		Coding:	<b>PACP 6.0</b>
Pipe Length (ft):	<b>165.6</b>	Owner:	<b>NA</b>	Pre Clean:	<b>Not Known</b>
P.O.#:		Surveyor:	<b>Byrd Fitzgerald</b>	PSR:	<b>P-805-036-037</b>
Customer:		Clean Date:	<b>01/01/1900</b>	Shape:	<b>C</b>

Location Details:		Direction of Survey:	<b>Upstream</b>
US MH:	<b>M-805-037</b>	DS MH:	<b>M-805-036</b>
		Total Length Surveyed (ft):	<b>120.0</b>

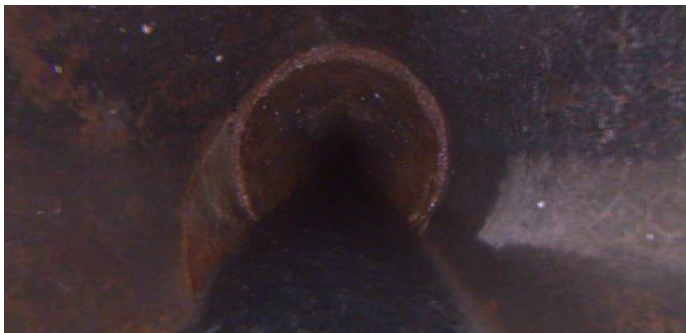
Code: **AMH**  
Description: **Manhole**

Distance (ft): **.0**  
Structural Grade: **0**  
O&M Grade: **0**  
Clock Start/From:  
Clock To:  
1st Value:  
2nd Value:  
Value Percent:  
Continuous Index:  
Within 8" of Joint: **NO**  
Remarks: **M-805-036**

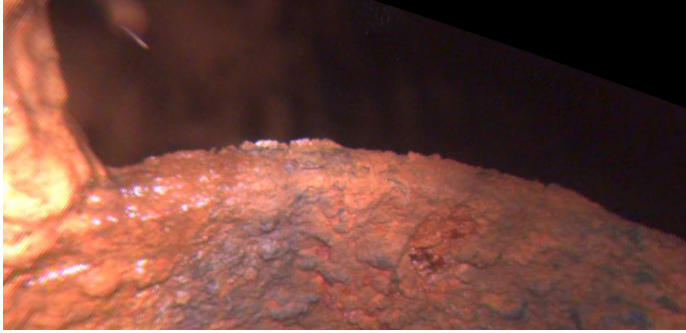
Code:	<b>AMH</b>
Description:	<b>Manhole</b>
Distance (ft):	<b>120.0</b>
Structural Grade:	<b>0</b>
O&M Grade:	<b>0</b>
Clock Start/From:	
Clock To:	
1st Value:	
2nd Value:	
Value Percent:	
Continuous Index:	
Within 8" of Joint:	<b>NO</b>
Remarks:	<b>M-805-037</b>
