Street:	Devanshire Street		Flow Control:	Not Controlled	
City:	Hobart, IN		Year Renewed:		
Location:	Local rural streets with light traffic, t		Tape/Media #:		
Purpose:	Routine Assessment		Dia/Height:	12"	
Use:	Sanitary Sewage Pipe		Material:	VCP	
Drain Area:			Lining:	None	
Category:	NA				
Comment:					
Location Details:			Direction of Survey:	Downstream	
US MH:	M-805-038	DS MH:	M-805-037	Total Length Surveyed (ft):	161.9

**Tuesday, April 25, 2023**

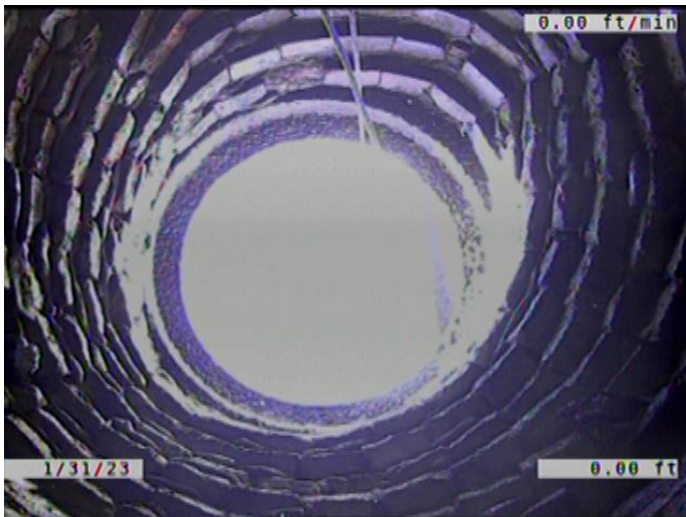
Code: **AMH**  
Description: **Manhole**

Distance (ft): **.0**  
Structural Grade: **0**  
O&M Grade: **0**  
Clock Start/From:  
Clock To:  
1st Value:  
2nd Value:  
Value Percent:  
Continuous Index:  
Within 8" of Joint: **NO**  
Remarks: **M-805-038**

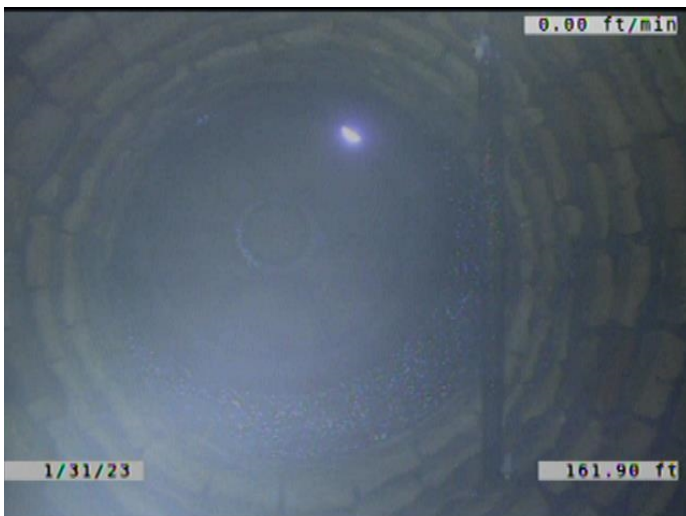
Code: **AMH**  
 Description: **Manhole**

Distance (ft): **161.9**  
 Structural Grade: **0**  
 O&M Grade: **0**  
 Clock Start/From:  
 Clock To:  
 1st Value:  
 2nd Value:  
 Value Percent:  
 Continuous Index:  
 Within 8" of Joint: **NO**  
 Remarks: **M-805-037**
