Profile/Photo Observation Report

Date:	01/31/2023	Weather:		Coding:	PACP 7.0
Pipe Length (ft):	156.0	Owner:	City of Hobart	Pre Clean:	Heavy Cleaning
P.O.#:	YES502259	Surveyor:	S. Bucklin	PSR:	P-805-038-039
Customer:	City of Hobart	Clean Date:	12/06/2022	Shape:	C

Street:	Devanshire Street	Flow Control:	Not Controlled
City:	Hobart, IN	Year Renewed:	
Location:	Local rural streets with light traffic, t	Tape/Media #:	
Purpose:	Routine Assessment	Dia/Height:	12"
Use:	Sanitary Sewage Pipe	Material:	VCP
Drain Area:		Lining:	None
Category:	NA		
Comment:			
Location Details:		Direction of Survey:	Downstream
US MH:	M-805-039	DS MH:	M-805-038
		Total Length Surveyed (ft):	155.8

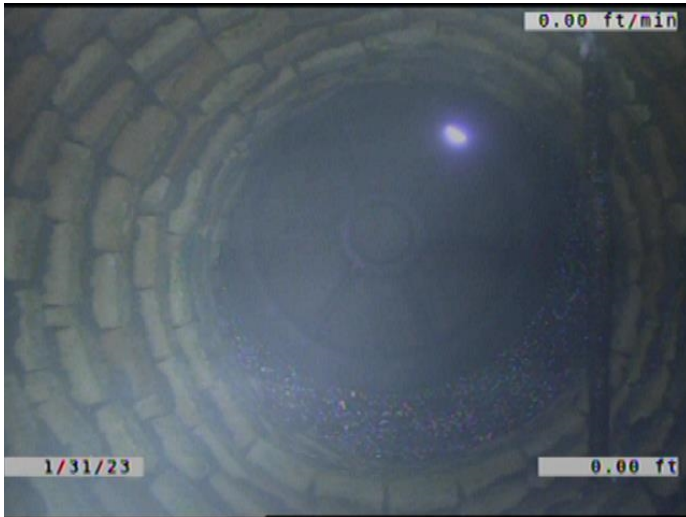
Code: **AMH**
Description: **Manhole**

Distance (ft): **.0**
Structural Grade: **0**
O&M Grade: **0**
Clock Start/From:
Clock To:
1st Value:
2nd Value:
Value Percent:
Continuous Index:
Within 8" of Joint: **NO**
Remarks: **M-805-039**

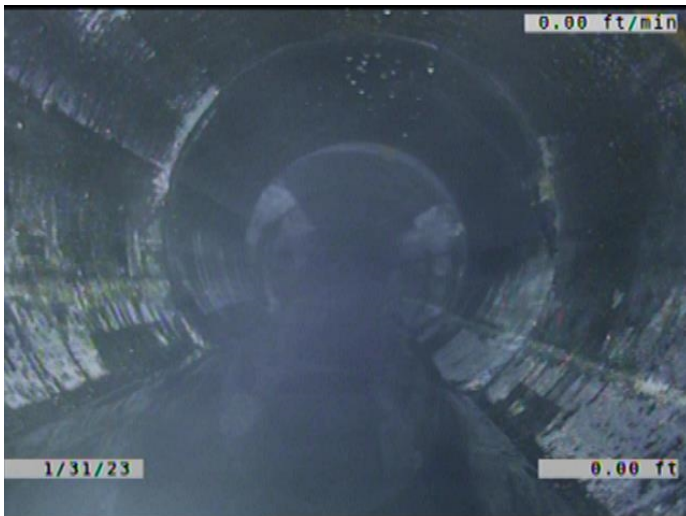
Code: **MWL**
Description: **Miscellaneous Water Level**

Distance (ft): **.0**
Structural Grade: **0**
O&M Grade: **0**
Clock Start/From:
Clock To:
1st Value:
2nd Value:
Value Percent: **10.000**
Continuous Index:
Within 8" of Joint: **NO**
Remarks:

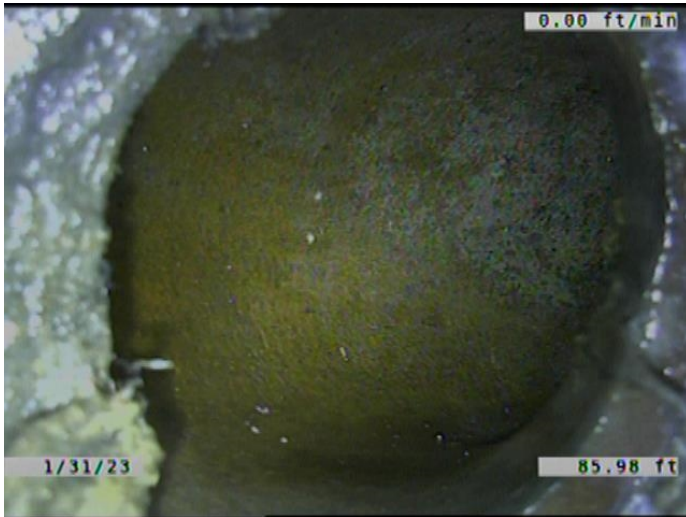
Code: **TB**
 Description: **Tap Break-in/Hammer**

Distance (ft): **86.0**
 Structural Grade: **0**
 O&M Grade: **0**
 Clock Start/From: **12**
 Clock To:
 1st Value: **6.000**
 2nd Value:
 Value Percent:
 Continuous Index:
 Within 8" of Joint: **YES**
 Remarks:

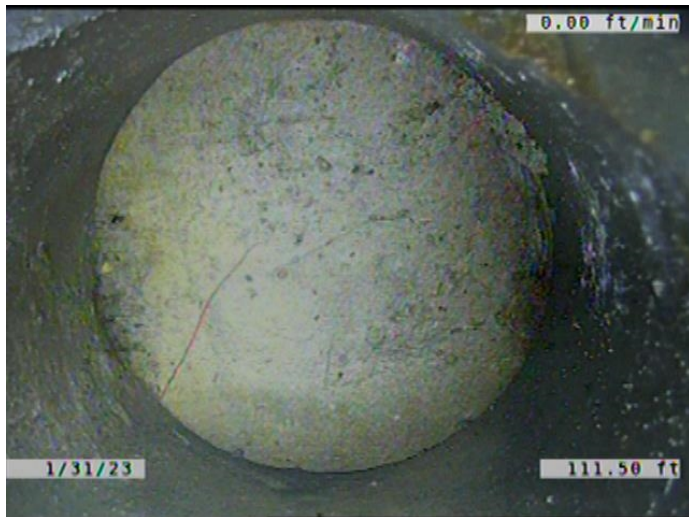
Code: **TFC**
 Description: **Tap Factory Capped**

Distance (ft): **111.5**
 Structural Grade: **0**
 O&M Grade: **0**
 Clock Start/From: **2**
 Clock To:
 1st Value: **6.000**
 2nd Value:
 Value Percent:
 Continuous Index:
 Within 8" of Joint: **YES**
 Remarks:

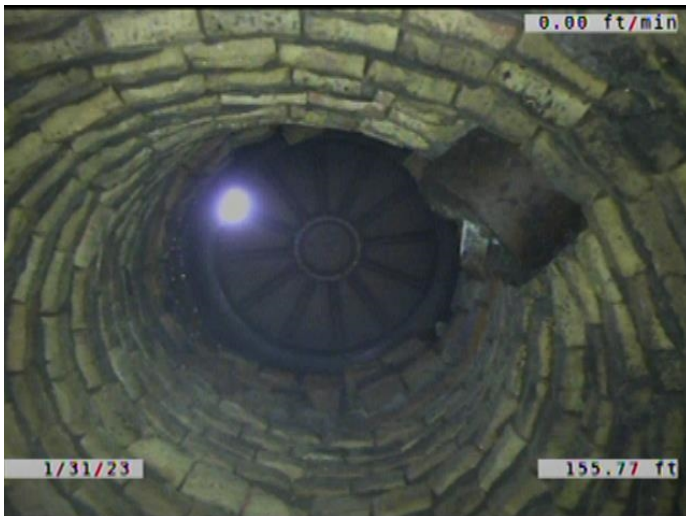
Code: **AMH**
 Description: **Manhole**

Distance (ft): **155.8**
 Structural Grade: **0**
 O&M Grade: **0**
 Clock Start/From:
 Clock To:
 1st Value:
 2nd Value:
 Value Percent:
 Continuous Index:
 Within 8" of Joint: **NO**
 Remarks: **M-805-038**
