# Profile/Photo Observation Report

Date:	01/21/2023	Weather:		Coding:	PACP 7.0
Pipe Length (ft):	402.0	Owner:	City of Hobart	Pre Clean:	Heavy Cleaning
P.O.#:	YES502259	Surveyor:	S. Bucklin	PSR:	P-805-056-055
Customer:	City of Hobart	Clean Date:	12/19/2022	Shape:	C

Street:	South Lillian Street	Flow Control:	Not Controlled
City:	Hobart, IN	Year Renewed:	
Location:	Local rural streets with light traffic, t	Tape/Media #:	
Purpose:	Routine Assessment	Dia/Height:	15"
Use:	Sanitary Sewage Pipe	Material:	VCP
Drain Area:		Lining:	None
Category:	NA		
Comment:			
Location Details:		Direction of Survey:	Downstream
US MH:	M-805-056	DS MH:	M-805-055
		Total Length Surveyed (ft):	396.6

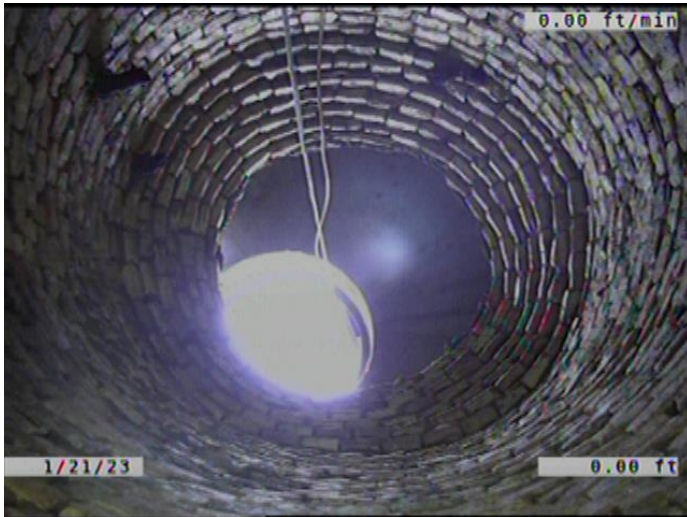
Code: **AMH**  
 Description: **Manhole**

Distance (ft): **.0**  
 Structural Grade: **0**  
 O&M Grade: **0**  
 Clock Start/From:  
 Clock To:  
 1st Value:  
 2nd Value:  
 Value Percent:  
 Continuous Index:  
 Within 8" of Joint: **NO**  
 Remarks: **M-805-056**

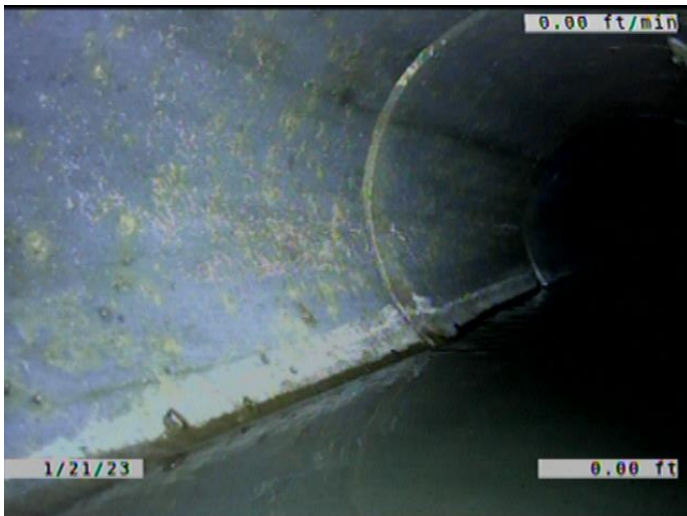
Code: **MWL**  
 Description: **Miscellaneous Water Level**

Distance (ft): **.0**  
 Structural Grade: **0**  
 O&M Grade: **0**  
 Clock Start/From:  
 Clock To:  
 1st Value:  
 2nd Value:  
 Value Percent: **10.000**  
 Continuous Index:  
 Within 8" of Joint: **NO**  
 Remarks:

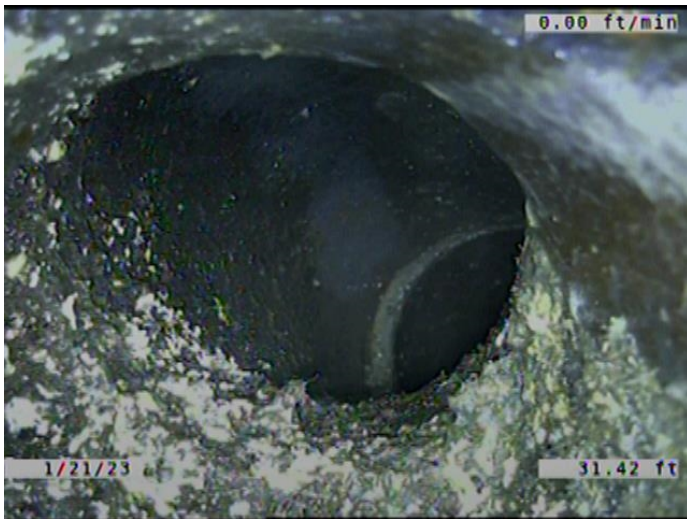
Code: **TF**  
Description: **Tap Factory**

Distance (ft): **31.4**  
Structural Grade: **0**  
O&M Grade: **0**  
Clock Start/From: **1**  
Clock To:  
1st Value: **6.000**  
2nd Value:  
Value Percent:  
Continuous Index:  
Within 8" of Joint: **YES**  
Remarks:

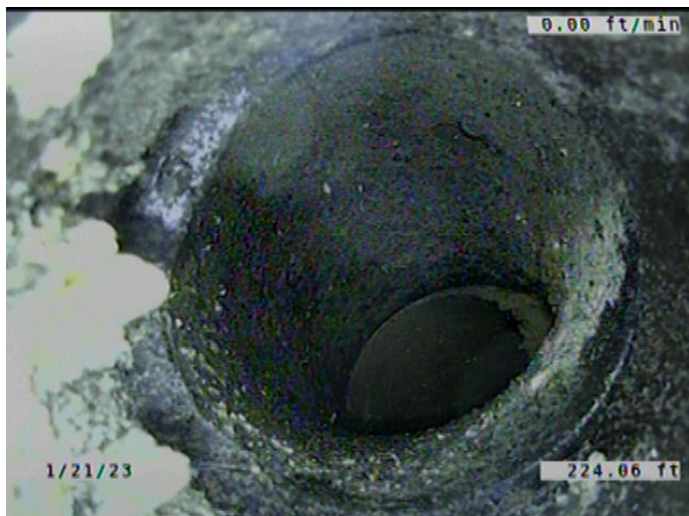
Code: **TF**  
Description: **Tap Factory**

Distance (ft): **224.1**  
Structural Grade: **0**  
O&M Grade: **0**  
Clock Start/From: **1**  
Clock To:  
1st Value: **6.000**  
2nd Value:  
Value Percent:  
Continuous Index:  
Within 8" of Joint: **YES**  
Remarks:

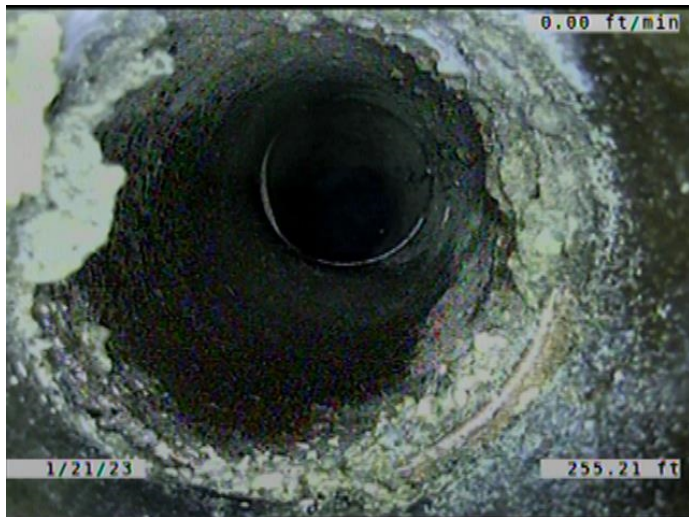
Code: **TF**  
 Description: **Tap Factory**

Distance (ft): **255.2**  
 Structural Grade: **0**  
 O&M Grade: **0**  
 Clock Start/From: **2**  
 Clock To:  
 1st Value: **6.000**  
 2nd Value:  
 Value Percent:  
 Continuous Index:  
 Within 8" of Joint: **YES**  
 Remarks:

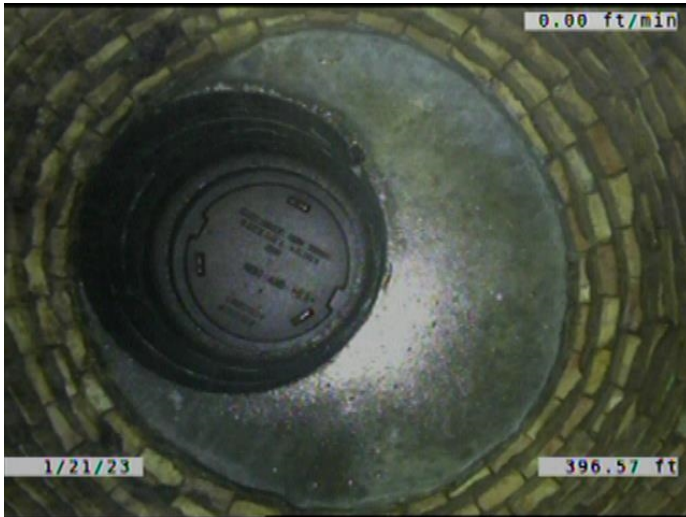
Code:	<b>AMH</b>
Description:	<b>Manhole</b>
Distance (ft):	<b>396.6</b>
Structural Grade:	<b>0</b>
O&M Grade:	<b>0</b>
Clock Start/From:	
Clock To:	
1st Value:	
2nd Value:	
Value Percent:	
Continuous Index:	
Within 8" of Joint:	<b>NO</b>
Remarks:	<b>M-805-055</b>
