Profile/Photo Observation Report

Date:	01/15/2023	Weather:		Coding:	PACP 7.0
Pipe Length (ft):	132.0	Owner:	City of Hobart	Pre Clean:	Heavy Cleaning
P.O.#:	YES502259	Surveyor:	S. Bucklin	PSR:	P-805-058-056
Customer:	City of Hobart	Clean Date:	01/11/2023	Shape:	C

Street:	South Indiana Street	Flow Control:	Not Controlled
City:	Hobart, IN	Year Renewed:	
Location:	Local rural streets with light traffic, t	Tape/Media #:	
Purpose:	Routine Assessment	Dia/Height:	15"
Use:	Sanitary Sewage Pipe	Material:	VCP
Drain Area:		Lining:	None
Category:	NA		
Comment:			
Location Details:		Direction of Survey:	Upstream
US MH:	M-805-058	DS MH:	M-805-056
		Total Length Surveyed (ft):	127.3

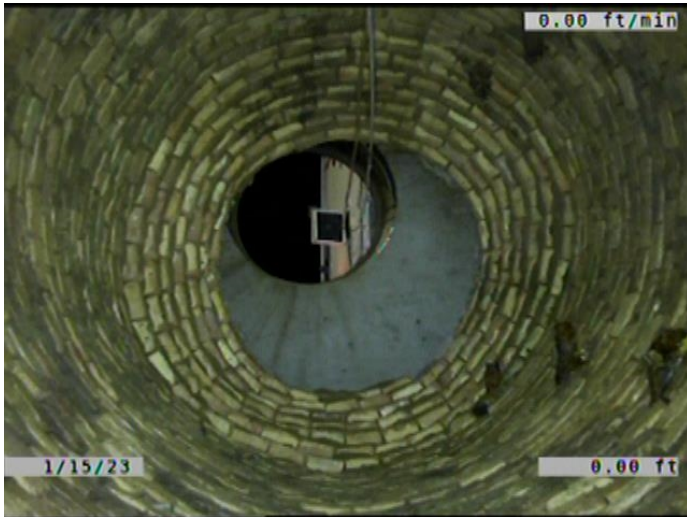
Code: **AMH**
Description: **Manhole**

Distance (ft): **.0**
Structural Grade: **0**
O&M Grade: **0**
Clock Start/From:
Clock To:
1st Value:
2nd Value:
Value Percent:
Continuous Index:
Within 8" of Joint: **NO**
Remarks: **M-805-056**

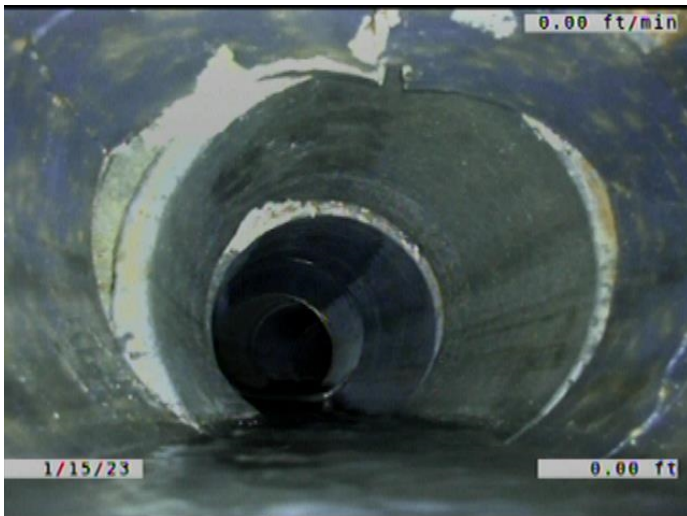
Code: **MWL**
Description: **Miscellaneous Water Level**

Distance (ft): **.0**
Structural Grade: **0**
O&M Grade: **0**
Clock Start/From:
Clock To:
1st Value:
2nd Value:
Value Percent: **10.000**
Continuous Index:
Within 8" of Joint: **NO**
Remarks:

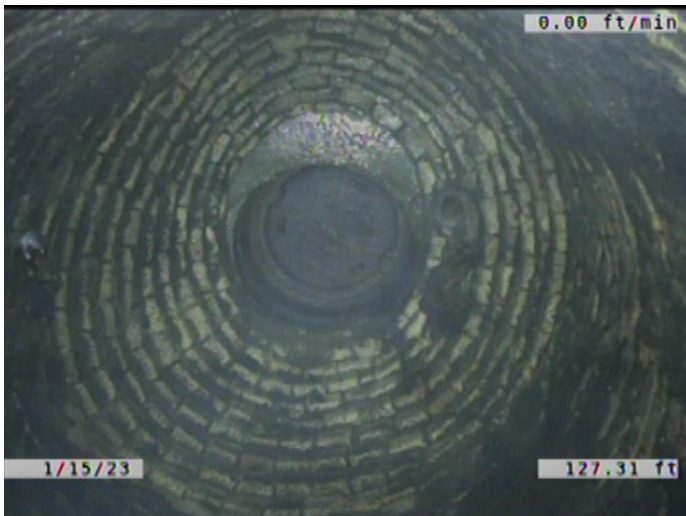
Code: **AMH**
 Description: **Manhole**

Distance (ft): **127.3**
 Structural Grade: **0**
 O&M Grade: **0**
 Clock Start/From:
 Clock To:
 1st Value:
 2nd Value:
 Value Percent:
 Continuous Index:
 Within 8" of Joint: **NO**
 Remarks: **M-805-058**
