# Profile/Photo Observation Report

Date:	<b>01/24/2023</b>	Weather:		Coding:	<b>PACP 7.0</b>
Pipe Length (ft):	<b>197.0</b>	Owner:	<b>City of Hobart</b>	Pre Clean:	<b>Heavy Cleaning</b>
P.O.#:	<b>YES502259</b>	Surveyor:	<b>Steven Bucklin</b>	PSR:	<b>P-805-059-058</b>
Customer:	<b>City of Hobart</b>	Clean Date:	<b>01/20/2023</b>	Shape:	<b>C</b>

Street:	<b>Devanshire Street</b>	Flow Control:	<b>Not Controlled</b>
City:	<b>Hobart, IN</b>	Year Renewed:	
Location:	<b>Local rural streets with light traffic, t</b>	Tape/Media #:	
Purpose:	<b>Routine Assessment</b>	Dia/Height:	<b>12"</b>
Use:	<b>Sanitary Sewage Pipe</b>	Material:	<b>VCP</b>
Drain Area:		Lining:	<b>None</b>
Category:	<b>NA</b>		
Comment:			
Location Details:		Direction of Survey:	<b>Downstream</b>
US MH:	<b>M-805-059</b>	DS MH:	<b>M-805-058</b>
		Total Length Surveyed (ft):	<b>193.9</b>

O&M Index:	<b>1.42</b>	O&M Quick:	<b>3824</b>	O&M Rating:	<b>68.00</b>
Structural Index:	<b>2.90</b>	Structural Quick:	<b>514A</b>	Structural Rating:	<b>122.00</b>
Overall Index:	<b>2.11</b>	Overall Quick:	<b>514A</b>	Overall Rating:	<b>190.00</b>

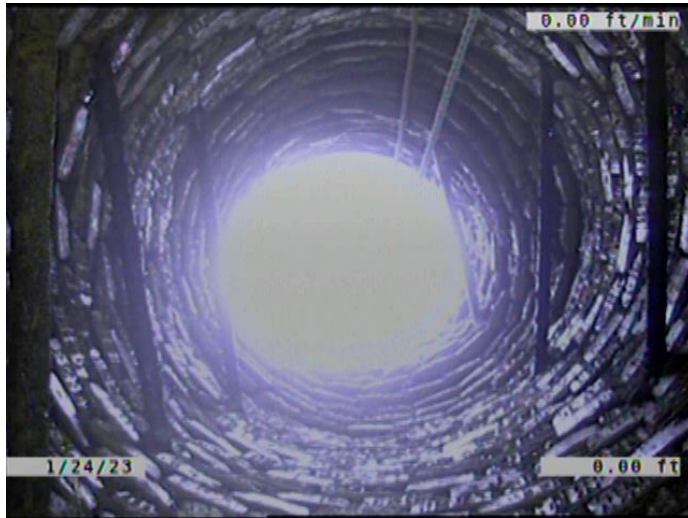
Code: **AMH**  
Description: **Manhole**

Distance (ft): **.0**  
Structural Grade: **0**  
O&M Grade: **0**  
Clock Start/From:  
Clock To:  
1st Value:  
2nd Value:  
Value Percent:  
Continuous Index:  
Within 8" of Joint: **NO**  
Remarks: **M-805-059**

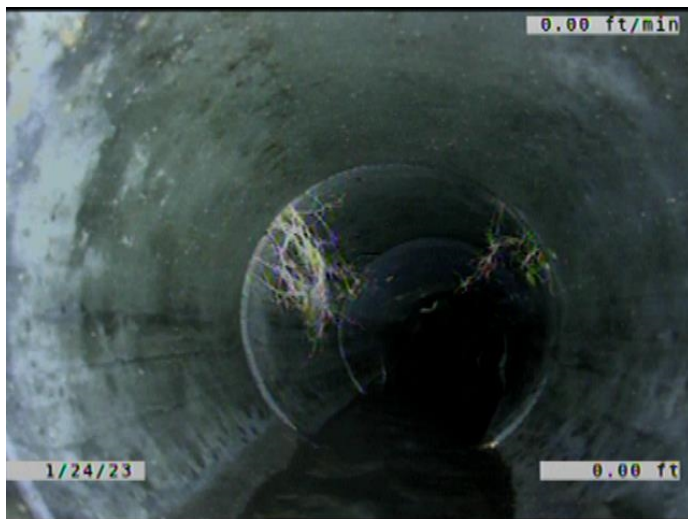
Code: **MWL**  
Description: **Miscellaneous Water Level**

Distance (ft): **.0**  
Structural Grade: **0**  
O&M Grade: **0**  
Clock Start/From:  
Clock To:  
1st Value:  
2nd Value:  
Value Percent: **10.000**  
Continuous Index:  
Within 8" of Joint: **NO**  
Remarks:

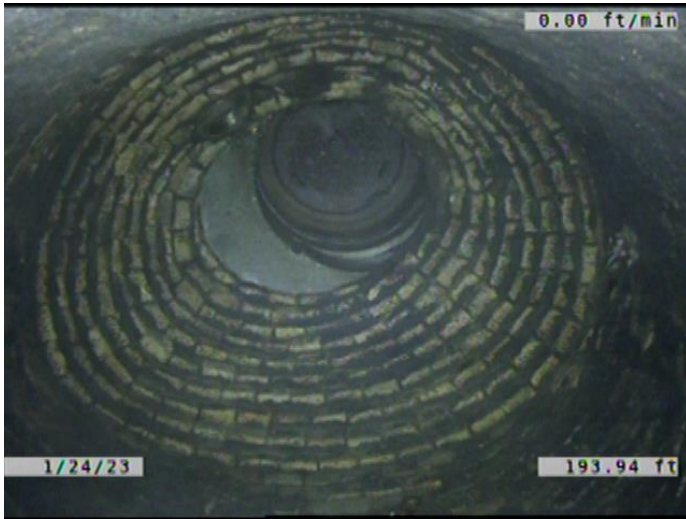
Code:	AMH
Description:	Manhole
Distance (ft):	193.9
Structural Grade:	0
O&M Grade:	0
Clock Start/From:	
Clock To:	
1st Value:	
2nd Value:	
Value Percent:	
Continuous Index:	
Within 8" of Joint:	NO
Remarks:	M-805-058
