Profile/Photo Observation Report

Date:	04/20/2018	Weather:		Coding:	PACP 6.0
Pipe Length (ft):	211.4	Owner:	NA	Pre Clean:	Not Known
P.O.#:		Surveyor:	Byrd Fitzgerald	PSR:	P-805-060-059
Customer:		Clean Date:	01/01/1900	Shape:	C

Street:	DEVONSHIRE ST & S OHIO ST	Flow Control:	Not Controlled
City:	Hobart, IN	Year Renewed:	
Location:	Other	Tape/Media #:	
Purpose:	Not Known	Dia/Height:	12"
Use:	Sanitary	Material:	VCP
Drain Area:	NA	Lining:	
Category:	NA		
Comment:			
Location Details:		Direction of Survey:	Upstream
US MH:	M-805-059	DS MH:	M-805-060
		Total Length Surveyed (ft):	48.8

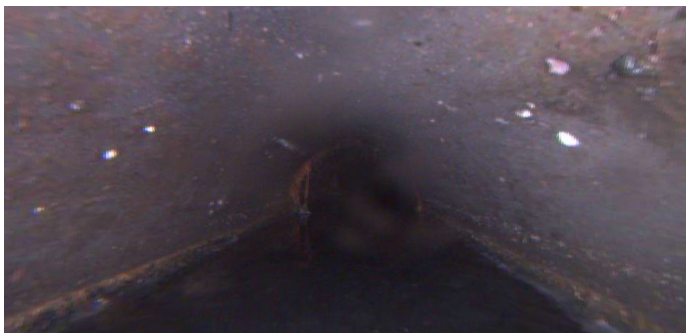
Code: **AMH**
Description: **Manhole**

Distance (ft): **.0**
Structural Grade: **0**
O&M Grade: **0**
Clock Start/From:
Clock To:
1st Value:
2nd Value:
Value Percent:
Continuous Index:
Within 8" of Joint: **NO**
Remarks: **M-805-060**
