Profile/Photo Observation Report

Date:	01/24/2023	Weather:		Coding:	PACP 7.0
Pipe Length (ft):	211.0	Owner:	City of Hobart	Pre Clean:	Heavy Cleaning
P.O.#:	YES502259	Surveyor:	Steven Bucklin	PSR:	P-805-060-059
Customer:	City of Hobart	Clean Date:		Shape:	C

Street:	Devanshire Street	Flow Control:	Not Controlled
City:	Hobart, IN	Year Renewed:	
Location:	Local rural streets with light traffic, t	Tape/Media #:	
Purpose:	Routine Assessment	Dia/Height:	12"
Use:	Sanitary Sewage Pipe	Material:	VCP
Drain Area:		Lining:	None
Category:	NA		
Comment:			
Location Details:		Direction of Survey:	Upstream
US MH:	M-805-059	DS MH:	M-805-060
		Total Length Surveyed (ft):	220.4

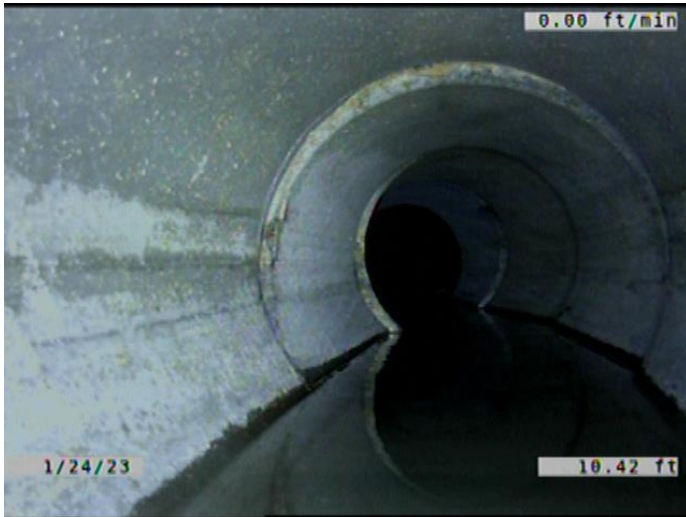
Code: **LR**
Description: **Line Right**

Distance (ft): **10.4**
Structural Grade: **0**
O&M Grade: **1**
Clock Start/From:
Clock To:
1st Value:
2nd Value:
Value Percent: **5.000**
Continuous Index:
Within 8" of Joint: **NO**
Remarks:

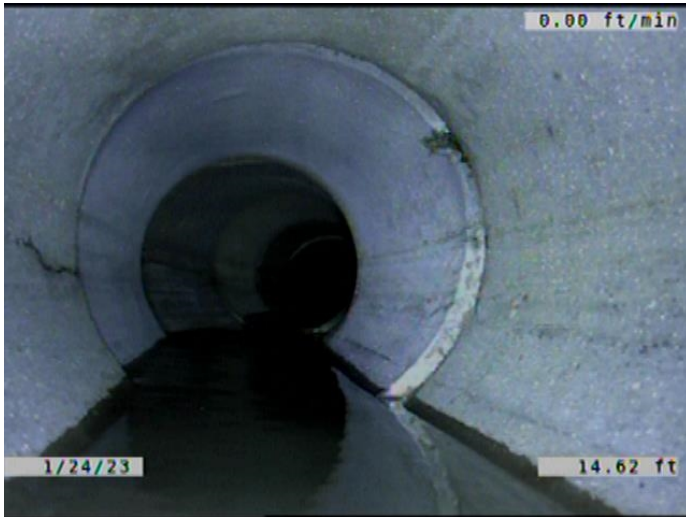
Code: **LL**
Description: **Line Left**

Distance (ft): **14.6**
Structural Grade: **0**
O&M Grade: **1**
Clock Start/From:
Clock To:
1st Value:
2nd Value:
Value Percent: **5.000**
Continuous Index:
Within 8" of Joint: **NO**
Remarks:

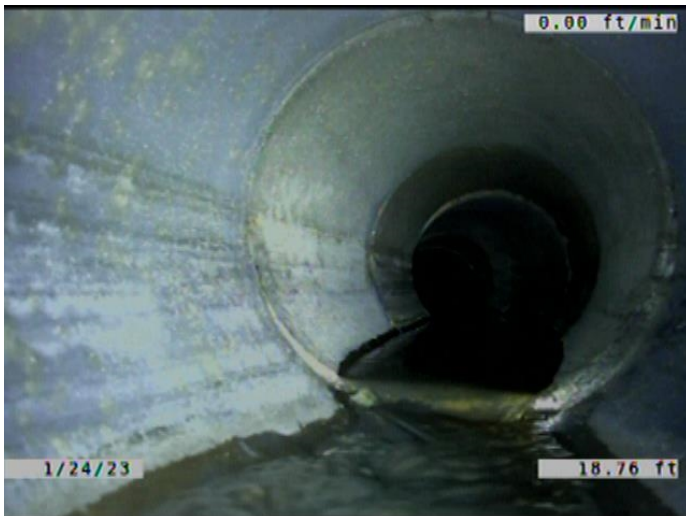
Code: **LR**
Description: **Line Right**

Distance (ft): **18.8**
Structural Grade: **0**
O&M Grade: **1**
Clock Start/From:
Clock To:
1st Value:
2nd Value:
Value Percent: **5.000**
Continuous Index:
Within 8" of Joint: **NO**
Remarks:

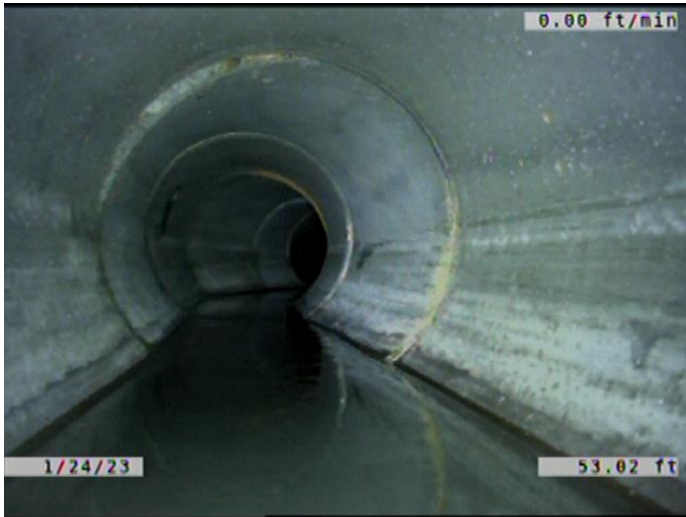
Code: **LL**
Description: **Line Left**

Distance (ft): **53.0**
Structural Grade: **0**
O&M Grade: **2**
Clock Start/From:
Clock To:
1st Value:
2nd Value:
Value Percent: **15.000**
Continuous Index:
Within 8" of Joint: **NO**
Remarks:

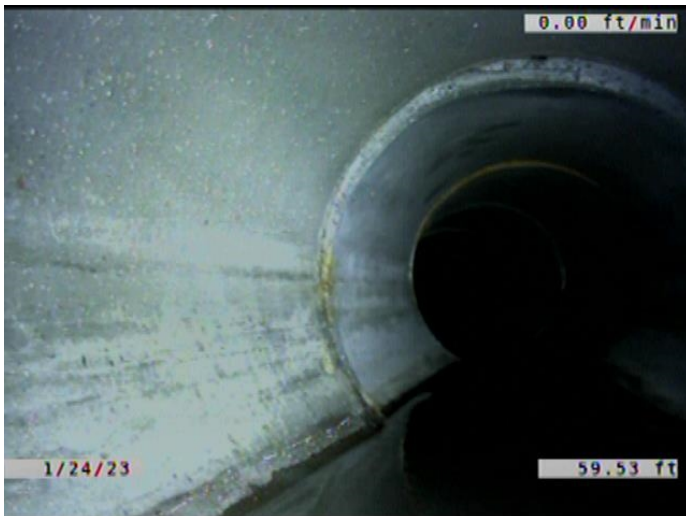
Code: **LR**
 Description: **Line Right**

Distance (ft): **59.5**
 Structural Grade: **0**
 O&M Grade: **1**
 Clock Start/From:
 Clock To:
 1st Value:
 2nd Value:
 Value Percent: **10.000**
 Continuous Index:
 Within 8" of Joint: **NO**
 Remarks:

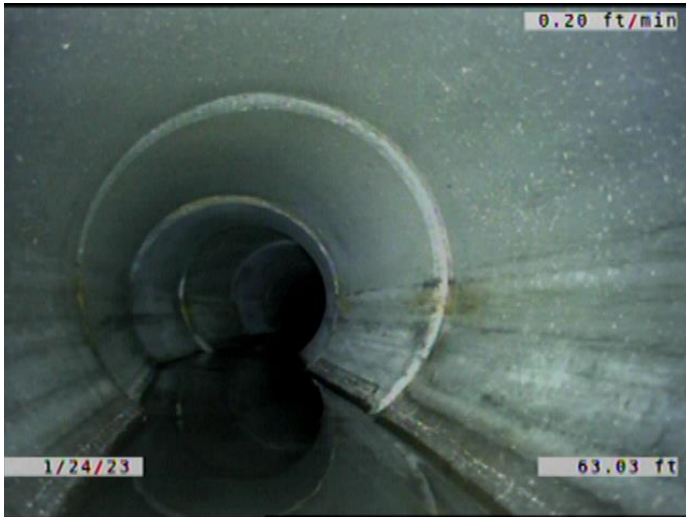
Code: **LL**
 Description: **Line Left**

Distance (ft): **63.0**
 Structural Grade: **0**
 O&M Grade: **1**
 Clock Start/From:
 Clock To:
 1st Value:
 2nd Value:
 Value Percent: **5.000**
 Continuous Index:
 Within 8" of Joint: **NO**
 Remarks:

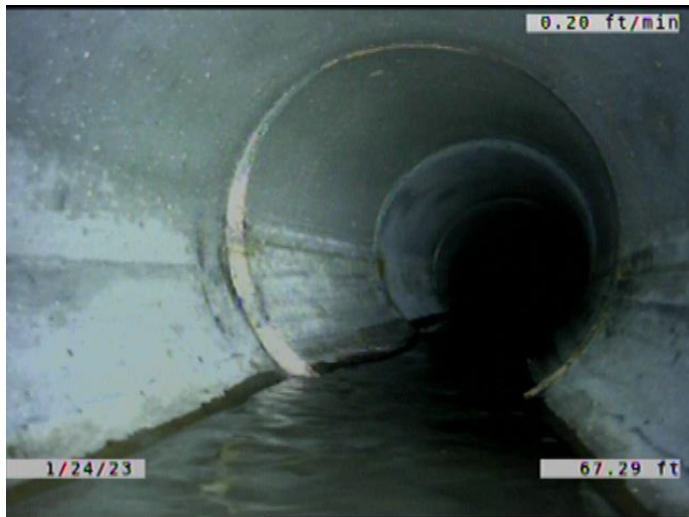
Code: **LR**
 Description: **Line Right**

Distance (ft): **67.3**
 Structural Grade: **0**
 O&M Grade: **1**
 Clock Start/From:
 Clock To:
 1st Value:
 2nd Value:
 Value Percent: **5.000**
 Continuous Index:
 Within 8" of Joint: **NO**
 Remarks:

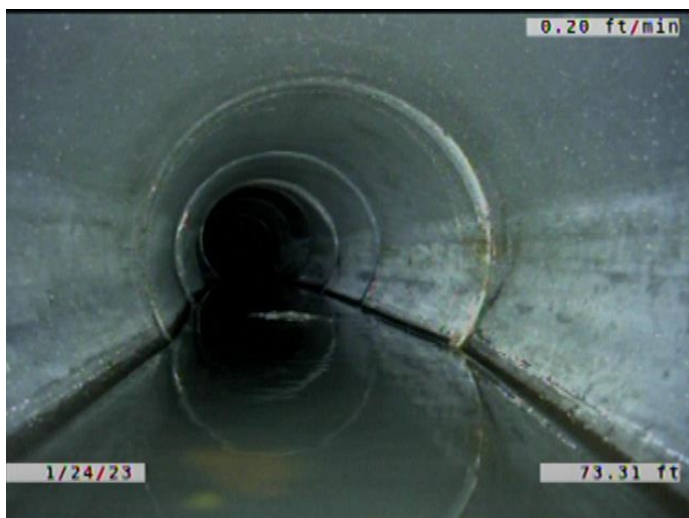
Code: **LL**
 Description: **Line Left**

Distance (ft): **73.3**
 Structural Grade: **0**
 O&M Grade: **1**
 Clock Start/From:
 Clock To:
 1st Value:
 2nd Value:
 Value Percent: **10.000**
 Continuous Index:
 Within 8" of Joint: **NO**
 Remarks:

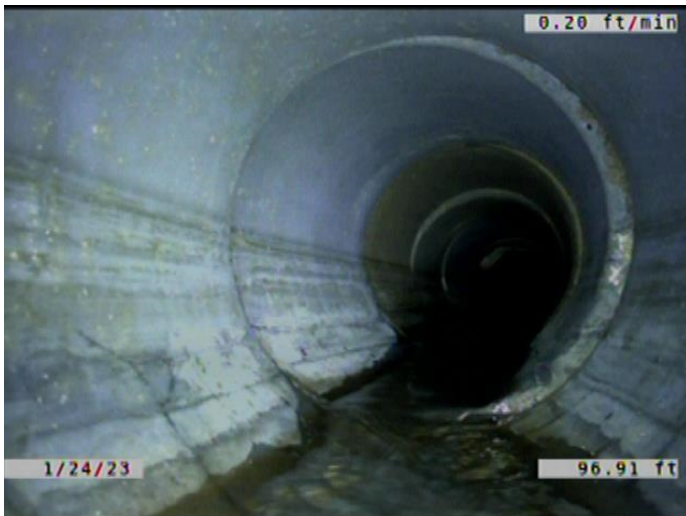
Code: **LR**
 Description: **Line Right**

Distance (ft): **96.9**
 Structural Grade: **0**
 O&M Grade: **1**
 Clock Start/From:
 Clock To:
 1st Value:
 2nd Value:
 Value Percent: **10.000**
 Continuous Index:
 Within 8" of Joint: **NO**
 Remarks:

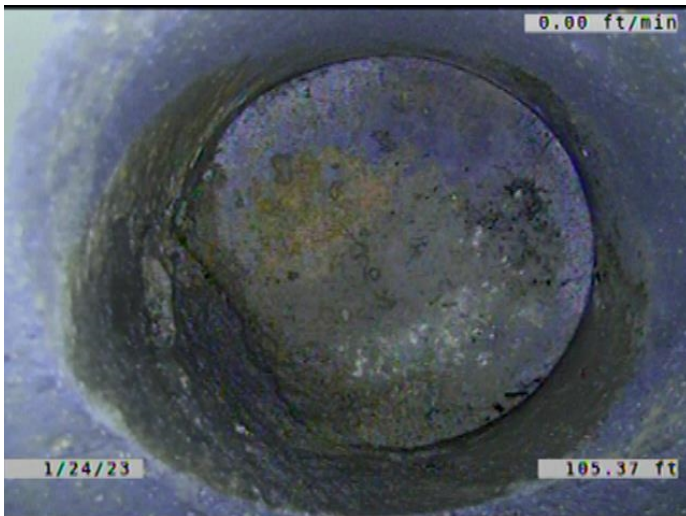
Code: **TFC**
 Description: **Tap Factory Capped**

Distance (ft): **105.4**
 Structural Grade: **0**
 O&M Grade: **0**
 Clock Start/From: **11**
 Clock To:
 1st Value: **6.000**
 2nd Value:
 Value Percent:
 Continuous Index:
 Within 8" of Joint: **YES**
 Remarks:

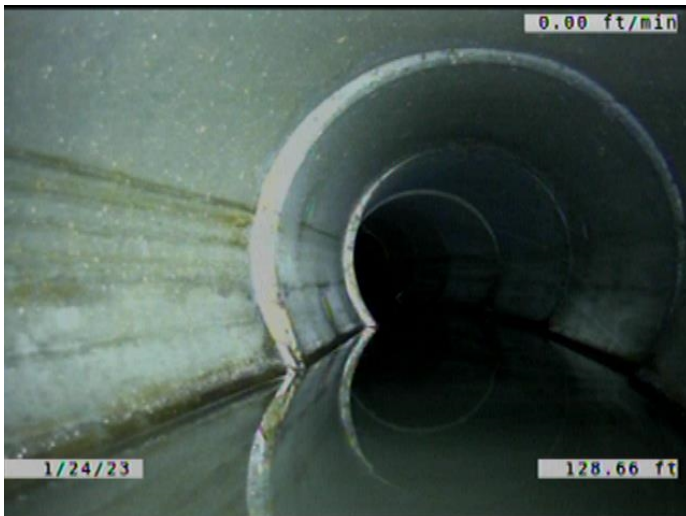
Code: **LR**
Description: **Line Right**

Distance (ft): **128.7**
Structural Grade: **0**
O&M Grade: **1**
Clock Start/From:
Clock To:
1st Value:
2nd Value:
Value Percent: **10.000**
Continuous Index:
Within 8" of Joint: **NO**
Remarks:

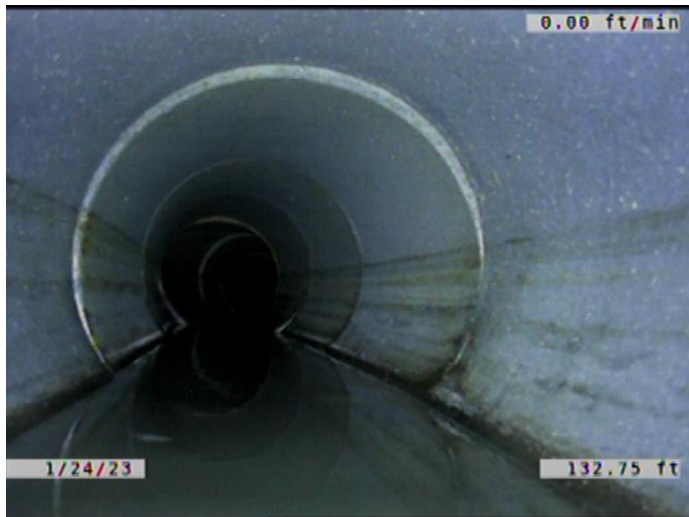
Code: **LL**
Description: **Line Left**

Distance (ft): **132.8**
Structural Grade: **0**
O&M Grade: **1**
Clock Start/From:
Clock To:
1st Value:
2nd Value:
Value Percent: **5.000**
Continuous Index:
Within 8" of Joint: **NO**
Remarks:

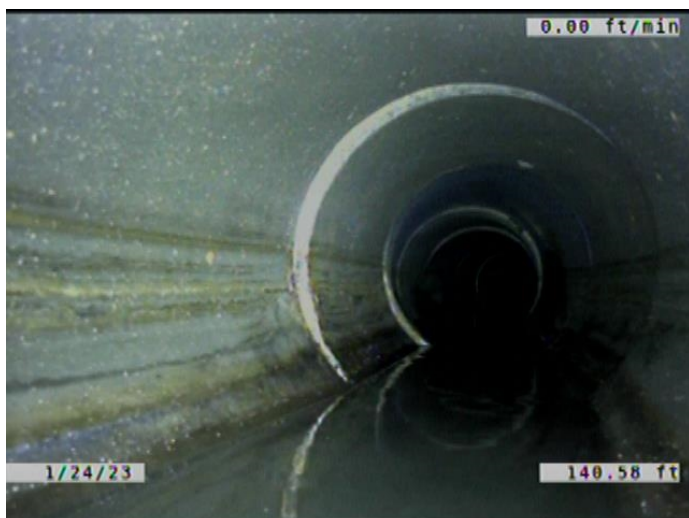
Code: **LR**
Description: **Line Right**

Distance (ft): **140.6**
Structural Grade: **0**
O&M Grade: **1**
Clock Start/From:
Clock To:
1st Value:
2nd Value:
Value Percent: **10.000**
Continuous Index:
Within 8" of Joint: **NO**
Remarks:

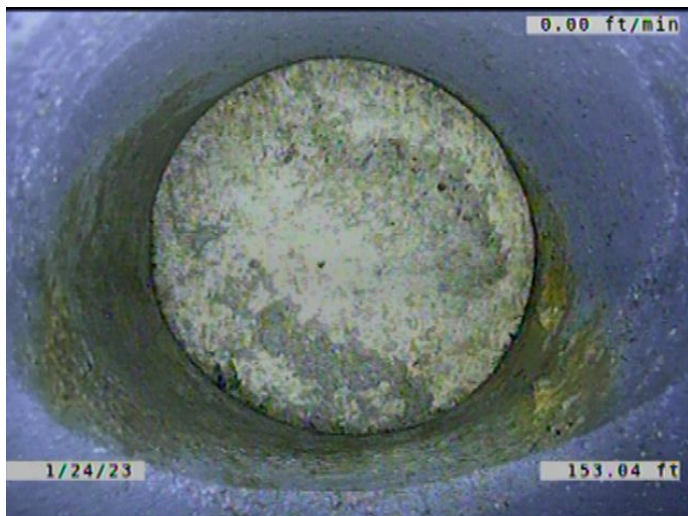
Code: **TFC**
Description: **Tap Factory Capped**

Distance (ft): **153.0**
Structural Grade: **0**
O&M Grade: **0**
Clock Start/From: **11**
Clock To:
1st Value: **6.000**
2nd Value:
Value Percent:
Continuous Index:
Within 8" of Joint: **YES**
Remarks:

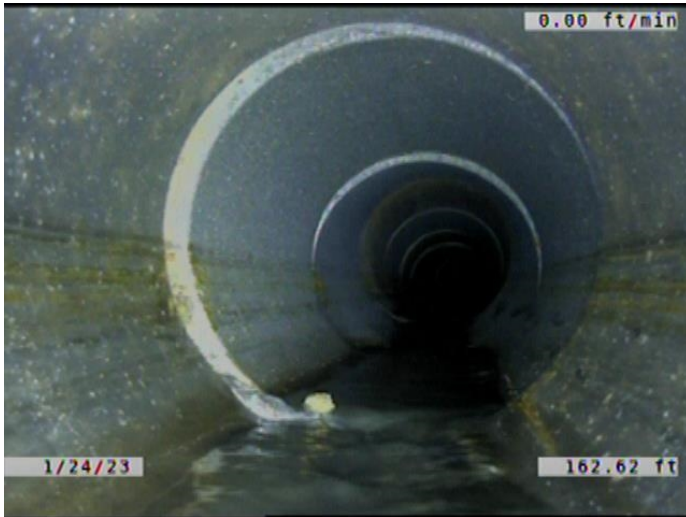
Code: **LR**
Description: **Line Right**

Distance (ft): **162.6**
Structural Grade: **0**
O&M Grade: **1**
Clock Start/From:
Clock To:
1st Value:
2nd Value:
Value Percent: **5.000**
Continuous Index:
Within 8" of Joint: **NO**
Remarks:
