Profile/Photo Observation Report

Date:	01/15/2023	Weather:		Coding:	PACP 7.0
Pipe Length (ft):	243.0	Owner:	City of Hobart	Pre Clean:	Heavy Cleaning
P.O.#:	YES502259	Surveyor:	S. Bucklin	PSR:	P-804-011-062
Customer:	City of Hobart	Clean Date:	01/12/2023	Shape:	C

Street:	South Indiana Street	Flow Control:	Not Controlled
City:	Hobart, IN	Year Renewed:	
Location:	Local rural streets with light traffic, t	Tape/Media #:	
Purpose:	Routine Assessment	Dia/Height:	8"
Use:	Sanitary Sewage Pipe	Material:	VCP
Drain Area:		Lining:	None
Category:	NA		
Comment:			
Location Details:		Direction of Survey:	Upstream
US MH:	M-805-062	DS MH:	M-804-011
		Total Length Surveyed (ft):	243.3

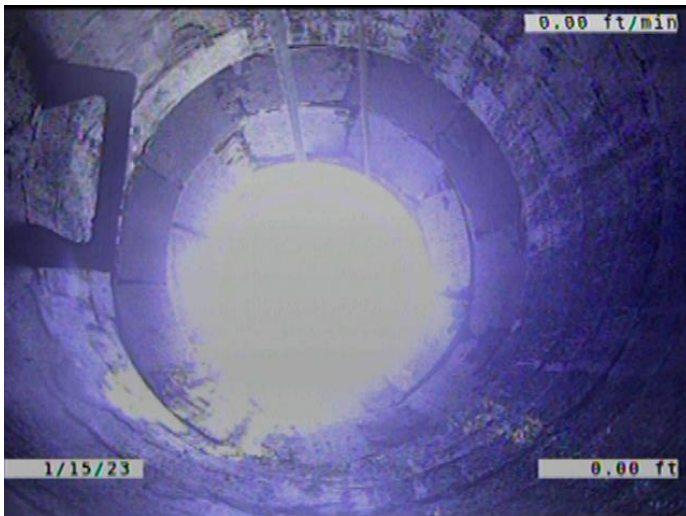
Code: **AMH**
Description: **Manhole**

Distance (ft): **.0**
Structural Grade: **0**
O&M Grade: **0**
Clock Start/From:
Clock To:
1st Value:
2nd Value:
Value Percent:
Continuous Index:
Within 8" of Joint: **NO**
Remarks: **M-804-011**

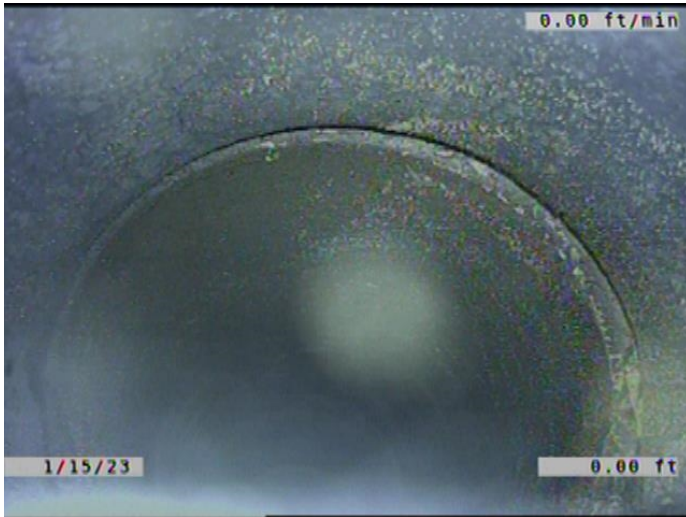
Code: **MWL**
 Description: **Miscellaneous Water Level**

Distance (ft): **.0**
 Structural Grade: **0**
 O&M Grade: **0**
 Clock Start/From:
 Clock To:
 1st Value:
 2nd Value:
 Value Percent: **20.000**
 Continuous Index:
 Within 8" of Joint: **NO**
 Remarks:

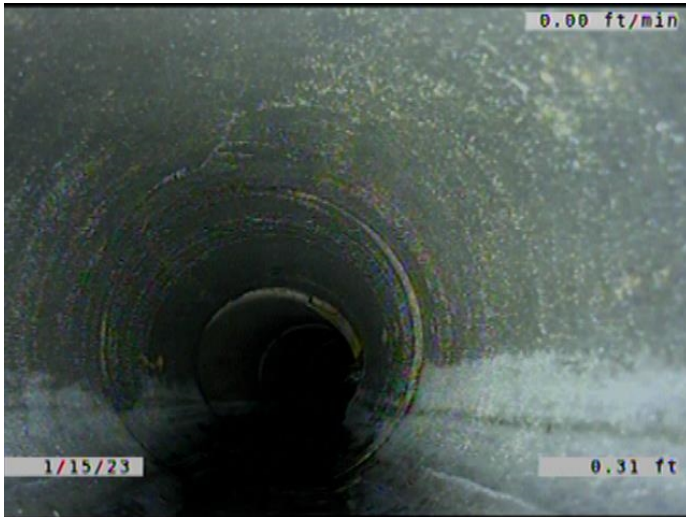
Code: **MWL**
 Description: **Miscellaneous Water Level**

Distance (ft): **.3**
 Structural Grade: **0**
 O&M Grade: **0**
 Clock Start/From:
 Clock To:
 1st Value:
 2nd Value:
 Value Percent: **5.000**
 Continuous Index:
 Within 8" of Joint: **NO**
 Remarks:

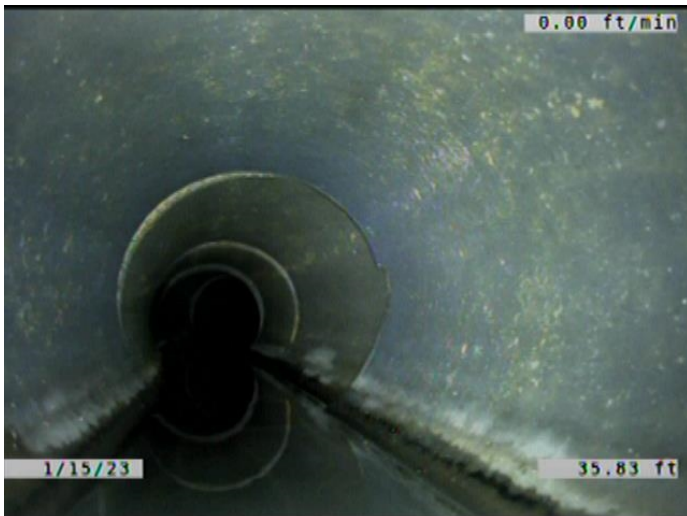
Code:	LL
Description:	Line Left
Distance (ft):	35.8
Structural Grade:	0
O&M Grade:	1
Clock Start/From:	
Clock To:	
1st Value:	
2nd Value:	
Value Percent:	5.000
Continuous Index:	
Within 8" of Joint:	NO
Remarks:

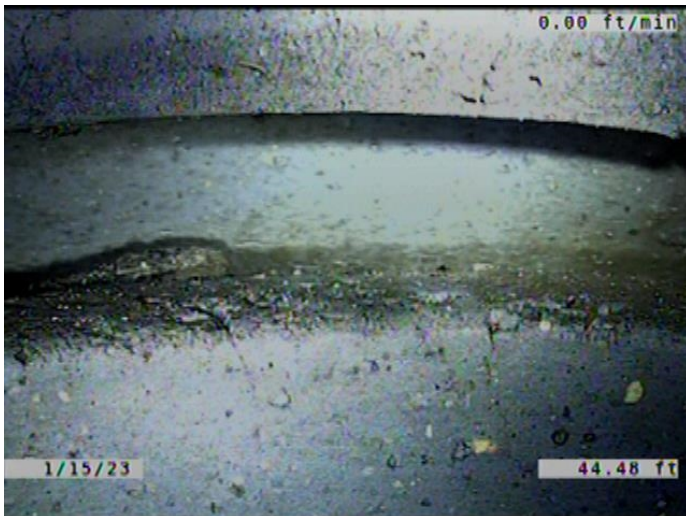
Code: **JAM**
 Description: **Joint Angular Medium**

Distance (ft): **44.5**
 Structural Grade: **3**
 O&M Grade: **0**
 Clock Start/From:
 Clock To:
 1st Value:
 2nd Value:
 Value Percent:
 Continuous Index:
 Within 8" of Joint: **NO**
 Remarks:

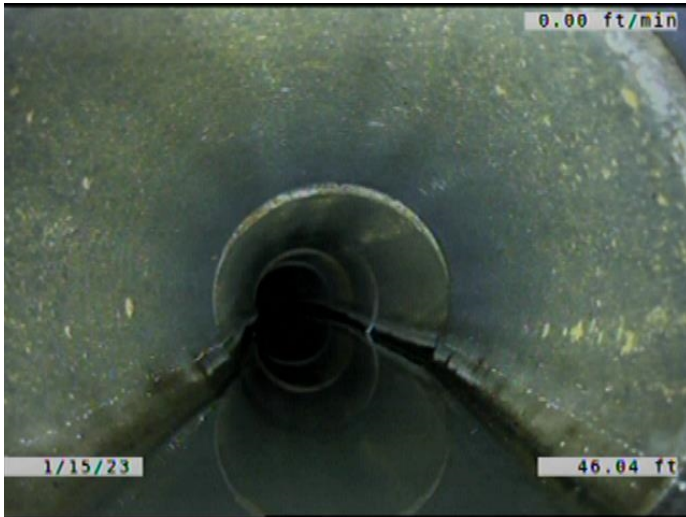
Code: **MWLS**
 Description: **Miscellaneous Water Level Sag**

Distance (ft): **46.0**
 Structural Grade: **2**
 O&M Grade: **0**
 Clock Start/From:
 Clock To:
 1st Value:
 2nd Value:
 Value Percent: **15.000**
 Continuous Index: **S04**
 Within 8" of Joint: **NO**
 Remarks:

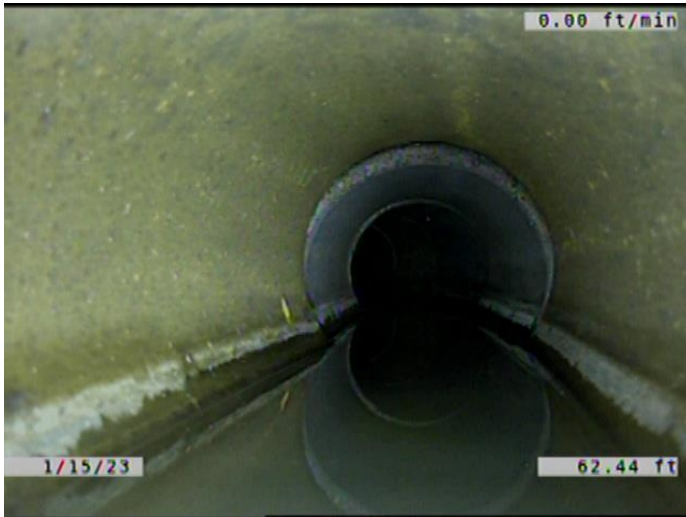
Code: **LR**
 Description: **Line Right**

Distance (ft): **62.4**
 Structural Grade: **0**
 O&M Grade: **1**
 Clock Start/From:
 Clock To:
 1st Value:
 2nd Value:
 Value Percent: **5.000**
 Continuous Index:
 Within 8" of Joint: **NO**
 Remarks:

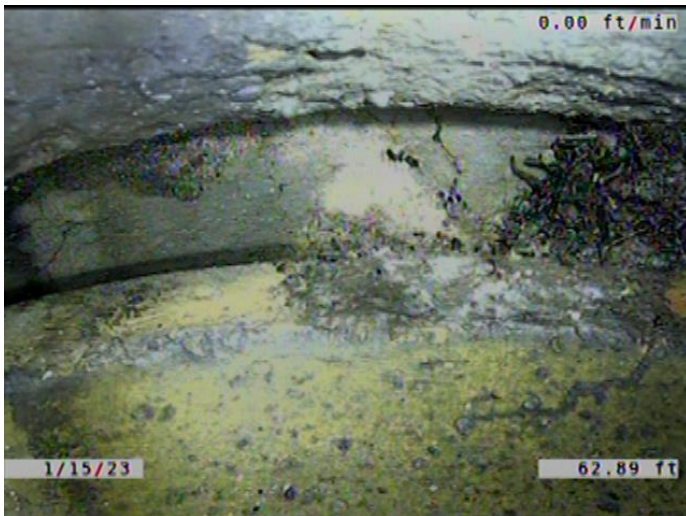
Code: **JAM**
 Description: **Joint Angular Medium**

Distance (ft): **62.9**
 Structural Grade: **3**
 O&M Grade: **0**
 Clock Start/From:
 Clock To:
 1st Value:
 2nd Value:
 Value Percent:
 Continuous Index:
 Within 8" of Joint: **NO**
 Remarks:

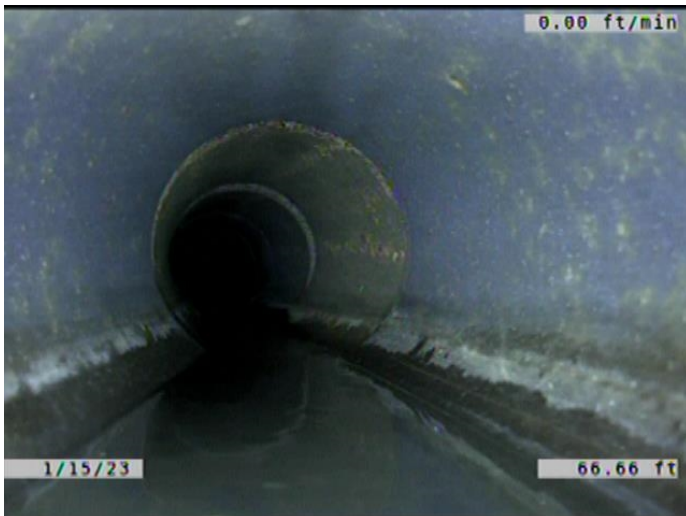
Code: **LL**
 Description: **Line Left**

Distance (ft): **66.6**
 Structural Grade: **0**
 O&M Grade: **2**
 Clock Start/From:
 Clock To:
 1st Value:
 2nd Value:
 Value Percent: **15.000**
 Continuous Index:
 Within 8" of Joint: **NO**
 Remarks:

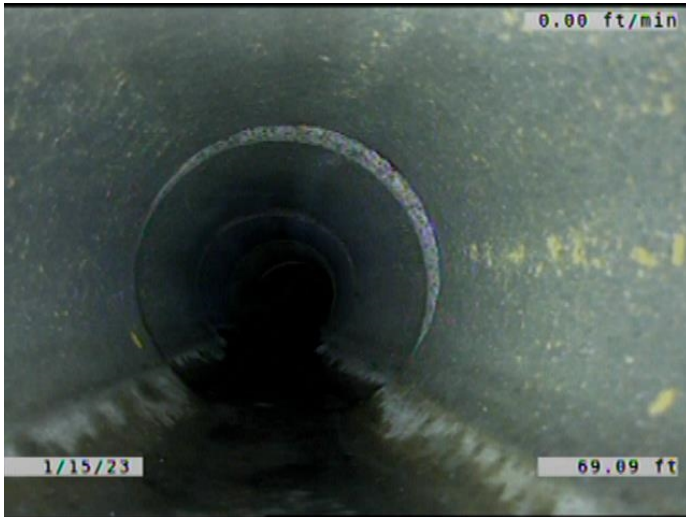
Code: **MWLS**
Description: **Miscellaneous Water Level Sag**

Distance (ft): **69.1**
Structural Grade: **2**
O&M Grade: **0**
Clock Start/From:
Clock To:
1st Value:
2nd Value:
Value Percent: **15.000**
Continuous Index: **F04**
Within 8" of Joint: **NO**
Remarks:

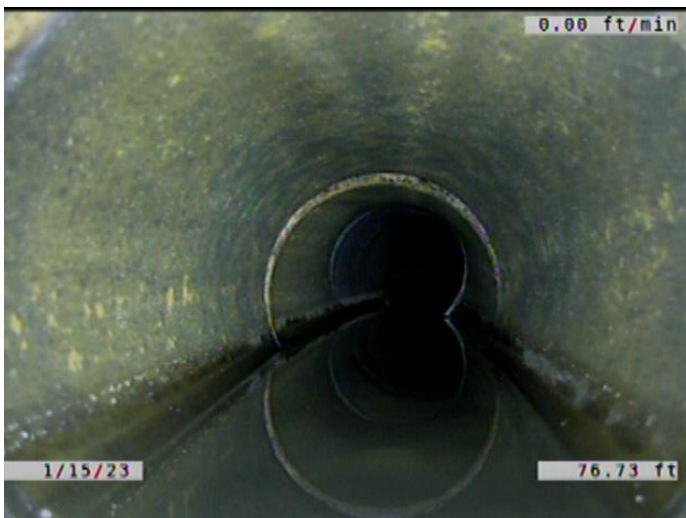
Code: **LR**
Description: **Line Right**

Distance (ft): **76.7**
Structural Grade: **0**
O&M Grade: **1**
Clock Start/From:
Clock To:
1st Value:
2nd Value:
Value Percent: **10.000**
Continuous Index:
Within 8" of Joint: **NO**
Remarks:

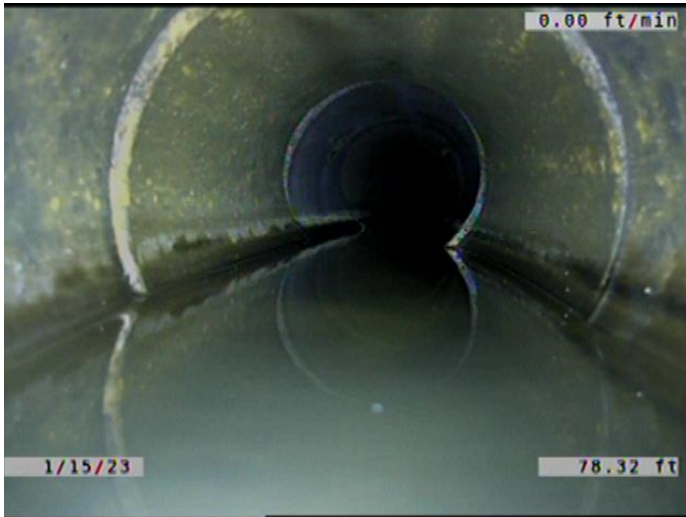
Code: **MWLS**
 Description: **Miscellaneous Water Level Sag**

Distance (ft): **78.3**
 Structural Grade: **2**
 O&M Grade: **0**
 Clock Start/From:
 Clock To:
 1st Value:
 2nd Value:
 Value Percent: **15.000**
 Continuous Index: **S05**
 Within 8" of Joint: **NO**
 Remarks:

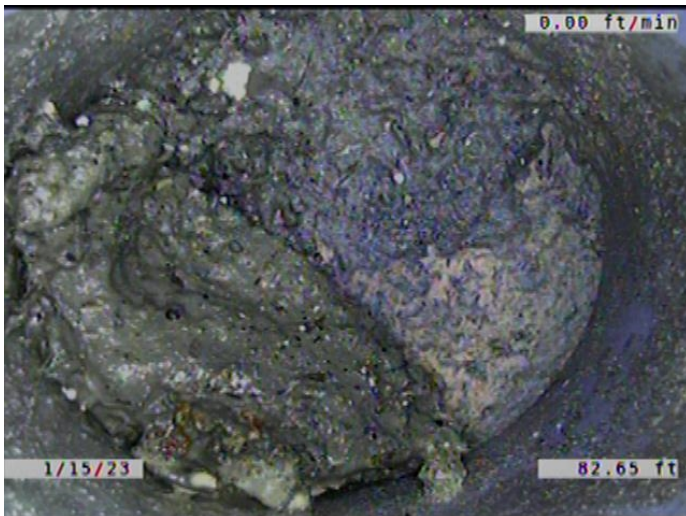
Code: **TFC**
 Description: **Tap Factory Capped**

Distance (ft): **82.6**
 Structural Grade: **0**
 O&M Grade: **0**
 Clock Start/From: **11**
 Clock To:
 1st Value: **6.000**
 2nd Value:
 Value Percent:
 Continuous Index:
 Within 8" of Joint: **YES**
 Remarks:

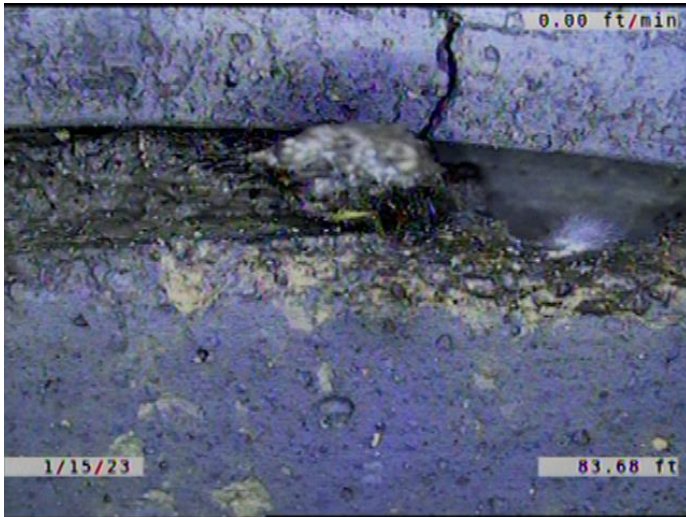
Code: **RFJ**
 Description: **Roots Fine Joint**

Distance (ft): **83.7**
 Structural Grade: **0**
 O&M Grade: **1**
 Clock Start/From: **11**
 Clock To: **1**
 1st Value:
 2nd Value:
 Value Percent:
 Continuous Index:
 Within 8" of Joint: **YES**
 Remarks:

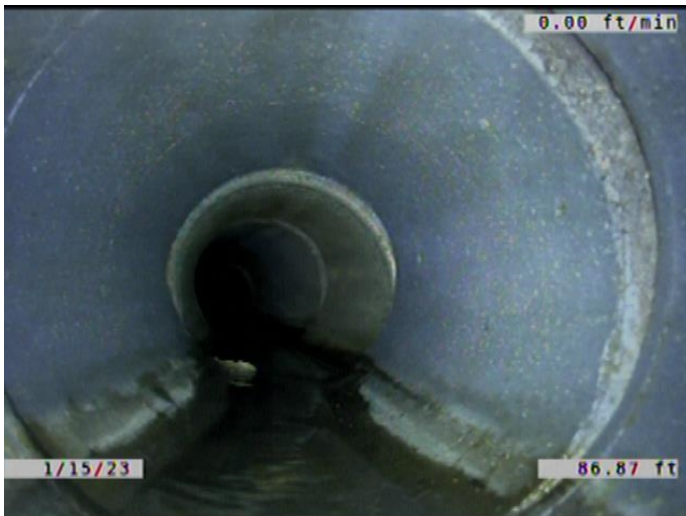
Code: **MWLS**
 Description: **Miscellaneous Water Level Sag**

Distance (ft): **86.9**
 Structural Grade: **2**
 O&M Grade: **0**
 Clock Start/From:
 Clock To:
 1st Value:
 2nd Value:
 Value Percent: **15.000**
 Continuous Index: **F05**
 Within 8" of Joint: **NO**
 Remarks:

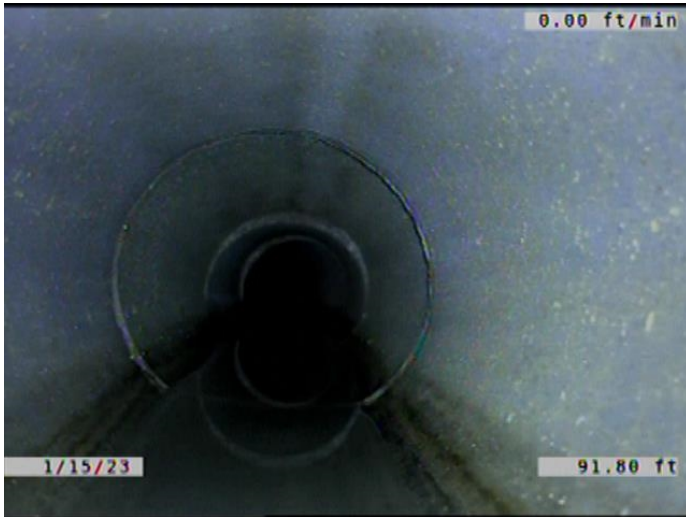
Code: **MWLS**
Description: **Miscellaneous Water Level Sag**

Distance (ft): **91.8**
Structural Grade: **2**
O&M Grade: **0**
Clock Start/From:
Clock To:
1st Value:
2nd Value:
Value Percent: **10.000**
Continuous Index: **S06**
Within 8" of Joint: **NO**
Remarks:

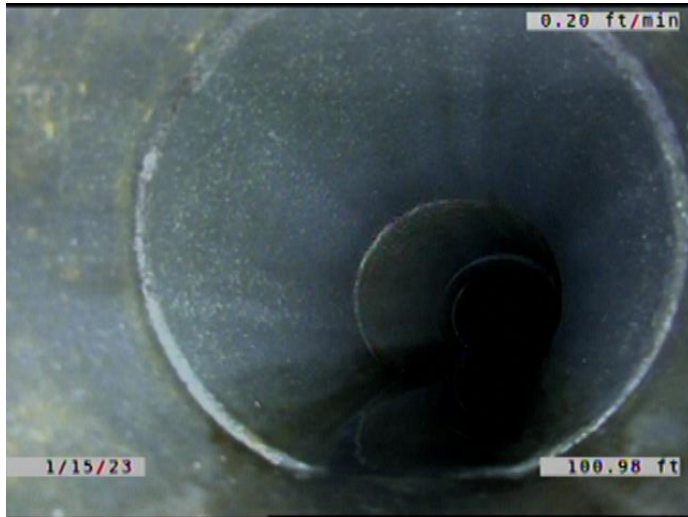
Code: **MWLS**
 Description: **Miscellaneous Water Level Sag**

Distance (ft): **101.0**
 Structural Grade: **2**
 O&M Grade: **0**
 Clock Start/From:
 Clock To:
 1st Value:
 2nd Value:
 Value Percent: **10.000**
 Continuous Index: **F06**
 Within 8" of Joint: **NO**
 Remarks:

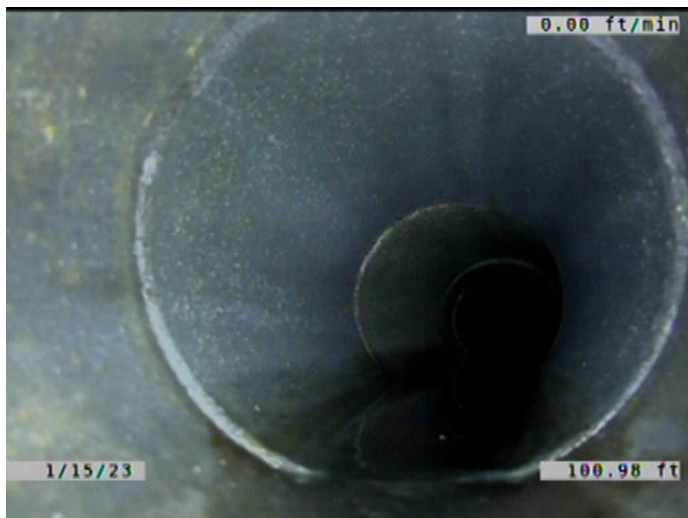
Code: **LR**
 Description: **Line Right**

Distance (ft): **101.0**
 Structural Grade: **0**
 O&M Grade: **2**
 Clock Start/From:
 Clock To:
 1st Value:
 2nd Value:
 Value Percent: **20.000**
 Continuous Index:
 Within 8" of Joint: **NO**
 Remarks:

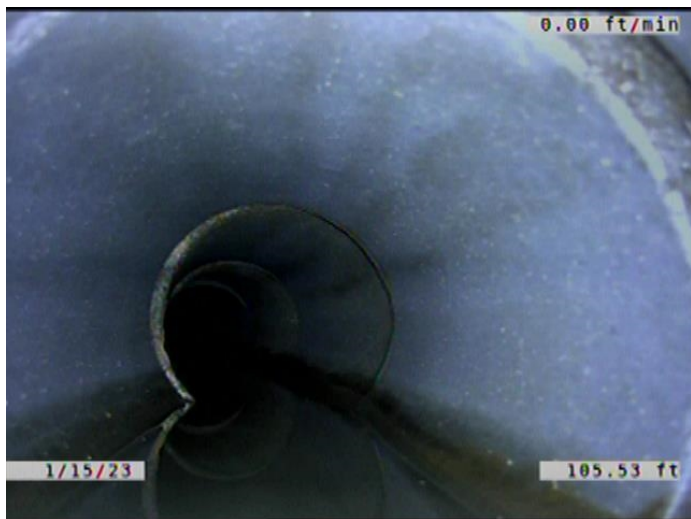
Code: **LL**
 Description: **Line Left**

Distance (ft): **105.5**
 Structural Grade: **0**
 O&M Grade: **2**
 Clock Start/From:
 Clock To:
 1st Value:
 2nd Value:
 Value Percent: **15.000**
 Continuous Index:
 Within 8" of Joint: **NO**
 Remarks:

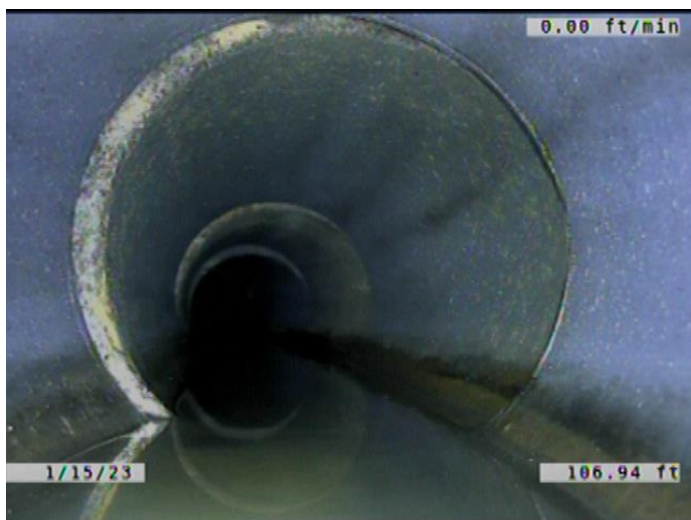
Code: **MWLS**
 Description: **Miscellaneous Water Level Sag**

Distance (ft): **106.9**
 Structural Grade: **2**
 O&M Grade: **0**
 Clock Start/From:
 Clock To:
 1st Value:
 2nd Value:
 Value Percent: **10.000**
 Continuous Index: **S08**
 Within 8" of Joint: **NO**
 Remarks:

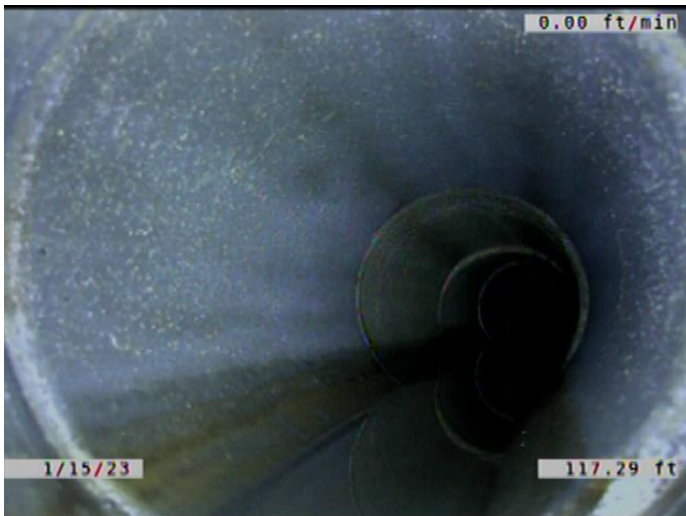
Code: **MWLS**
 Description: **Miscellaneous Water Level Sag**

Distance (ft): **117.3**
 Structural Grade: **2**
 O&M Grade: **0**
 Clock Start/From:
 Clock To:
 1st Value:
 2nd Value:
 Value Percent: **10.000**
 Continuous Index: **F08**
 Within 8" of Joint: **NO**
 Remarks:

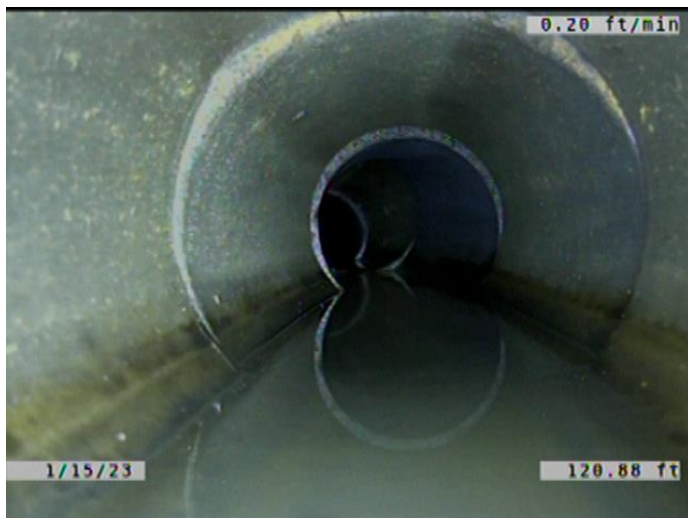
Code: **MWLS**
 Description: **Miscellaneous Water Level Sag**

Distance (ft): **120.9**
 Structural Grade: **2**
 O&M Grade: **0**
 Clock Start/From:
 Clock To:
 1st Value:
 2nd Value:
 Value Percent: **15.000**
 Continuous Index: **S09**
 Within 8" of Joint: **NO**
 Remarks:

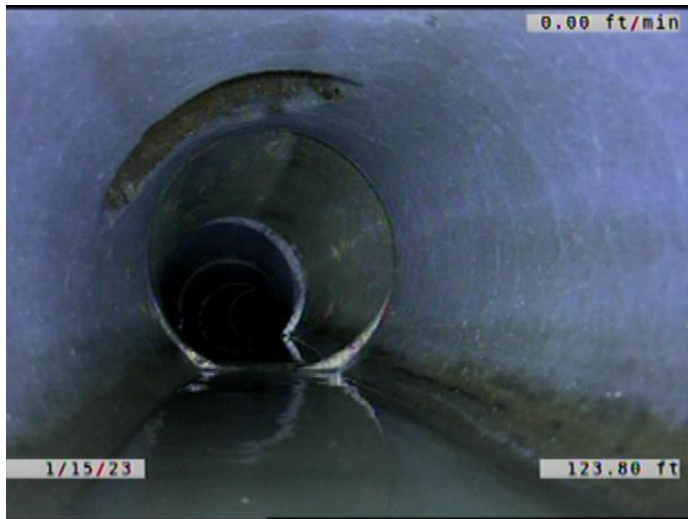
Code: **LL**
Description: **Line Left**

Distance (ft): **123.8**
Structural Grade: **0**
O&M Grade: **1**
Clock Start/From:
Clock To:
1st Value:
2nd Value:
Value Percent: **10.000**
Continuous Index:
Within 8" of Joint: **NO**
Remarks:

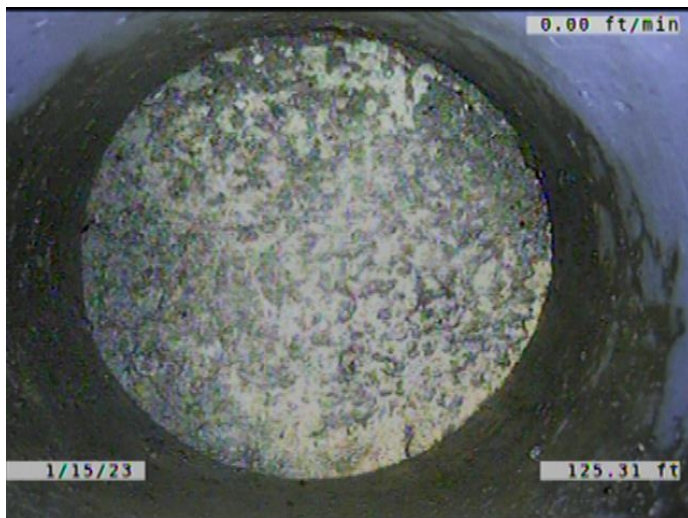
Code: **TFC**
Description: **Tap Factory Capped**

Distance (ft): **125.3**
Structural Grade: **0**
O&M Grade: **0**
Clock Start/From: **11**
Clock To:
1st Value: **6.000**
2nd Value:
Value Percent:
Continuous Index:
Within 8" of Joint: **YES**
Remarks:

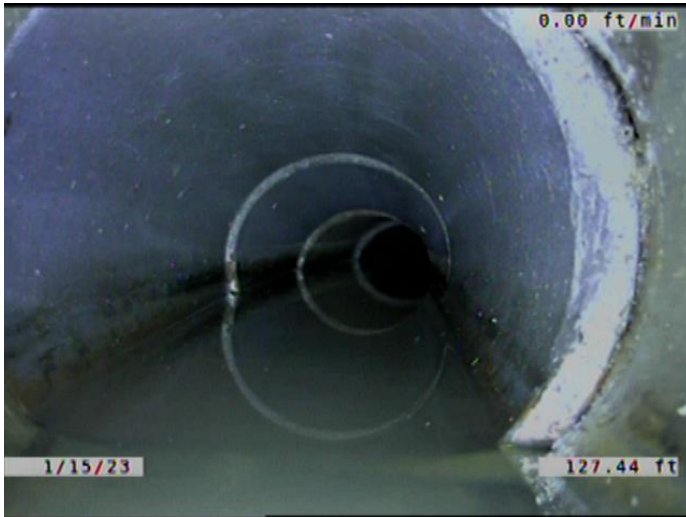
Code: **MWLS**
Description: **Miscellaneous Water Level Sag**

Distance (ft): **127.4**
Structural Grade: **2**
O&M Grade: **0**
Clock Start/From:
Clock To:
1st Value:
2nd Value:
Value Percent: **15.000**
Continuous Index: **F09**
Within 8" of Joint: **NO**
Remarks:

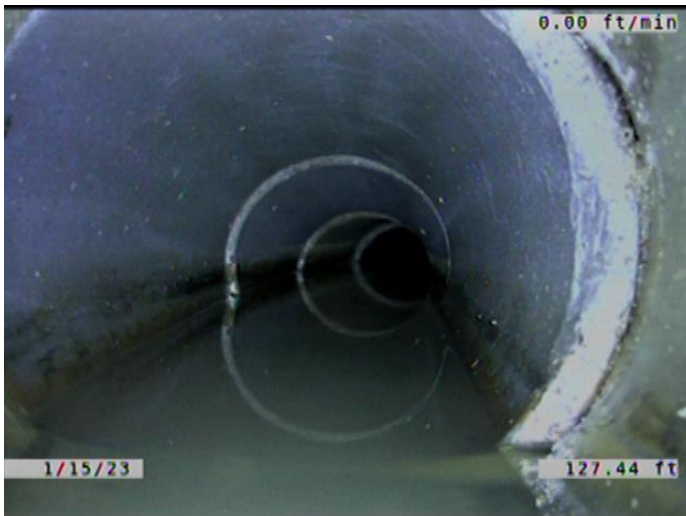
Code: **MWLS**
Description: **Miscellaneous Water Level Sag**

Distance (ft): **127.4**
Structural Grade: **3**
O&M Grade: **0**
Clock Start/From:
Clock To:
1st Value:
2nd Value:
Value Percent: **35.000**
Continuous Index: **S10**
Within 8" of Joint: **NO**
Remarks:

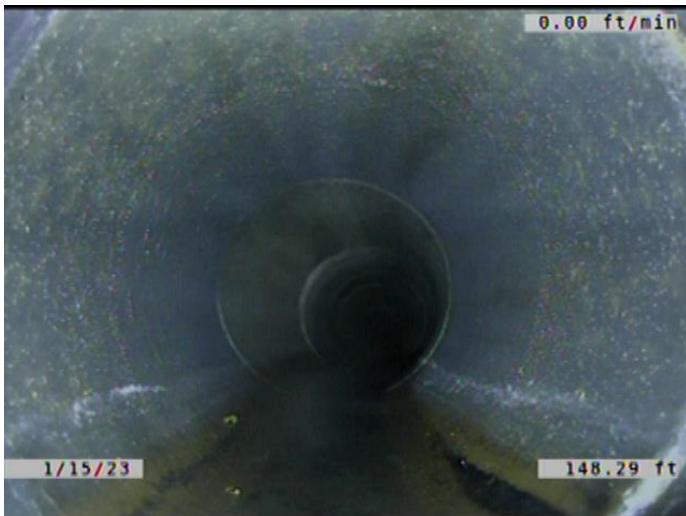
Code:	MWLS
Description:	Miscellaneous Water Level Sag
Distance (ft):	148.3
Structural Grade:	3
O&M Grade:	0
Clock Start/From:	
Clock To:	
1st Value:	
2nd Value:	
Value Percent:	35.000
Continuous Index:	F10
Within 8" of Joint:	NO
Remarks:

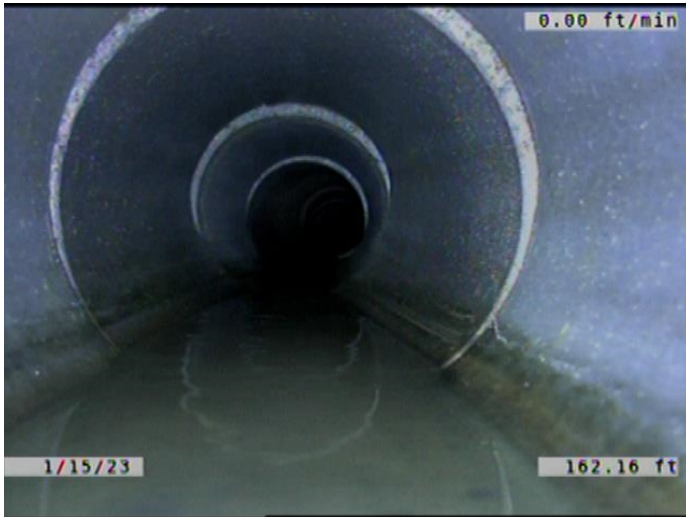
Code: **MWLS**
Description: **Miscellaneous Water Level Sag**

Distance (ft): **162.2**
Structural Grade: **2**
O&M Grade: **0**
Clock Start/From:
Clock To:
1st Value:
2nd Value:
Value Percent: **10.000**
Continuous Index: **S11**
Within 8" of Joint: **NO**
Remarks:

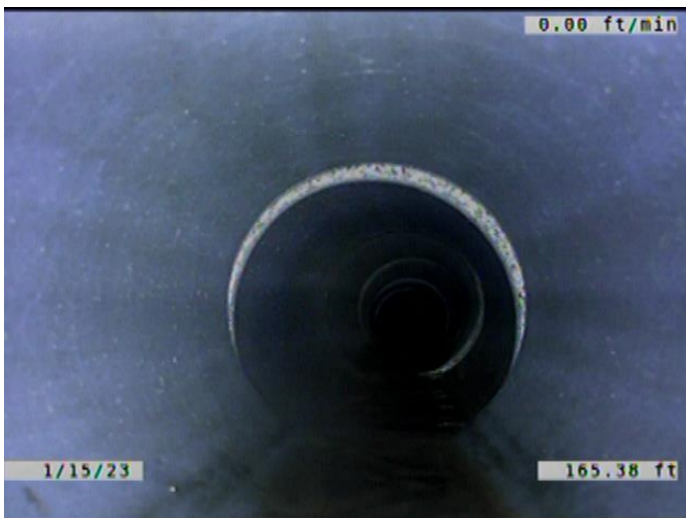
Code: **MWLS**
Description: **Miscellaneous Water Level Sag**

Distance (ft): **165.4**
Structural Grade: **2**
O&M Grade: **0**
Clock Start/From:
Clock To:
1st Value:
2nd Value:
Value Percent: **10.000**
Continuous Index: **F11**
Within 8" of Joint: **NO**
Remarks:

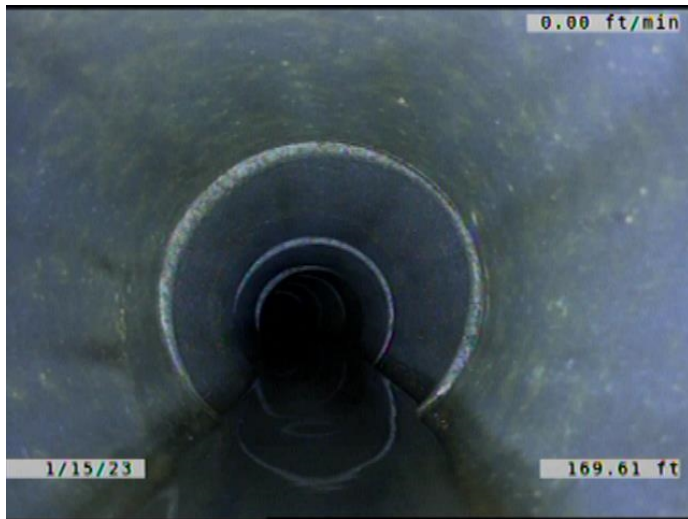
Code: **MWLS**
 Description: **Miscellaneous Water Level Sag**

Distance (ft): **169.6**
 Structural Grade: **2**
 O&M Grade: **0**
 Clock Start/From:
 Clock To:
 1st Value:
 2nd Value:
 Value Percent: **15.000**
 Continuous Index: **S12**
 Within 8" of Joint: **NO**
 Remarks:

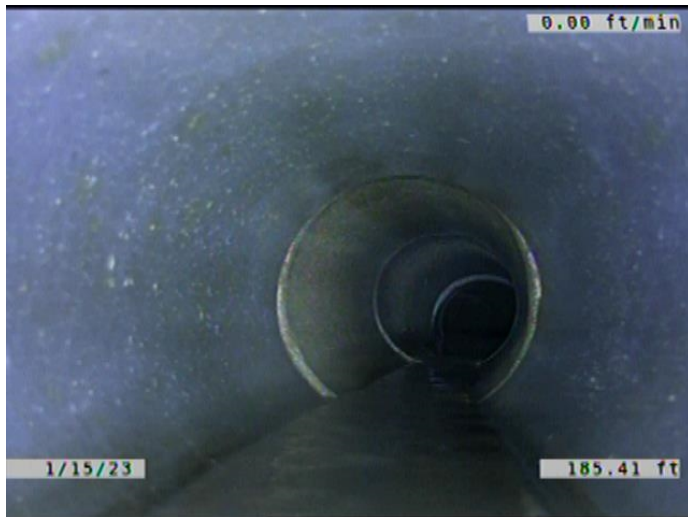
Code: **MWLS**
 Description: **Miscellaneous Water Level Sag**

Distance (ft): **185.4**
 Structural Grade: **2**
 O&M Grade: **0**
 Clock Start/From:
 Clock To:
 1st Value:
 2nd Value:
 Value Percent: **15.000**
 Continuous Index: **F12**
 Within 8" of Joint: **NO**
 Remarks:

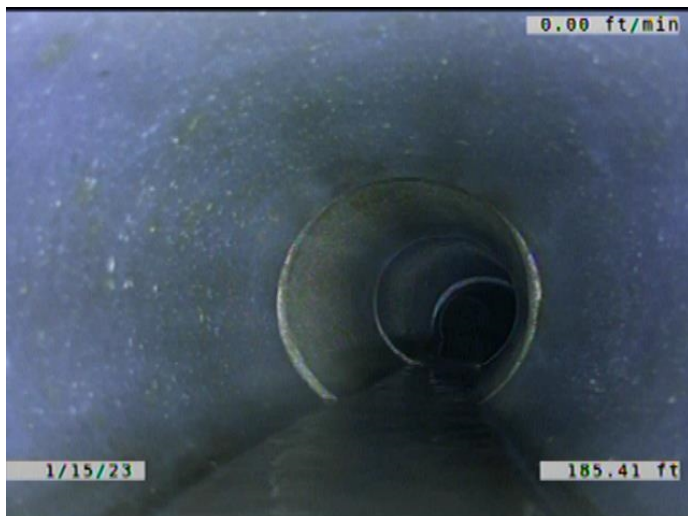
Code: **LR**
 Description: **Line Right**

Distance (ft): **185.4**
 Structural Grade: **0**
 O&M Grade: **2**
 Clock Start/From:
 Clock To:
 1st Value:
 2nd Value:
 Value Percent: **15.000**
 Continuous Index:
 Within 8" of Joint: **NO**
 Remarks:

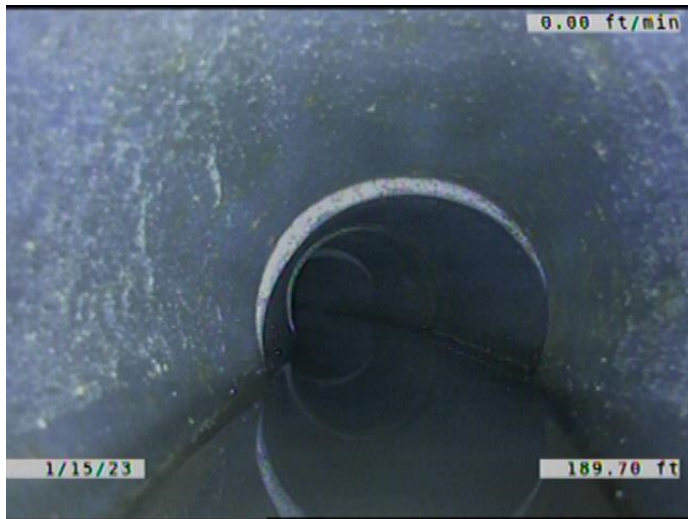
Code: **MWLS**
 Description: **Miscellaneous Water Level Sag**

Distance (ft): **189.7**
 Structural Grade: **2**
 O&M Grade: **0**
 Clock Start/From:
 Clock To:
 1st Value:
 2nd Value:
 Value Percent: **20.000**
 Continuous Index: **S13**
 Within 8" of Joint: **NO**
 Remarks:

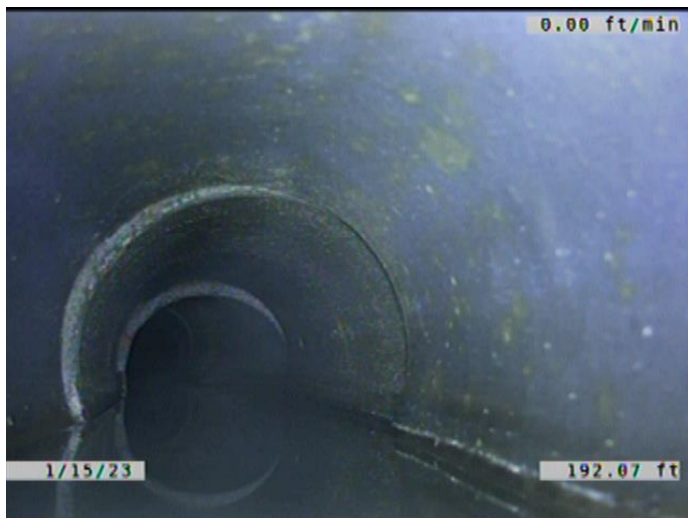
Code: **LL**
 Description: **Line Left**

Distance (ft): **192.1**
 Structural Grade: **0**
 O&M Grade: **1**
 Clock Start/From:
 Clock To:
 1st Value:
 2nd Value:
 Value Percent: **10.000**
 Continuous Index:
 Within 8" of Joint: **NO**
 Remarks:

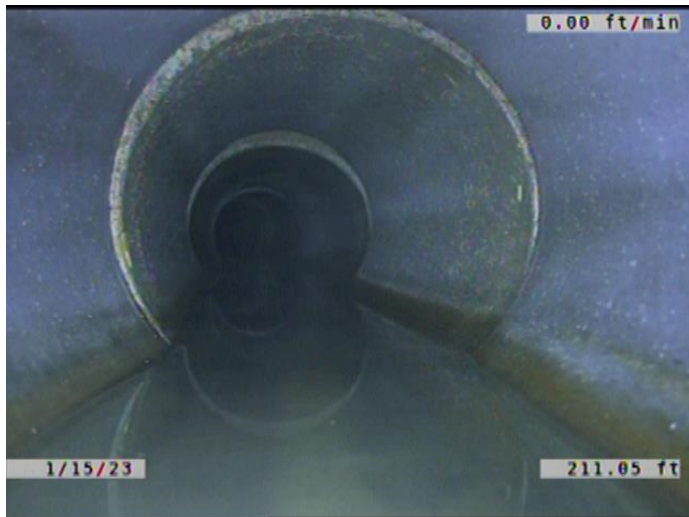
Code: **LL**
Description: **Line Left**

Distance (ft): **211.1**
Structural Grade: **0**
O&M Grade: **1**
Clock Start/From:
Clock To:
1st Value:
2nd Value:
Value Percent: **5.000**
Continuous Index:
Within 8" of Joint: **NO**
Remarks:

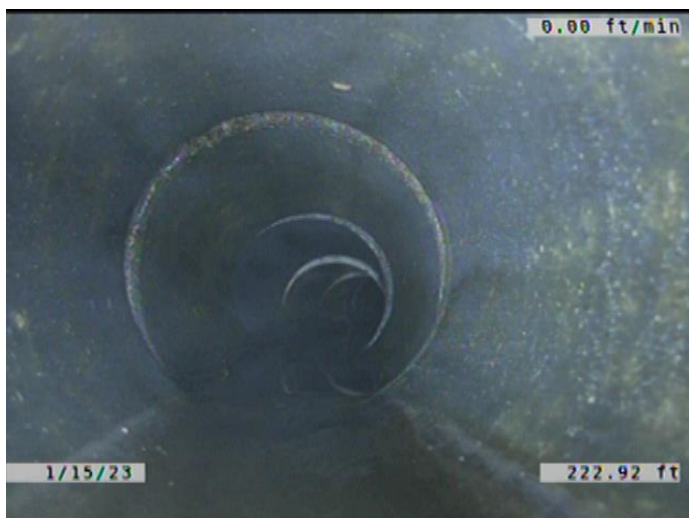
Code: **MWLS**
Description: **Miscellaneous Water Level Sag**

Distance (ft): **222.9**
Structural Grade: **2**
O&M Grade: **0**
Clock Start/From:
Clock To:
1st Value:
2nd Value:
Value Percent: **20.000**
Continuous Index: **F13**
Within 8" of Joint: **NO**
Remarks:

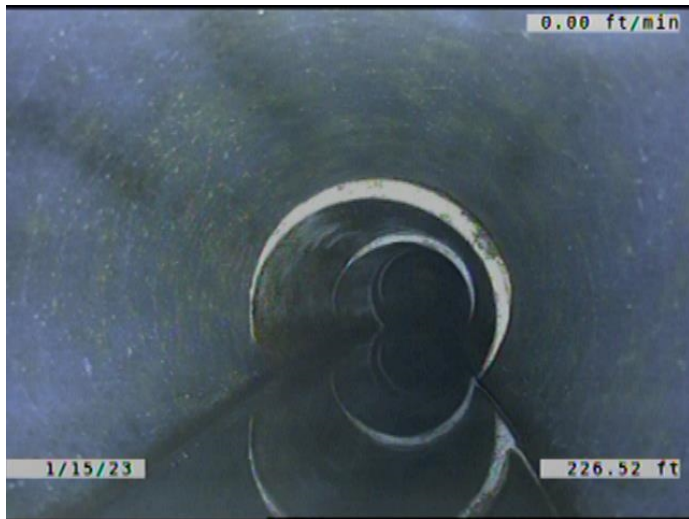
Code: **LR**
 Description: **Line Right**

Distance (ft): **226.5**
 Structural Grade: **0**
 O&M Grade: **1**
 Clock Start/From:
 Clock To:
 1st Value:
 2nd Value:
 Value Percent: **5.000**
 Continuous Index:
 Within 8" of Joint: **NO**
 Remarks:

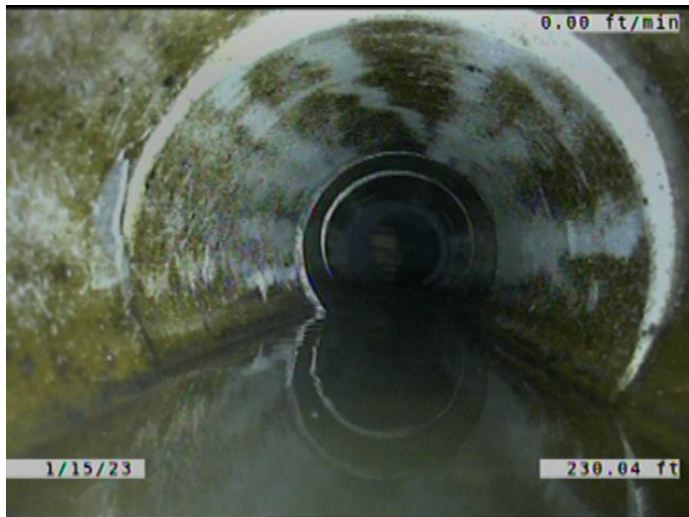
Code: **BSV**
 Description: **Broken Soil Visible**

Distance (ft): **229.1**
 Structural Grade: **5**
 O&M Grade: **0**
 Clock Start/From: **12**
 Clock To: **3**
 1st Value:
 2nd Value:
 Value Percent:
 Continuous Index:
 Within 8" of Joint: **YES**
 Remarks:

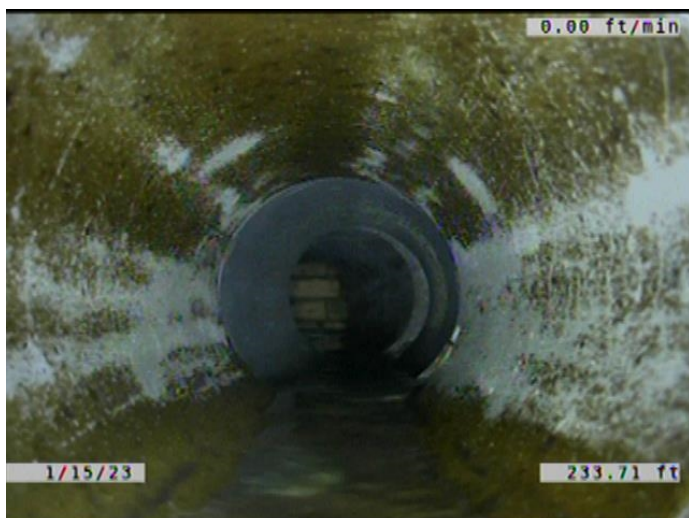
Code: **MWLS**
Description: **Miscellaneous Water Level Sag**

Distance (ft): **230.0**
Structural Grade: **2**
O&M Grade: **0**
Clock Start/From:
Clock To:
1st Value:
2nd Value:
Value Percent: **15.000**
Continuous Index: **S14**
Within 8" of Joint: **NO**
Remarks:

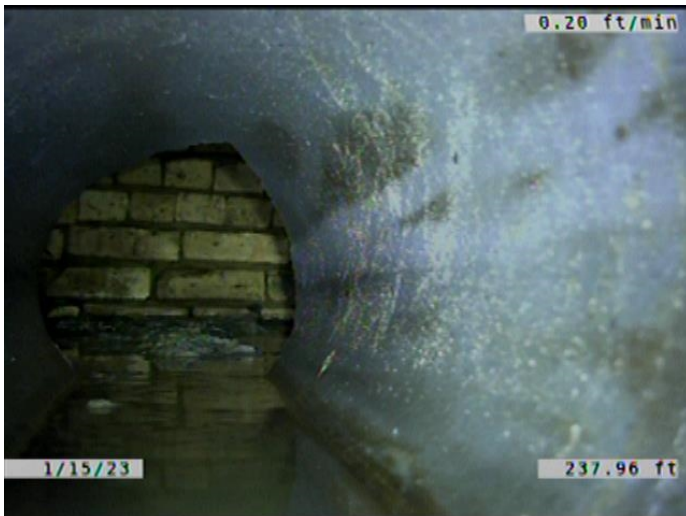
Code: **HVV**
Description: **Hole Void Visible**

Distance (ft): **236.2**
Structural Grade: **5**
O&M Grade: **0**
Clock Start/From: **3**
Clock To: **6**
1st Value:
2nd Value:
Value Percent:
Continuous Index:
Within 8" of Joint: **YES**
Remarks: **VOID AND SOIL VISIBLE.**
