## Profile/Photo Observation Report

Street:	<b>S INDIANA ST &amp; E 1ST PL</b>	Flow Control:	<b>Not Controlled</b>
City:	<b>Hobart, IN</b>	Year Renewed:	
Location:	<b>Other</b>	Tape/Media #:	
Purpose:	<b>Not Known</b>	Dia/Height:	<b>8"</b>
Use:	<b>Sanitary</b>	Material:	<b>VCP</b>
Drain Area:	<b>NA</b>	Lining:	
Category:	<b>NA</b>		
Comment:

Location Details:		Direction of Survey:	<b>Downstream</b>
US MH:	<b>M-805-062</b>	DS MH:	<b>M-805-058</b>
		Total Length Surveyed (ft):	<b>52.3</b>

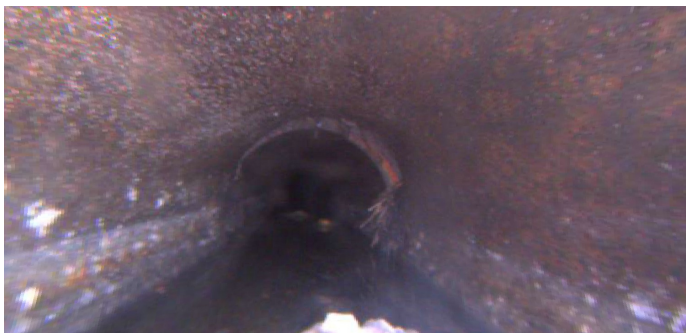
Code: **AMH**  
Description: **Manhole**

Distance (ft): **.0**  
Structural Grade: **0**  
O&M Grade: **0**  
Clock Start/From:  
Clock To:  
1st Value:  
2nd Value:  
Value Percent:  
Continuous Index:  
Within 8" of Joint: **NO**  
Remarks: **M-805-062**
