Profile/Photo Observation Report

Street:	LUTHER DR	Flow Control:	Not Controlled
City:	Hobart, IN	Year Renewed:	
Location:	Light Highway	Tape/Media #:	
Purpose:	Maintenance Related	Dia/Height:	10"
Use:	Sanitary	Material:	VCP
Drain Area:	NA	Lining:	Cured in Place
Category:	NA		
Comment:	flow incorrect.

Location Details:		Direction of Survey:	Upstream
US MH:	M-806-006	DS MH:	M-806-005
		Total Length Surveyed (ft):	278.2

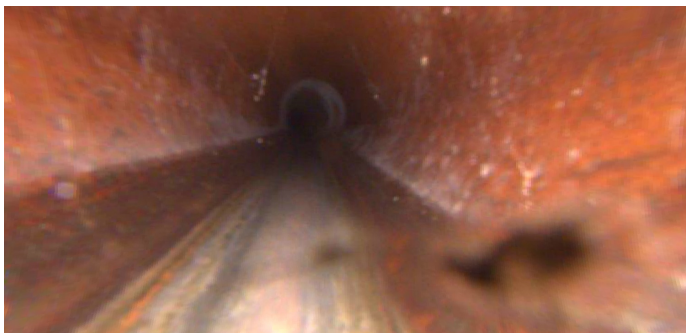
Code: **AMH**
Description: **Manhole**

Distance (ft): **.0**
Structural Grade: **0**
O&M Grade: **0**
Clock Start/From:
Clock To:
1st Value:
2nd Value:
Value Percent:
Continuous Index:
Within 8" of Joint: **NO**
Remarks: **M-806-005**

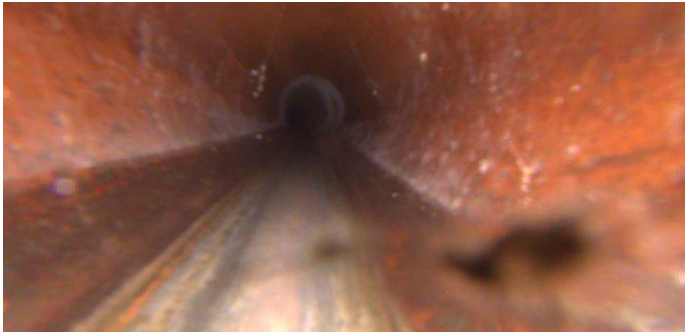
Code:	MWL
Description:	Water Level

Distance (ft):	.0
Structural Grade:	0
O&M Grade:	0
Clock Start/From:	
Clock To:	
1st Value:	
2nd Value:	
Value Percent:	5.000
Continuous Index:	
Within 8" of Joint:	NO
Remarks:

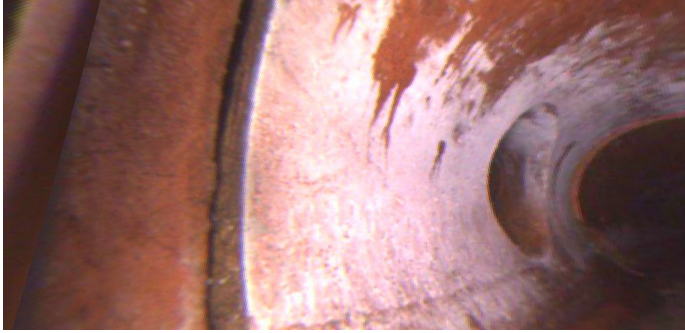
Code: **TF**
Description: **Tap Factory**

Distance (ft): **6.8**
Structural Grade: **0**
O&M Grade: **0**
Clock Start/From: **3**
Clock To:
1st Value: **4.000**
2nd Value:
Value Percent:
Continuous Index:
Within 8" of Joint: **YES**
Remarks:

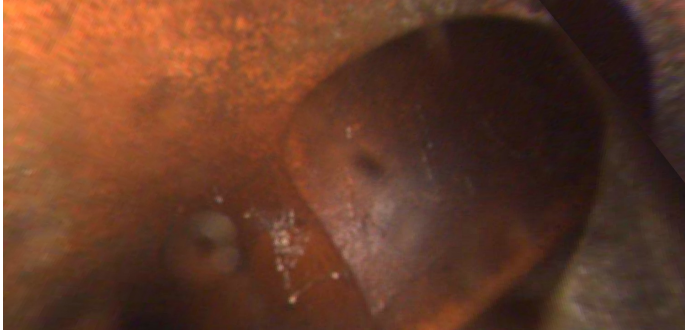
Code: **TF**
Description: **Tap Factory**

Distance (ft): **107.3**
Structural Grade: **0**
O&M Grade: **0**
Clock Start/From: **2**
Clock To:
1st Value: **4.000**
2nd Value:
Value Percent:
Continuous Index:
Within 8" of Joint: **YES**
Remarks:

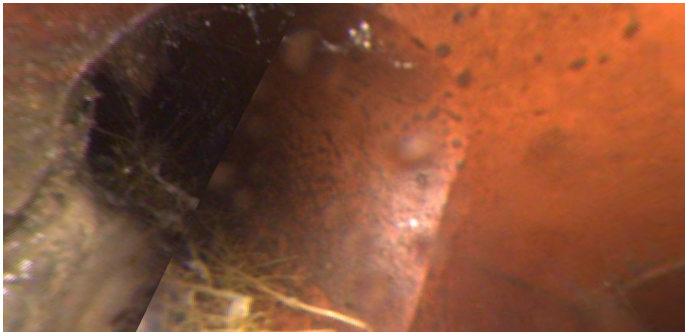
Code: **TF**
Description: **Tap Factory**

Distance (ft): **117.7**
Structural Grade: **0**
O&M Grade: **0**
Clock Start/From: **10**
Clock To:
1st Value: **4.000**
2nd Value:
Value Percent:
Continuous Index:
Within 8" of Joint:
Remarks:

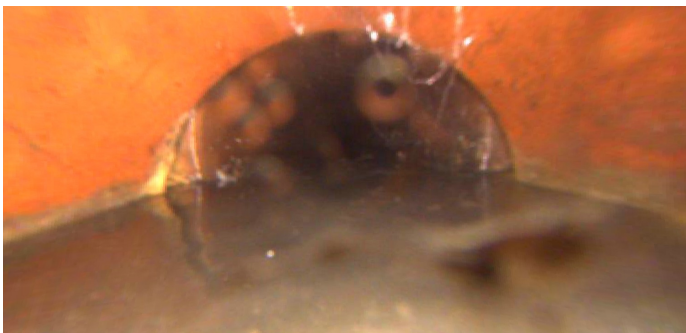
Code: **MWL**
Description: **Water Level**

Distance (ft): **214.7**
Structural Grade: **0**
O&M Grade: **0**
Clock Start/From:
Clock To:
1st Value:
2nd Value:
Value Percent: **50.000**
Continuous Index:
Within 8" of Joint: **NO**
Remarks:

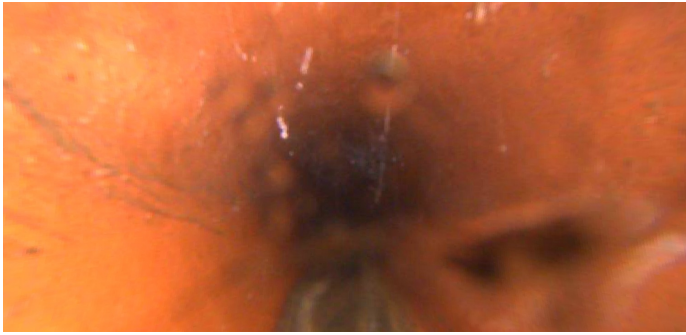
Code: **MWL**
Description: **Water Level**

Distance (ft): **220.1**
Structural Grade: **0**
O&M Grade: **0**
Clock Start/From:
Clock To:
1st Value:
2nd Value:
Value Percent: **5.000**
Continuous Index:
Within 8" of Joint: **NO**
Remarks:

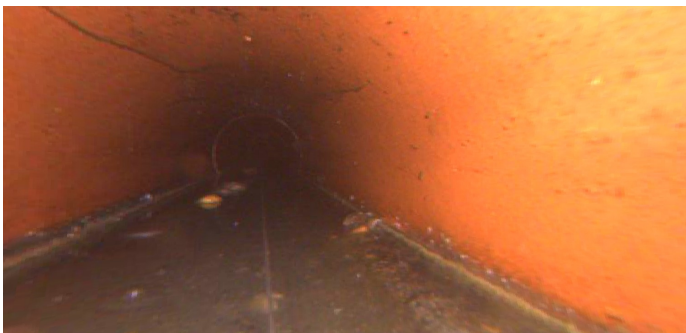
Code: **MGO**
Description: **General Observation**

Distance (ft): **230.8**
Structural Grade: **0**
O&M Grade: **0**
Clock Start/From:
Clock To:
1st Value:
2nd Value:
Value Percent:
Continuous Index:
Within 8" of Joint: **NO**
Remarks: **rear camera/cob webs**

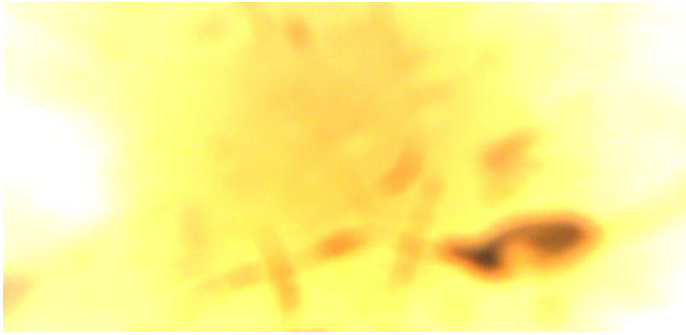
Code:	AMH
Description:	Manhole
Distance (ft):	278.2
Structural Grade:	0
O&M Grade:	0
Clock Start/From:	
Clock To:	
1st Value:	
2nd Value:	
Value Percent:	
Continuous Index:	
Within 8" of Joint:	NO
Remarks:	M-806-006
