Profile/Photo Observation Report

Date:	04/20/2018	Weather:		Coding:	PACP 6.0
Pipe Length (ft):	274.7	Owner:	NA	Pre Clean:	Not Known
P.O.#:		Surveyor:	Byrd Fitzgerald	PSR:	P-806-005-006
Customer:		Clean Date:	01/01/1900	Shape:	C

Street:	Capitol	Flow Control:	Not Controlled
City:	Hobart, IN	Year Renewed:	
Location:	Light Highway	Tape/Media #:	
Purpose:	Maintenance Related	Dia/Height:	10"
Use:	Sanitary	Material:	VCP
Drain Area:	NA	Lining:	Cured in Place
Category:	NA		
Comment:	flow incorrect.

Location Details:		Direction of Survey:	Upstream
US MH:	M-806-006	DS MH:	M-806-005
		Total Length Surveyed (ft):	278.2

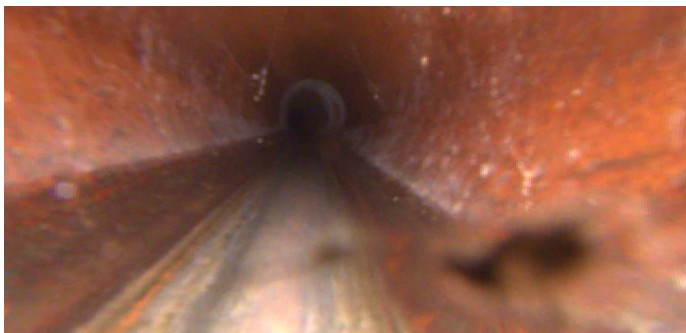
Code: **AMH**
Description: **Manhole**

Distance (ft): **.0**
Structural Grade: **0**
O&M Grade: **0**
Clock Start/From:
Clock To:
1st Value:
2nd Value:
Value Percent:
Continuous Index:
Within 8" of Joint: **NO**
Remarks: **M-806-005**

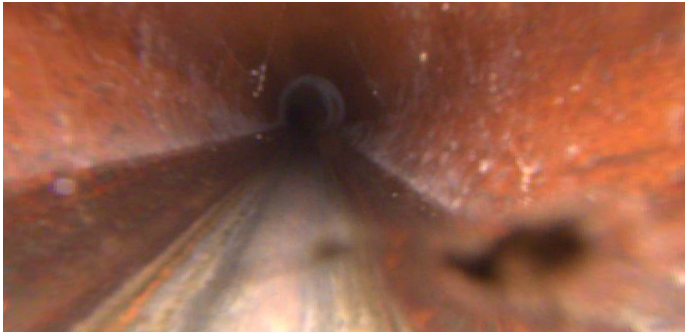
Code:	MWL
Description:	Water Level

Distance (ft):	.0
Structural Grade:	0
O&M Grade:	0
Clock Start/From:	
Clock To:	
1st Value:	
2nd Value:	
Value Percent:	5.000
Continuous Index:	
Within 8" of Joint:	NO
Remarks:

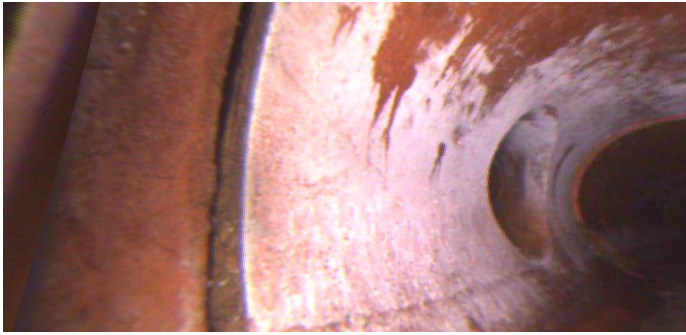
Code: **TF**
Description: **Tap Factory**

Distance (ft): **6.8**
Structural Grade: **0**
O&M Grade: **0**
Clock Start/From: **3**
Clock To:
1st Value: **4.000**
2nd Value:
Value Percent:
Continuous Index:
Within 8" of Joint: **YES**
Remarks:

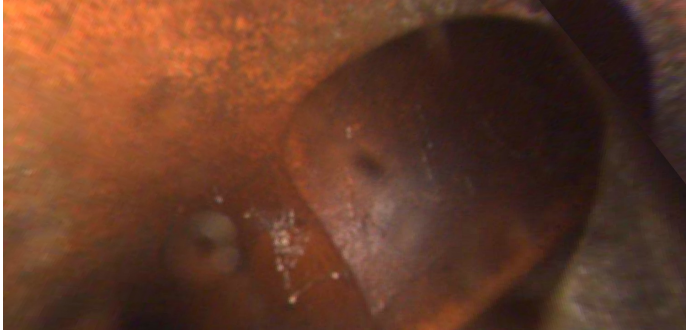
Code: **TF**
Description: **Tap Factory**

Distance (ft): **107.3**
Structural Grade: **0**
O&M Grade: **0**
Clock Start/From: **2**
Clock To:
1st Value: **4.000**
2nd Value:
Value Percent:
Continuous Index:
Within 8" of Joint: **YES**
Remarks:

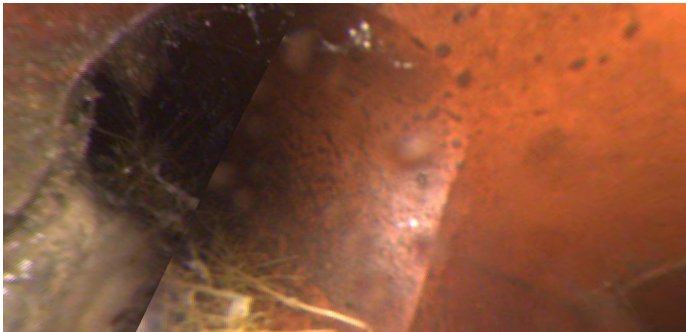
Code: **TF**
Description: **Tap Factory**

Distance (ft): **117.7**
Structural Grade: **0**
O&M Grade: **0**
Clock Start/From: **10**
Clock To:
1st Value: **4.000**
2nd Value:
Value Percent:
Continuous Index:
Within 8" of Joint:
Remarks:

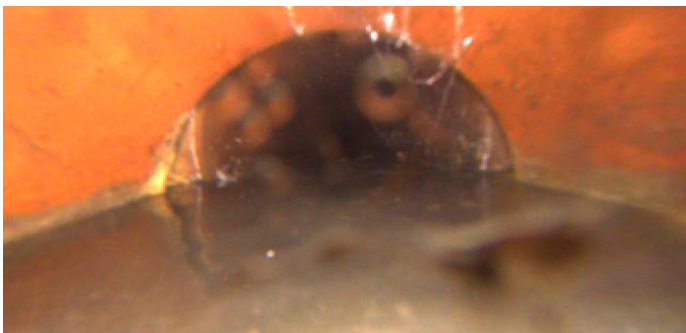
Code: **MWL**
Description: **Water Level**

Distance (ft): **214.7**
Structural Grade: **0**
O&M Grade: **0**
Clock Start/From:
Clock To:
1st Value:
2nd Value:
Value Percent: **50.000**
Continuous Index:
Within 8" of Joint: **NO**
Remarks:

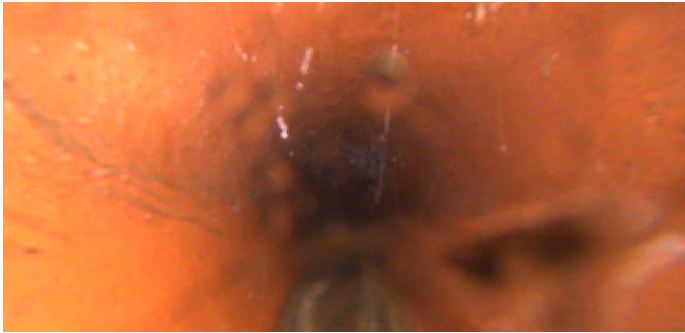
Code: **MWL**
Description: **Water Level**

Distance (ft): **220.1**
Structural Grade: **0**
O&M Grade: **0**
Clock Start/From:
Clock To:
1st Value:
2nd Value:
Value Percent: **5.000**
Continuous Index:
Within 8" of Joint: **NO**
Remarks:

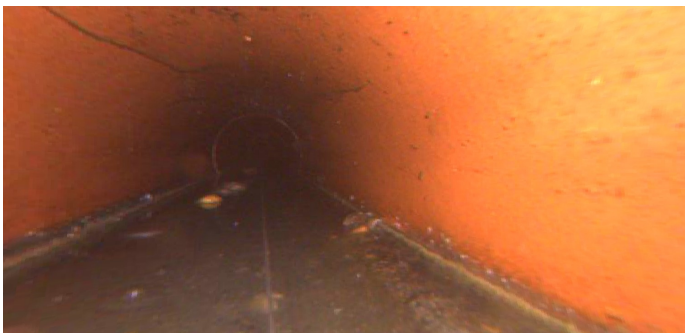
Code: **MGO**
Description: **General Observation**

Distance (ft): **230.8**
Structural Grade: **0**
O&M Grade: **0**
Clock Start/From:
Clock To:
1st Value:
2nd Value:
Value Percent:
Continuous Index:
Within 8" of Joint: **NO**
Remarks: **rear camera/cob webs**
