Profile/Photo Observation Report

Date:	04/17/2018	Weather:		Coding:	PACP 6.0
Pipe Length (ft):	198.8	Owner:	NA	Pre Clean:	Not Known
P.O.#:		Surveyor:	Byrd Fitzgerald	PSR:	P-806-013-014
Customer:		Clean Date:	01/01/1900	Shape:	C

Street:	MEMORY LN	Flow Control:	Not Controlled
City:	Hobart, IN	Year Renewed:	
Location:	Light Highway	Tape/Media #:	
Purpose:	Maintenance Related	Dia/Height:	10"
Use:	Sanitary	Material:	VCP
Drain Area:	NA	Lining:	Cured in Place
Category:	NA		
Comment:	heavy debris at 54'.		
Location Details:		Direction of Survey:	Upstream
US MH:	M-806-014	DS MH:	M-806-013
		Total Length Surveyed (ft):	55.4

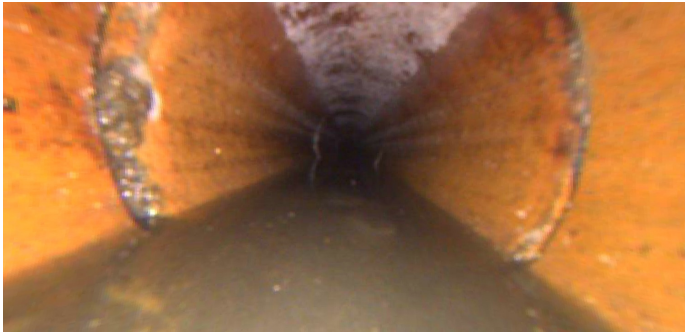
Code:	MWL
Description:	Water Level

Distance (ft):	.0
Structural Grade:	0
O&M Grade:	0
Clock Start/From:	
Clock To:	
1st Value:	
2nd Value:	
Value Percent:	5.000
Continuous Index:	
Within 8" of Joint:	NO
Remarks:
