Profile/Photo Observation Report

Date:	04/17/2018	Weather:		Coding:	PACP 6.0
Pipe Length (ft):	198.8	Owner:	NA	Pre Clean:	Not Known
P.O.#:		Surveyor:	Byrd Fitzgerald	PSR:	P-806-013-014
Customer:		Clean Date:	01/01/1900	Shape:	C

Location Details:		Direction of Survey:	Upstream
US MH:	M-806-014	DS MH:	M-806-013
		Total Length Surveyed (ft):	55.4

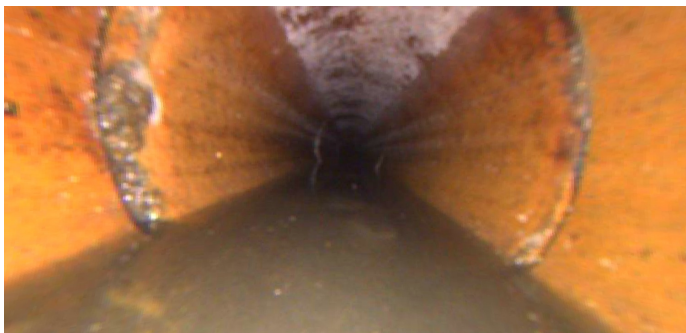
Code: **AMH**
Description: **Manhole**

Distance (ft): **.0**
Structural Grade: **0**
O&M Grade: **0**
Clock Start/From:
Clock To:
1st Value:
2nd Value:
Value Percent:
Continuous Index:
Within 8" of Joint: **NO**
Remarks: **M-806-013**
