## Profile/Photo Observation Report

| Street: | <b>Capitol</b> | Flow Control: | <b>Not Controlled</b> |
| City: | <b>Hobart, IN</b> | Year Renewed: | |
| US MH: | <b>M-806-055</b> | DS MH: | <b>M-806-054</b> |

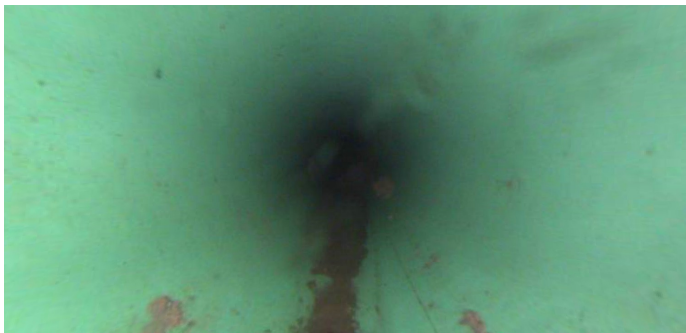
Code: **AMH**  
Description: **Manhole**

Distance (ft): **.0**  
Structural Grade: **0**  
O&M Grade: **0**  
Clock Start/From:  
Clock To:  
1st Value:  
2nd Value:  
Value Percent:  
Continuous Index:  
Within 8" of Joint: **NO**  
Remarks: **M-806-054**

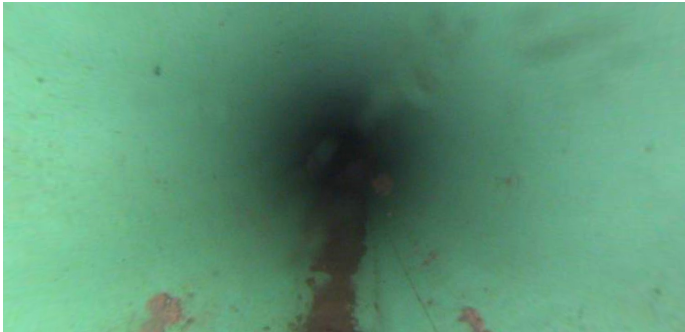
| Code: | <b>MWL</b> |
| Description: | <b>Water Level</b> |

| Distance (ft): | <b>.0</b> |
| Value Percent: | <b>5.000</b> |

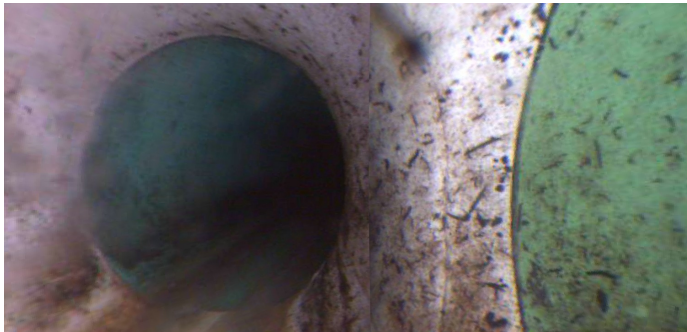
| Code: | <b>TFA</b> |
| Description: | <b>Tap Factory Active</b> |
| Distance (ft): | <b>11.2</b> |
| Clock Start/From: | <b>9</b> |
| 1st Value: | <b>4.000</b> |

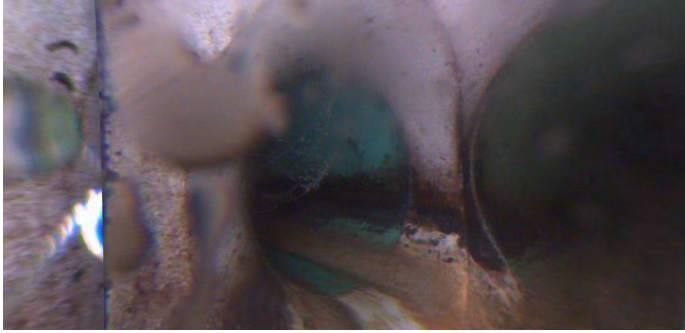
Code: **TFA**  
Description: **Tap Factory Active**

Distance (ft): **17.9**  
Structural Grade: **0**  
O&M Grade: **0**  
Clock Start/From: **3**  
Clock To:  
1st Value: **4.000**  
2nd Value:  
Value Percent:  
Continuous Index:  
Within 8" of Joint:  
Remarks:

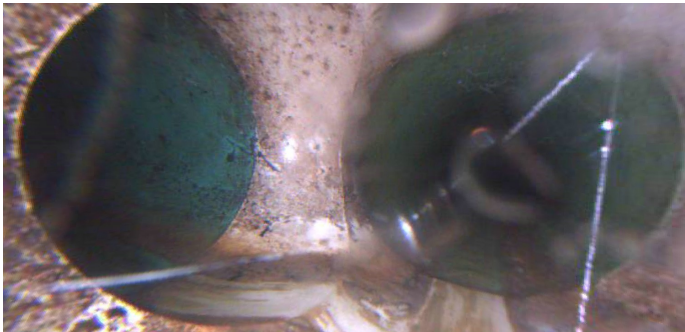
Code: **TFA**  
Description: **Tap Factory Active**

Distance (ft): **30.3**  
Structural Grade: **0**  
O&M Grade: **0**  
Clock Start/From: **9**  
Clock To:  
1st Value: **4.000**  
2nd Value:  
Value Percent:  
Continuous Index:  
Within 8" of Joint:  
Remarks:
