Profile/Photo Observation Report

Street:	Tanager	Flow Control:	Not Controlled
City:	Hobart, IN	Year Renewed:	
Location:	Sidewalk	Tape/Media #:	
Purpose:	Maintenance Related	Dia/Height:	8"
Use:	Sanitary	Material:	PVC
Drain Area:	NA	Lining:	
Category:	NA		
Comment:	Flow direction wrong.

Location Details:		Direction of Survey:	Downstream
US MH:	M-809-007	DS MH:	M-809-008
		Total Length Surveyed (ft):	96.6

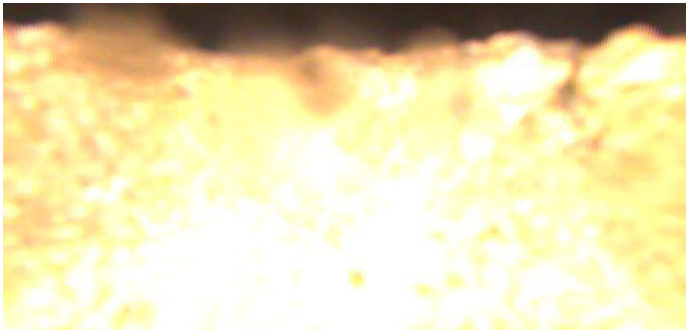
Code: **AMH**
Description: **Manhole**

Distance (ft): **96.6**
Structural Grade: **0**
O&M Grade: **0**
Clock Start/From:
Clock To:
1st Value:
2nd Value:
Value Percent:
Continuous Index:
Within 8" of Joint: **NO**
Remarks: **M-809-008**
