Profile/Photo Observation Report

Street:	Oak	Flow Control:	Not Controlled
City:	Hobart, IN	Year Renewed:	
Location:	Ditch	Tape/Media #:	
Purpose:	Maintenance Related	Dia/Height:	8"
Use:	Sanitary	Material:	PVC
Drain Area:	NA	Lining:	
Category:	NA		
Comment:	battery at 152'.

Location Details:		Direction of Survey:	Upstream
US MH:	M-809-011	DS MH:	M-809-012
		Total Length Surveyed (ft):	153.9

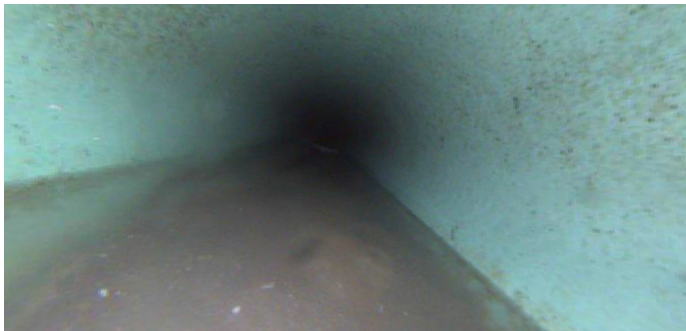
Code: **AMH**
Description: **Manhole**

Distance (ft): **.0**
Structural Grade: **0**
O&M Grade: **0**
Clock Start/From:
Clock To:
1st Value:
2nd Value:
Value Percent:
Continuous Index:
Within 8" of Joint: **NO**
Remarks: **M-809-012**

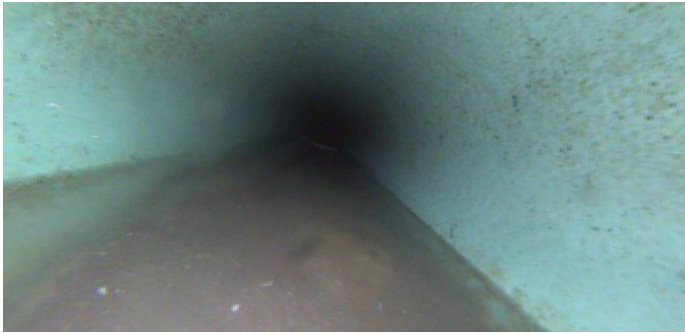
Code:	MWL
Description:	Water Level

Distance (ft):	.0
Structural Grade:	0
O&M Grade:	0
Clock Start/From:	
Clock To:	
1st Value:	
2nd Value:	
Value Percent:	10.000
Continuous Index:	
Within 8" of Joint:	NO
Remarks:
