## Profile/Photo Observation Report

Street:	<b>TANAGER ST</b>	Flow Control:	<b>Not Controlled</b>
City:	<b>Hobart, IN</b>	Year Renewed:	
Location:	<b>Light Highway</b>	Tape/Media #:	
Purpose:	<b>Maintenance Related</b>	Dia/Height:	<b>12"</b>
Use:	<b>Sanitary</b>	Material:	<b>PVC</b>
Drain Area:	<b>NA</b>	Lining:	
Category:	<b>NA</b>		
Comment:

Location Details:		Direction of Survey:	<b>Upstream</b>
US MH:	<b>M-809-018</b>	DS MH:	<b>M-809-033</b>
		Total Length Surveyed (ft):	<b>353.6</b>

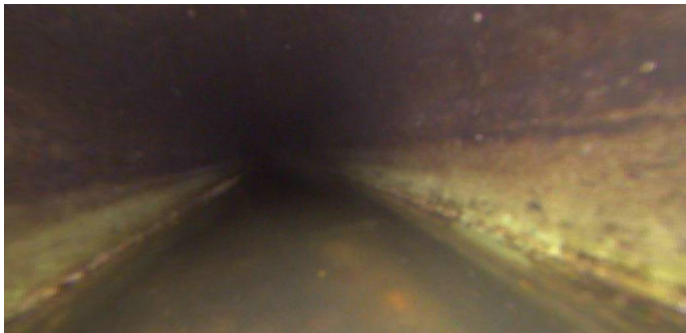
The diagram shows a vertical pipe with inspection points marked by circles and lines. The pipe is labeled with 'M-809-033' at the top and 'M-809-018' at the bottom. A red arrow on the left indicates the 'Camera Direction' pointing downwards. The data table on the right lists the following observations:

Position	Code	Observation	Video (sec)	Grade
.0	AMH	Manhole	10	NA
.0	MWL	Water Level	21	NA
57.3	DSZ	Deposits Settled Other	147	M 2
64.5	TFA	Tap Factory Active	173	NA
66.8	TF	Tap Factory	189	NA
145.3	TB	Tap Break-in	358	NA
210.9	TFA	Tap Factory Active	501	NA
213.4	TF	Tap Factory	517	NA
353.6	AMH	Manhole	809	NA
