Profile/Photo Observation Report

Date:	03/23/2018	Weather:		Coding:	PACP 6.0
Pipe Length (ft):	101.1	Owner:	NA	Pre Clean:	Not Known
P.O.#:		Surveyor:	Jen Costello	PSR:	P-902-006-007
Customer:		Clean Date:	01/01/1900	Shape:	C

Street:	E 34TH LN	Flow Control:	Not Controlled
City:	Hobart, IN	Year Renewed:	
Location:	Other	Tape/Media #:	
Purpose:	Not Known	Dia/Height:	10"
Use:	Sanitary	Material:	VCP
Drain Area:	NA	Lining:	
Category:	NA		
Comment:

Location Details:		Direction of Survey:	Downstream
US MH:	M-902-007	DS MH:	M-902-006
		Total Length Surveyed (ft):	6.1

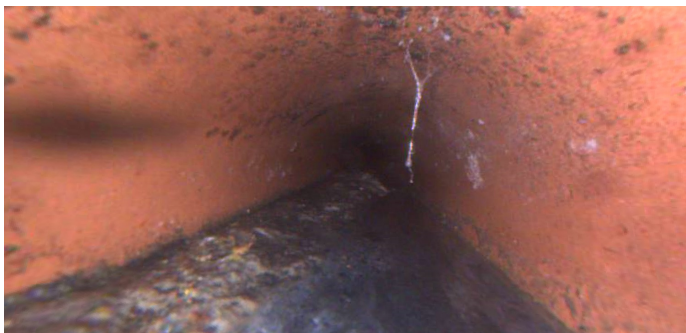
Code: **AMH**
Description: **Manhole**

Distance (ft): **.0**
Structural Grade: **0**
O&M Grade: **0**
Clock Start/From:
Clock To:
1st Value:
2nd Value:
Value Percent:
Continuous Index:
Within 8" of Joint: **NO**
Remarks: **M-902-007**
