Profile/Photo Observation Report

Date:	10/15/2021	Weather:		Coding:	PACP 6.0
Pipe Length (ft):		Owner:	Hobart, IN	Pre Clean:	Not Known
P.O.#:	809_1	Surveyor:	M. Pielacha	PSR:	P-902-019B-022
Customer:	Hobart, IN	Clean Date:		Shape:	C

Street:	Off 34th Court	Flow Control:	
City:	Hobart, IN	Year Renewed:	
Location:	Yard	Tape/Media #:	809
Purpose:	Routine Assessment	Dia/Height:	12"
Use:	Sanitary	Material:	VCP
Drain Area:		Lining:	
Category:	NA		
Comment:

Location Details:		Direction of Survey:	Downstream
US MH:	M-902-019B	DS MH:	M-902-22
		Total Length Surveyed (ft):	397.7

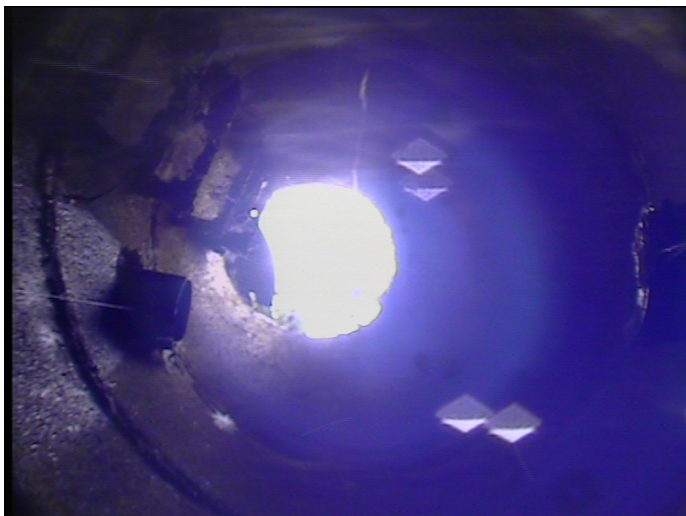
Code: **AMH**
 Description: **Manhole**

Distance (ft): **.0**
 Structural Grade: **0**
 O&M Grade: **0**
 Clock Start/From:
 Clock To:
 1st Value:
 2nd Value:
 Value Percent:
 Continuous Index:
 Within 8" of Joint: **NO**
 Remarks: **M-902-019B**

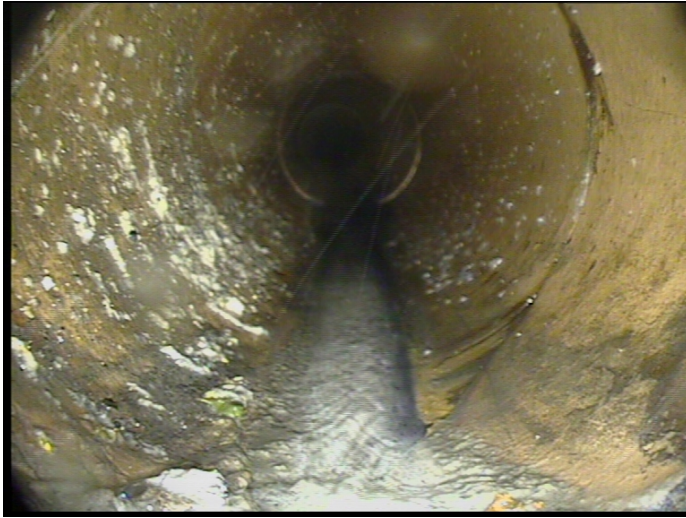
Code: **MWL**
Description: **Water Level**

Distance (ft): **.0**
Structural Grade: **0**
O&M Grade: **0**
Clock Start/From:
Clock To:
1st Value:
2nd Value:
Value Percent: **5.000**
Continuous Index:
Within 8" of Joint: **NO**
Remarks:

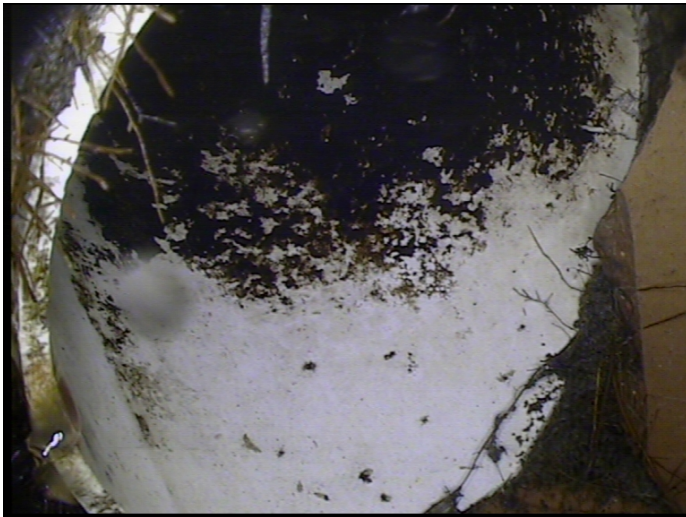
Code: **TB**
Description: **Tap Break-in**

Distance (ft): **98.0**
Structural Grade: **0**
O&M Grade: **0**
Clock Start/From: **9**
Clock To:
1st Value: **4.000**
2nd Value:
Value Percent:
Continuous Index:
Within 8" of Joint: **NO**
Remarks:

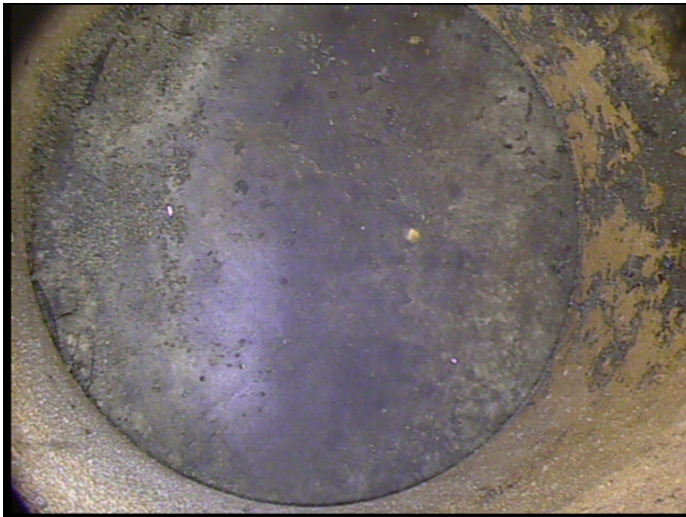
Code:	TFC
Description:	Tap Factory Capped
Distance (ft):	168.6
Structural Grade:	0
O&M Grade:	0
Clock Start/From:	9
Clock To:	
1st Value:	4.000
2nd Value:	
Value Percent:	
Continuous Index:	
Within 8" of Joint:	NO
Remarks:

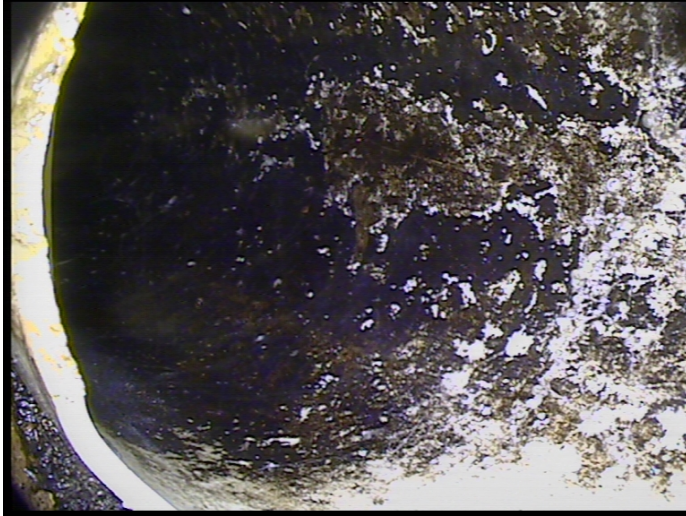
Code: **TB**
Description: **Tap Break-in**

Distance (ft): **181.0**
Structural Grade: **0**
O&M Grade: **0**
Clock Start/From: **9**
Clock To:
1st Value: **4.000**
2nd Value:
Value Percent:
Continuous Index:
Within 8" of Joint: **NO**
Remarks:

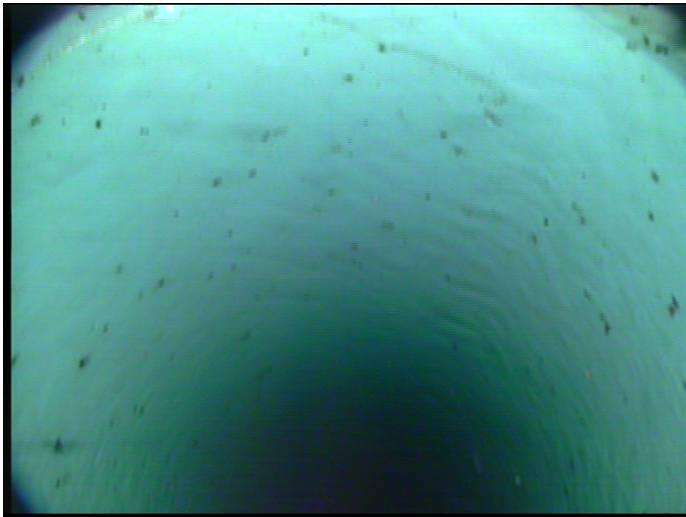
Code: **MMC**
Description: **Material Change**

Distance (ft): **245.7**
Structural Grade: **0**
O&M Grade: **0**
Clock Start/From:
Clock To:
1st Value:
2nd Value:
Value Percent:
Continuous Index:
Within 8" of Joint: **NO**
Remarks: **pvc**

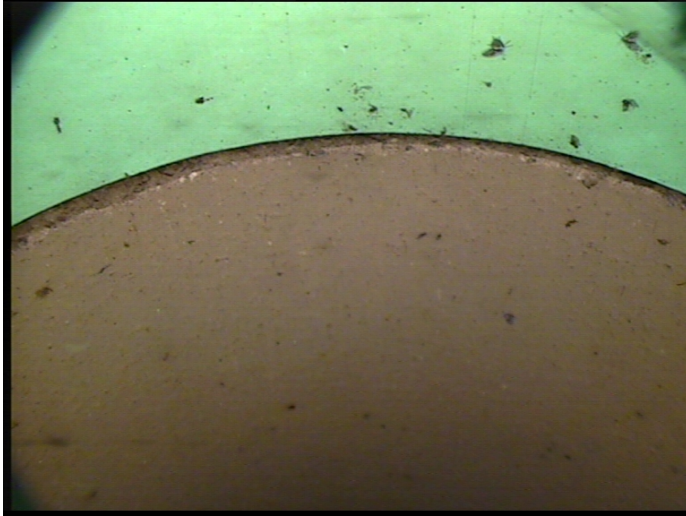
Code: **MMC**
Description: **Material Change**

Distance (ft): **263.4**
Structural Grade: **0**
O&M Grade: **0**
Clock Start/From:
Clock To:
1st Value:
2nd Value:
Value Percent:
Continuous Index:
Within 8" of Joint: **NO**
Remarks: **vcp**

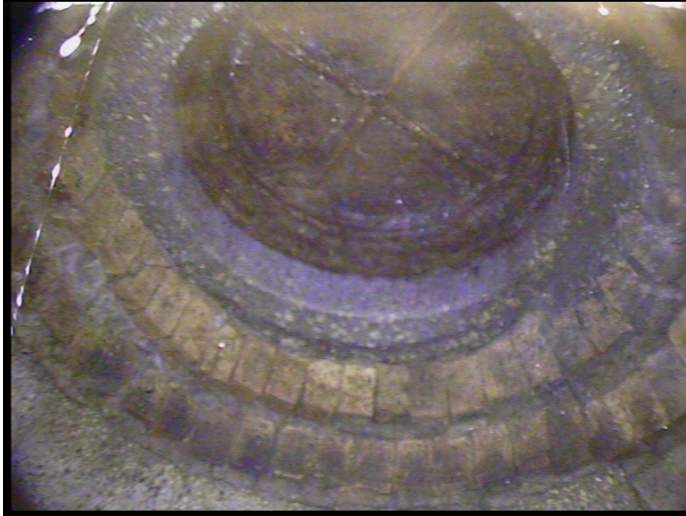
Code:	AMH
Description:	Manhole
Distance (ft):	397.7
Structural Grade:	0
O&M Grade:	0
Clock Start/From:	
Clock To:	
1st Value:	
2nd Value:	
Value Percent:	
Continuous Index:	
Within 8" of Joint:	NO
Remarks:	M-902-22
