Profile/Photo Observation Report

Date:	03/20/2018	Weather:		Coding:	PACP 6.0
Pipe Length (ft):	316.7	Owner:	NA	Pre Clean:	Not Known
P.O.#:		Surveyor:	John Kuglmaier	PSR:	P-902-025-024
Customer:		Clean Date:	01/01/1900	Shape:	C

Street:	Randolph Pl	Flow Control:	Not Controlled
City:	Hobart, IN	Year Renewed:	
Location:	Main Highway - Suburban/Rural	Tape/Media #:	
Purpose:	Resurvey	Dia/Height:	10"
Use:	Sanitary	Material:	VCP
Drain Area:	NA	Lining:	
Category:	NA		
Comment:

Location Details:		Direction of Survey:	Downstream
US MH:	M-902-025	DS MH:	M-902-024
		Total Length Surveyed (ft):	199.9

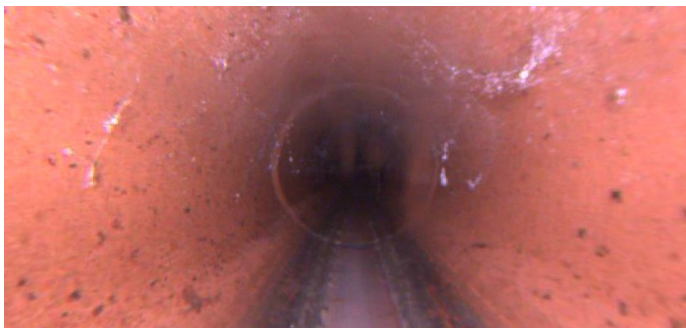
Code: **AMH**
Description: **Manhole**

Distance (ft): **.0**
Structural Grade: **0**
O&M Grade: **0**
Clock Start/From:
Clock To:
1st Value:
2nd Value:
Value Percent:
Continuous Index:
Within 8" of Joint: **NO**
Remarks: **M-902-025**

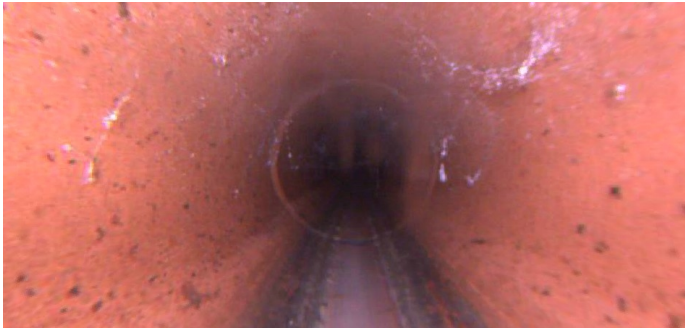
Code:	MWL
Description:	Water Level

Distance (ft):	.0
Structural Grade:	0
O&M Grade:	0
Clock Start/From:	
Clock To:	
1st Value:	
2nd Value:	
Value Percent:	5.000
Continuous Index:	
Within 8" of Joint:	NO
Remarks:

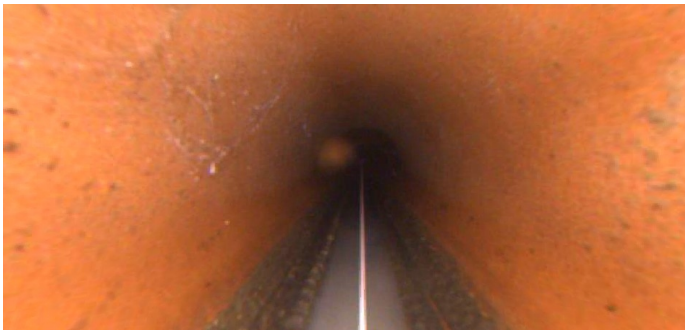
Code:	MGO
Description:	General Observation

Distance (ft):	11.7
Structural Grade:	0
O&M Grade:	0
Clock Start/From:	
Clock To:	
1st Value:	
2nd Value:	
Value Percent:	
Continuous Index:	
Within 8" of Joint:	NO
Remarks:	Switching to rear camera

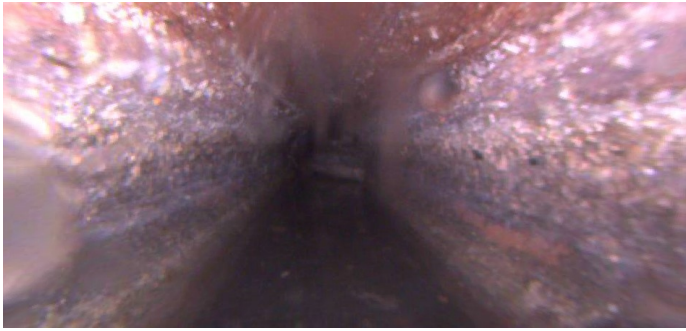
Code: **MGO**
Description: **General Observation**

Distance (ft): **197.1**
Structural Grade: **0**
O&M Grade: **0**
Clock Start/From:
Clock To:
1st Value:
2nd Value:
Value Percent:
Continuous Index:
Within 8" of Joint: **NO**
Remarks: **Switching to front camera**
