Profile/Photo Observation Report

Date:	06/13/2023	Weather:		Coding:	PACP 7.0
Pipe Length (ft):	150.0	Owner:	City of Hobart	Pre Clean:	Heavy Cleaning
P.O.#:	YES502259	Surveyor:	S. Bucklin	PSR:	P-902-032-032A
Customer:	City of Hobart	Clean Date:	05/10/2023	Shape:	C

Street:	North Shelby Street	Flow Control:	Not Controlled
City:	Hobart, IN	Year Renewed:	
Location:	Easement/Right of Way	Tape/Media #:	
Purpose:	Routine Assessment	Dia/Height:	18"
Use:	Sanitary Sewage Pipe	Material:	RCP
Drain Area:		Lining:	None
Category:	NA		
Comment:			
Location Details:		Direction of Survey:	Downstream
US MH:	M-902-032	DS MH:	M-902-032A
		Total Length Surveyed (ft):	151.1

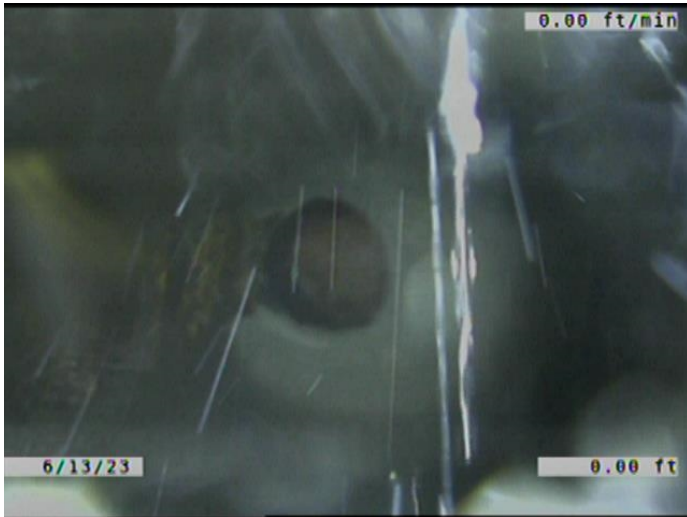
Code: **AMH**
Description: **Manhole**

Distance (ft): **.0**
Structural Grade: **0**
O&M Grade: **0**
Clock Start/From:
Clock To:
1st Value:
2nd Value:
Value Percent:
Continuous Index:
Within 8" of Joint: **NO**
Remarks: **M-902-032**

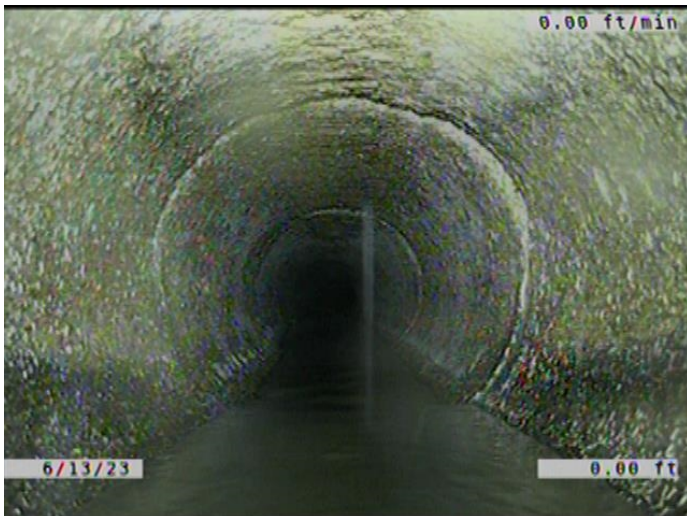
Code: **MWL**
Description: **Miscellaneous Water Level**

Distance (ft): **.0**
Structural Grade: **0**
O&M Grade: **0**
Clock Start/From:
Clock To:
1st Value:
2nd Value:
Value Percent: **15.000**
Continuous Index:
Within 8" of Joint: **NO**
Remarks:

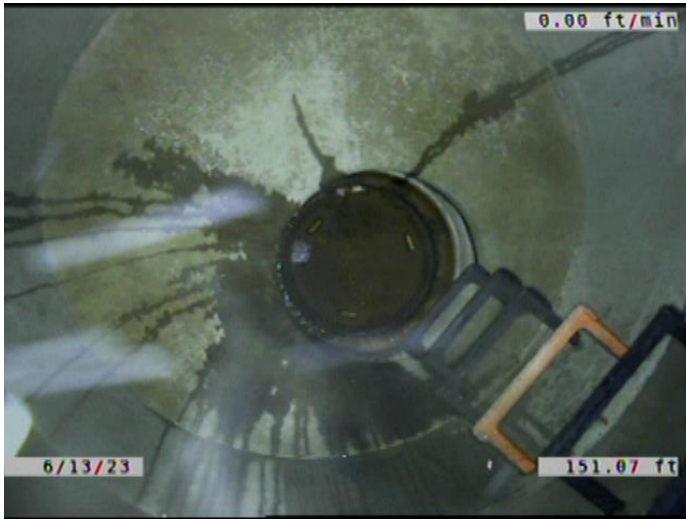
Code:	AMH
Description:	Manhole
Distance (ft):	151.1
Structural Grade:	0
O&M Grade:	0
Clock Start/From:	
Clock To:	
1st Value:	
2nd Value:	
Value Percent:	
Continuous Index:	
Within 8" of Joint:	NO
Remarks:	M-902-032A
