Profile/Photo Observation Report

Date:	09/18/2023	Weather:		Coding:	PACP 7.0
Pipe Length (ft):	205.0	Owner:	City of Hobart	Pre Clean:	Heavy Cleaning
P.O.#:	YES502259	Surveyor:	S. Bucklin	PSR:	P-902-034-033
Customer:	City of Hobart	Clean Date:	08/14/2023	Shape:	C

Street:	East 34th Place	Flow Control:	Not Controlled
City:	Hobart, IN	Year Renewed:	
Location:	Easement/Right of Way	Tape/Media #:	
Purpose:	Routine Assessment	Dia/Height:	8"
Use:	Sanitary Sewage Pipe	Material:	VCP
Drain Area:		Lining:	None
Category:	NA		
Comment:			
Location Details:		Direction of Survey:	Downstream
US MH:	M-902-034	DS MH:	M-902-033
		Total Length Surveyed (ft):	199.4

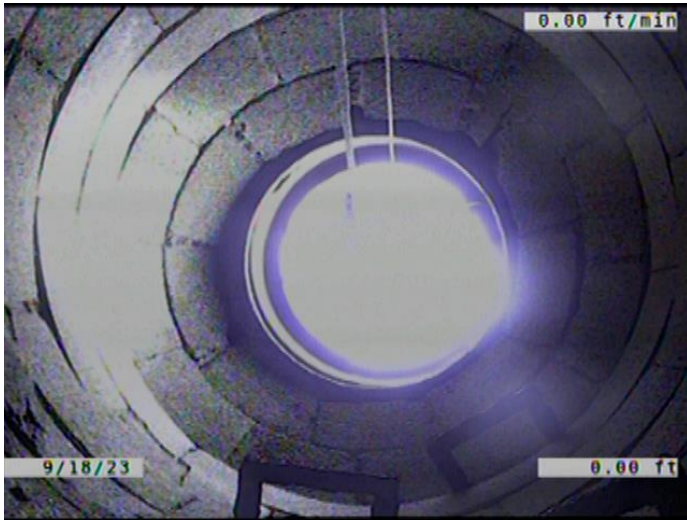
Code: **AMH**
Description: **Manhole**

Distance (ft): **.0**
Structural Grade: **0**
O&M Grade: **0**
Clock Start/From:
Clock To:
1st Value:
2nd Value:
Value Percent:
Continuous Index:
Within 8" of Joint: **NO**
Remarks: **M-902-034**

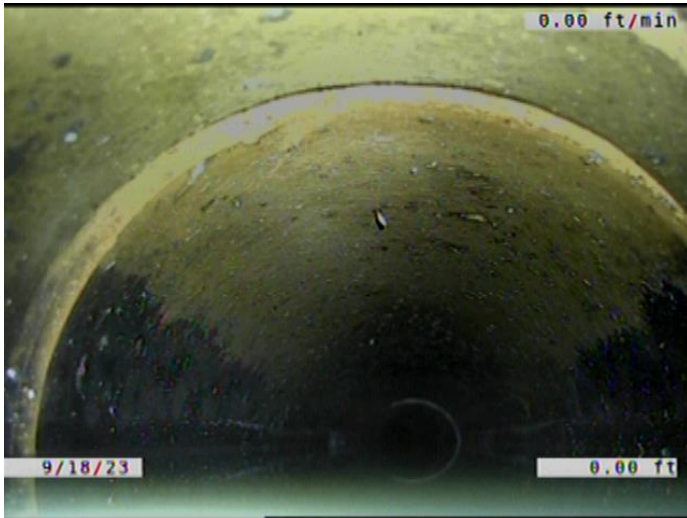
Code: **MWL**
Description: **Miscellaneous Water Level**

Distance (ft): **.0**
Structural Grade: **0**
O&M Grade: **0**
Clock Start/From:
Clock To:
1st Value:
2nd Value:
Value Percent: **35.000**
Continuous Index:
Within 8" of Joint: **NO**
Remarks:

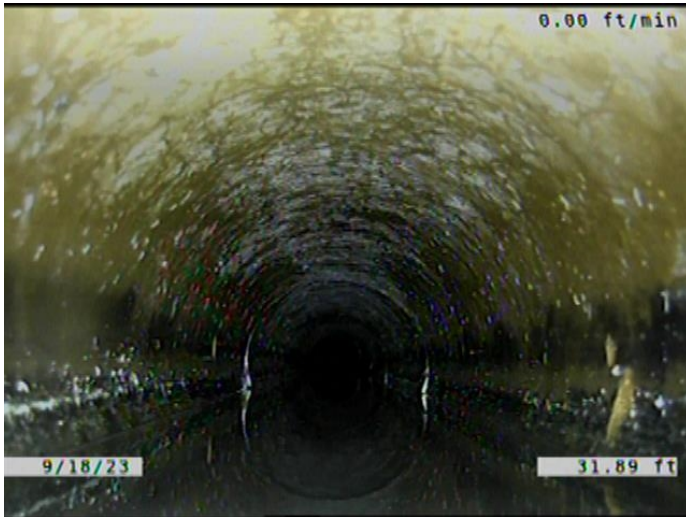
Code: **MWL**
Description: **Miscellaneous Water Level**

Distance (ft): **31.9**
Structural Grade: **0**
O&M Grade: **0**
Clock Start/From:
Clock To:
1st Value:
2nd Value:
Value Percent: **20.000**
Continuous Index:
Within 8" of Joint: **NO**
Remarks:

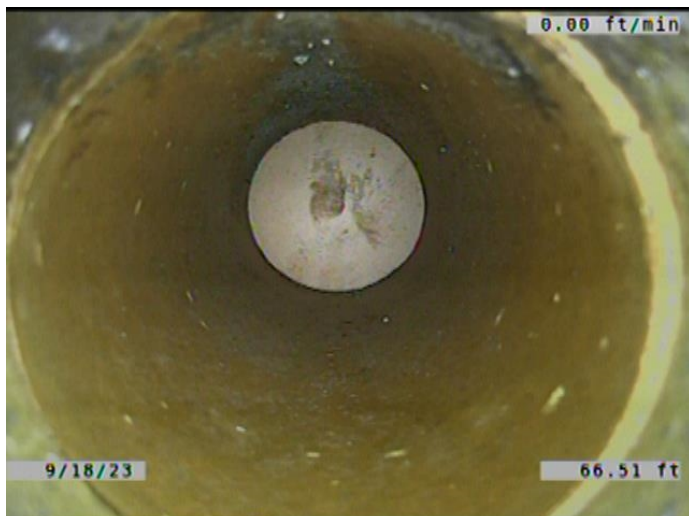
Code: **TFC**
Description: **Tap Factory Capped**

Distance (ft): **66.5**
Structural Grade: **0**
O&M Grade: **0**
Clock Start/From: **12**
Clock To:
1st Value: **6.000**
2nd Value:
Value Percent:
Continuous Index:
Within 8" of Joint: **YES**
Remarks:

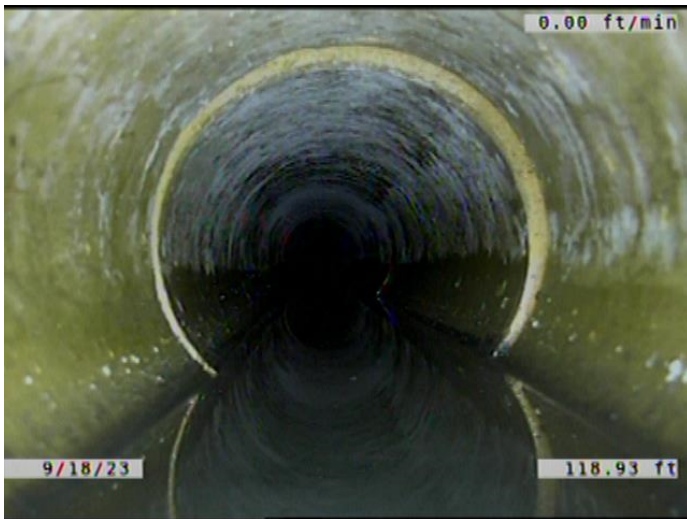
Code: **MWL**
Description: **Miscellaneous Water Level**

Distance (ft): **118.9**
Structural Grade: **0**
O&M Grade: **0**
Clock Start/From:
Clock To:
1st Value:
2nd Value:
Value Percent: **10.000**
Continuous Index:
Within 8" of Joint: **NO**
Remarks:

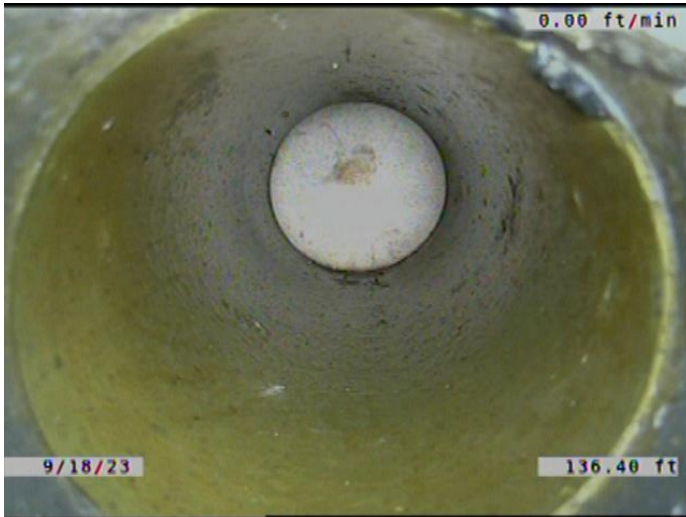
Code: **TFC**
Description: **Tap Factory Capped**

Distance (ft): **136.4**
Structural Grade: **0**
O&M Grade: **0**
Clock Start/From: **12**
Clock To:
1st Value: **6.000**
2nd Value:
Value Percent:
Continuous Index:
Within 8" of Joint: **YES**
Remarks:

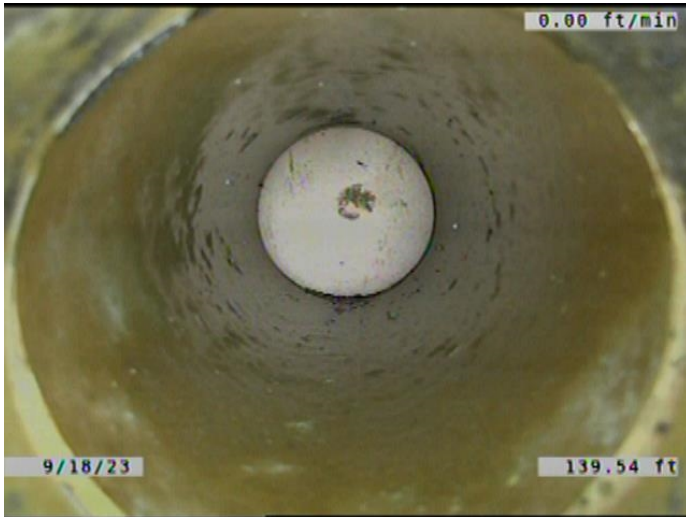
Code: **TFC**
 Description: **Tap Factory Capped**

Distance (ft): **139.5**
 Structural Grade: **0**
 O&M Grade: **0**
 Clock Start/From: **12**
 Clock To:
 1st Value: **6.000**
 2nd Value:
 Value Percent:
 Continuous Index:
 Within 8" of Joint: **YES**
 Remarks:

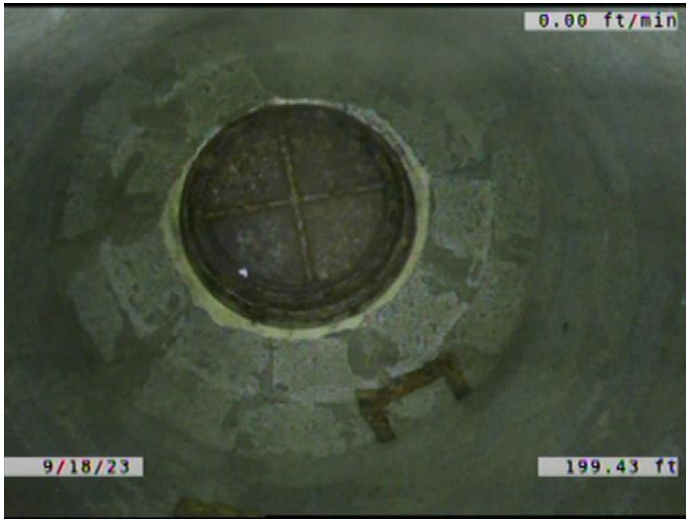
Code:	AMH
Description:	Manhole
Distance (ft):	199.4
Structural Grade:	0
O&M Grade:	0
Clock Start/From:	
Clock To:	
1st Value:	
2nd Value:	
Value Percent:	
Continuous Index:	
Within 8" of Joint:	NO
Remarks:	M-902-033
