Profile/Photo Observation Report

| Street: | RUSH PL | Flow Control: | Not Controlled |
| City: | Hobart, IN | Year Renewed: | |

| US MH: | M-902-056 | DS MH: | M-902-031 |

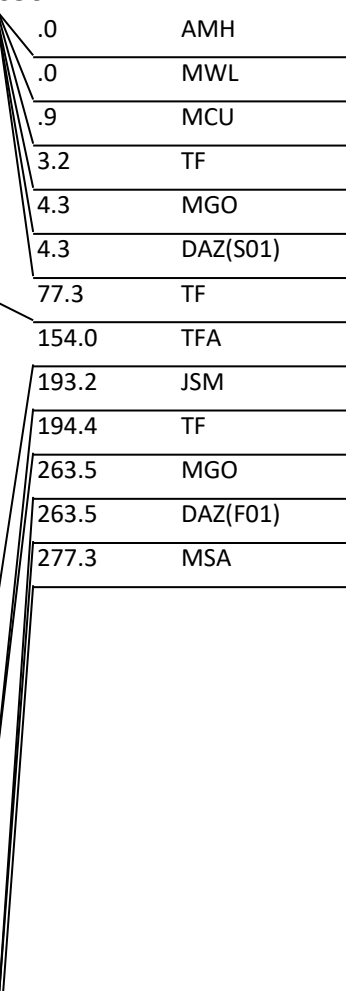
| Position | Code | Observation | Video (sec) | Grade |
|---|---|---|---|---|
| .0 | AMH | Manhole | 10 | NA |
| .0 | MWL | Water Level | 21 | NA |
| .9 | MCU | Camera Underwater | 35 | M 4 |
| 3.2 | TF | Tap Factory | 53 | NA |
| 4.3 | MGO | General Observation | 71 | NA |
| 4.3 | DAZ(S01) | Deposits Attached Other | 82 | M 2 |
| 77.3 | TF | Tap Factory | 240 | NA |
| 154.0 | TFA | Tap Factory Active | 406 | NA |
