Profile/Photo Observation Report

Date:	03/21/2018	Weather:		Coding:	PACP 6.0
Pipe Length (ft):	174.2	Owner:	NA	Pre Clean:	Not Known
P.O.#:		Surveyor:	Selasie Honu	PSR:	P-902-059-058
Customer:		Clean Date:	01/01/1900	Shape:	C

Street:	E 36TH ST & RUSH PL	Flow Control:	Not Controlled
City:	Hobart, IN	Year Renewed:	
Location:	Other	Tape/Media #:	
Purpose:	Not Known	Dia/Height:	10"
Use:	Sanitary	Material:	PVC
Drain Area:	NA	Lining:	Cured in Place
Category:	NA		
Comment:

Location Details:		Direction of Survey:	Upstream
US MH:	M-902-058	DS MH:	M-902-059
		Total Length Surveyed (ft):	79.4

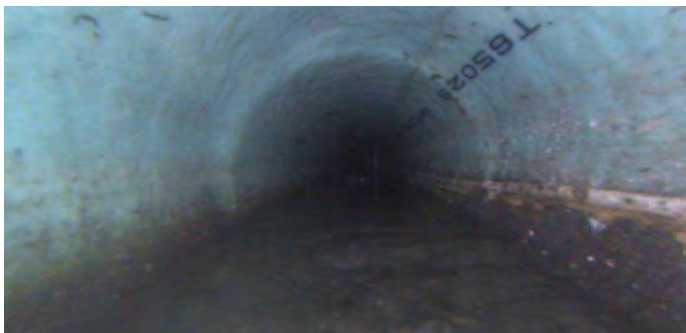
Code: **AMH**
Description: **Manhole**

Distance (ft): **.0**
Structural Grade: **0**
O&M Grade: **0**
Clock Start/From:
Clock To:
1st Value:
2nd Value:
Value Percent:
Continuous Index:
Within 8" of Joint: **NO**
Remarks: **M-902-059**

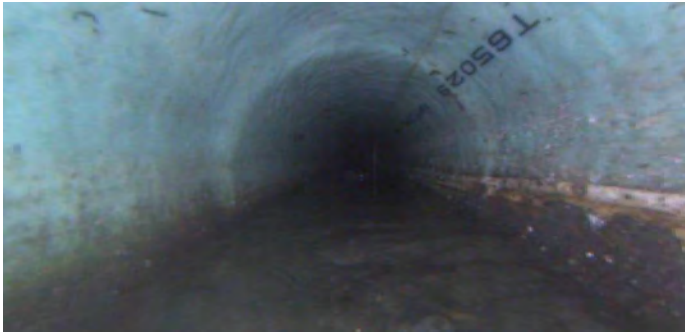
Code:	MWL
Description:	Water Level

Distance (ft):	.0
Structural Grade:	0
O&M Grade:	0
Clock Start/From:	
Clock To:	
1st Value:	
2nd Value:	
Value Percent:	5.000
Continuous Index:	
Within 8" of Joint:	NO
Remarks:

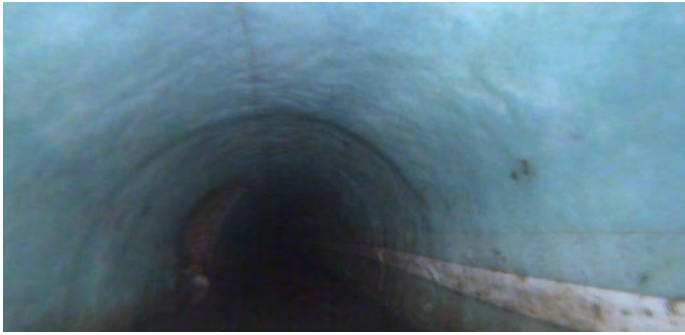
Code: **TF**
Description: **Tap Factory**

Distance (ft): **15.9**
Structural Grade: **0**
O&M Grade: **0**
Clock Start/From: **9**
Clock To:
1st Value: **4.000**
2nd Value:
Value Percent:
Continuous Index:
Within 8" of Joint:
Remarks:

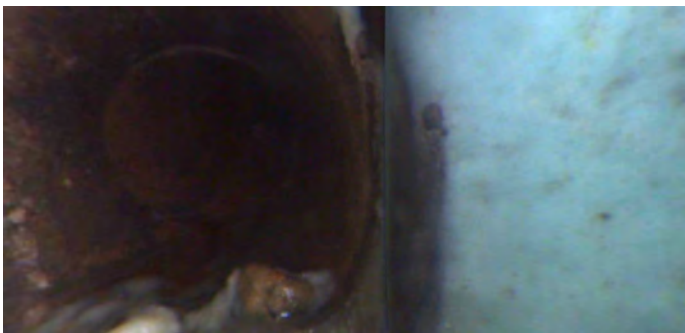
Code: **TF**
Description: **Tap Factory**

Distance (ft): **17.4**
Structural Grade: **0**
O&M Grade: **0**
Clock Start/From: **9**
Clock To:
1st Value: **4.000**
2nd Value:
Value Percent:
Continuous Index:
Within 8" of Joint:
Remarks:
