Profile/Photo Observation Report

Date:	03/22/2018	Weather:		Coding:	PACP 6.0
Pipe Length (ft):	406.8	Owner:	NA	Pre Clean:	Not Known
P.O.#:		Surveyor:	Selasie Honu	PSR:	P-902-062-003.5
Customer:		Clean Date:	01/01/1900	Shape:	C

Street:	saint joesph pl	Flow Control:	Not Controlled
City:	Hobart, IN	Year Renewed:	
Location:	Other	Tape/Media #:	
Purpose:	Not Known	Dia/Height:	10"
Use:	Sanitary	Material:	PVC
Drain Area:	NA	Lining:	
Category:	NA		
Comment:

Location Details:		Direction of Survey:	Upstream
US MH:	M-902-062	DS MH:	M-902-003.5
		Total Length Surveyed (ft):	329.5

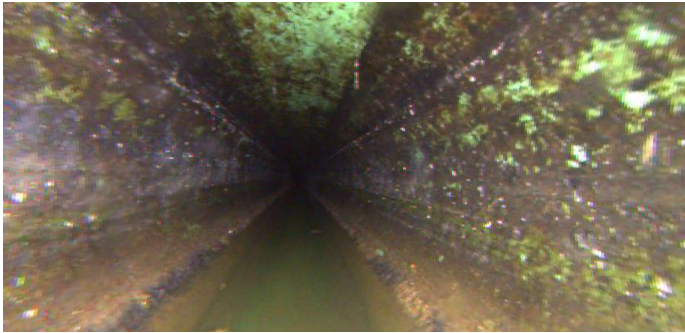
Code:	AMH
Description:	Manhole

Distance (ft):	.0
Structural Grade:	0
O&M Grade:	0
Clock Start/From:	
Clock To:	
1st Value:	
2nd Value:	
Value Percent:	
Continuous Index:	
Within 8" of Joint:	NO
Remarks:	M-902-003.5

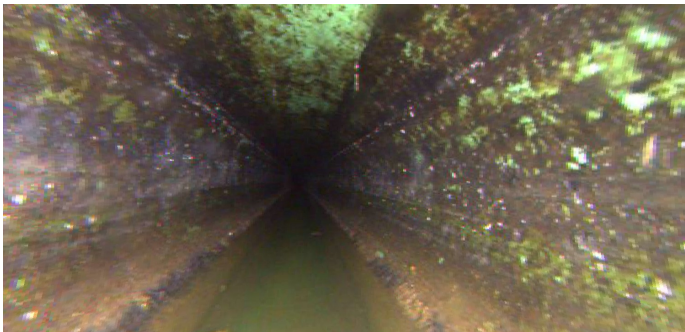
Code:	MWL
Description:	Water Level

Distance (ft):	.0
Structural Grade:	0
O&M Grade:	0
Clock Start/From:	
Clock To:	
1st Value:	
2nd Value:	
Value Percent:	5.000
Continuous Index:	
Within 8" of Joint:	NO
Remarks:
