Profile/Photo Observation Report

Date:	06/13/2023	Weather:		Coding:	PACP 7.0
Pipe Length (ft):	146.0	Owner:	City of Hobart	Pre Clean:	Heavy Cleaning
P.O.#:	YES502259	Surveyor:	S. Bucklin	PSR:	P-902-076-039
Customer:	City of Hobart	Clean Date:	05/10/2023	Shape:	C

Street:	East 34th Lane	Flow Control:	Not Controlled
City:	Hobart, IN	Year Renewed:	
Location:	Local rural streets with light traffic, t	Tape/Media #:	
Purpose:	Routine Assessment	Dia/Height:	18"
Use:	Sanitary Sewage Pipe	Material:	RCP
Drain Area:		Lining:	None
Category:	NA		
Comment:			
Location Details:		Direction of Survey:	Downstream
US MH:	M-902-076	DS MH:	M-902-039
		Total Length Surveyed (ft):	146.8

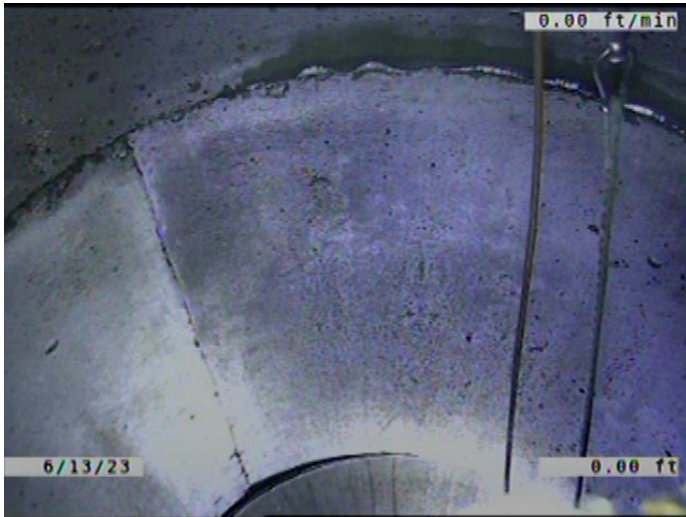
Code: **AMH**
Description: **Manhole**

Distance (ft): **.0**
Structural Grade: **0**
O&M Grade: **0**
Clock Start/From:
Clock To:
1st Value:
2nd Value:
Value Percent:
Continuous Index:
Within 8" of Joint: **NO**
Remarks: **M-902-076**

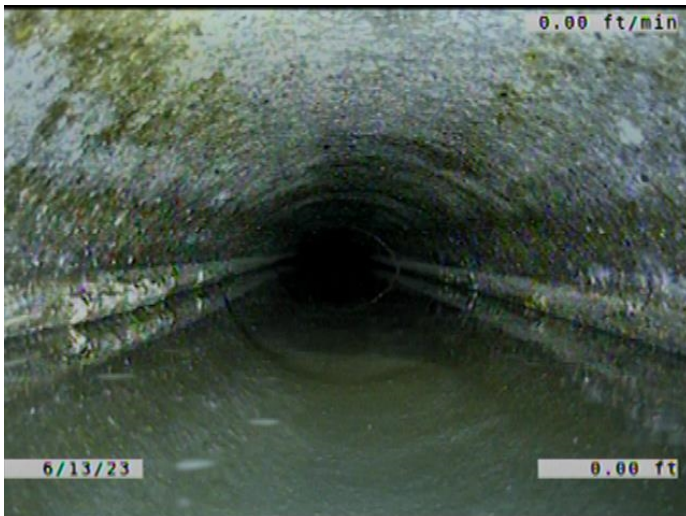
Code: **MWL**
Description: **Miscellaneous Water Level**

Distance (ft): **.0**
Structural Grade: **0**
O&M Grade: **0**
Clock Start/From:
Clock To:
1st Value:
2nd Value:
Value Percent: **60.000**
Continuous Index:
Within 8" of Joint: **NO**
Remarks:

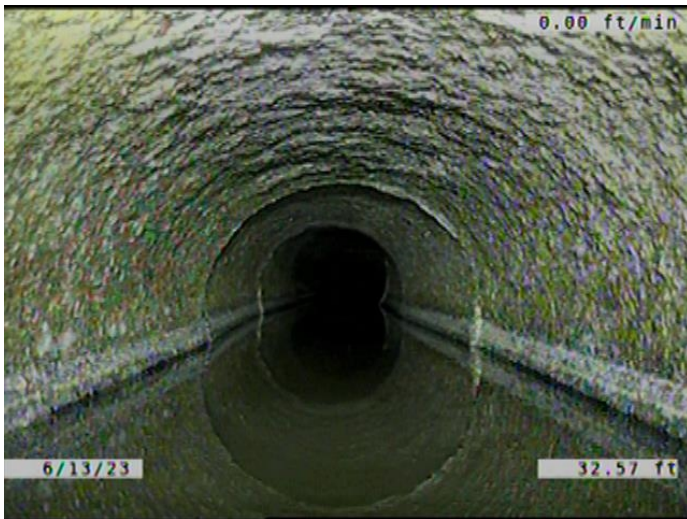
Code: **MWL**
 Description: **Miscellaneous Water Level**

Distance (ft): **32.6**
 Structural Grade: **0**
 O&M Grade: **0**
 Clock Start/From:
 Clock To:
 1st Value:
 2nd Value:
 Value Percent: **35.000**
 Continuous Index:
 Within 8" of Joint: **NO**
 Remarks:

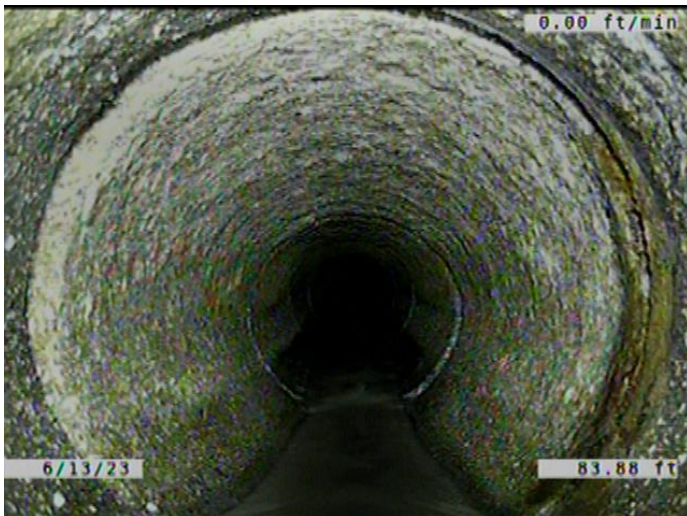
Code: **MWL**
 Description: **Miscellaneous Water Level**

Distance (ft): **83.9**
 Structural Grade: **0**
 O&M Grade: **0**
 Clock Start/From:
 Clock To:
 1st Value:
 2nd Value:
 Value Percent: **5.000**
 Continuous Index:
 Within 8" of Joint: **NO**
 Remarks:

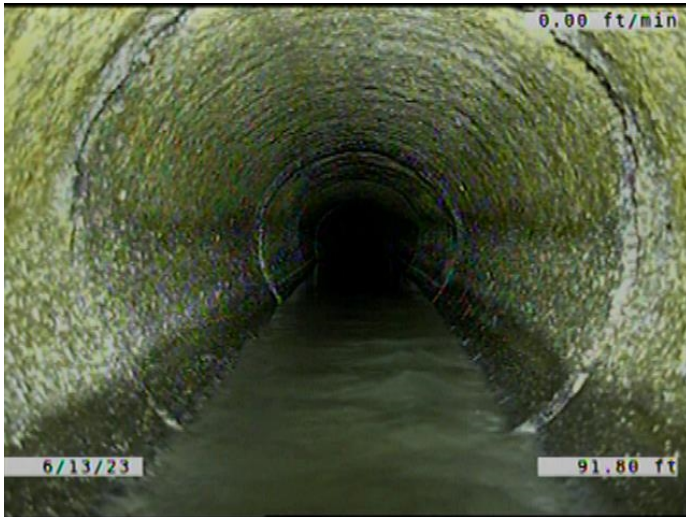
Code: **MWL**
Description: **Miscellaneous Water Level**

Distance (ft): **91.8**
Structural Grade: **0**
O&M Grade: **0**
Clock Start/From:
Clock To:
1st Value:
2nd Value:
Value Percent: **20.000**
Continuous Index:
Within 8" of Joint: **NO**
Remarks:

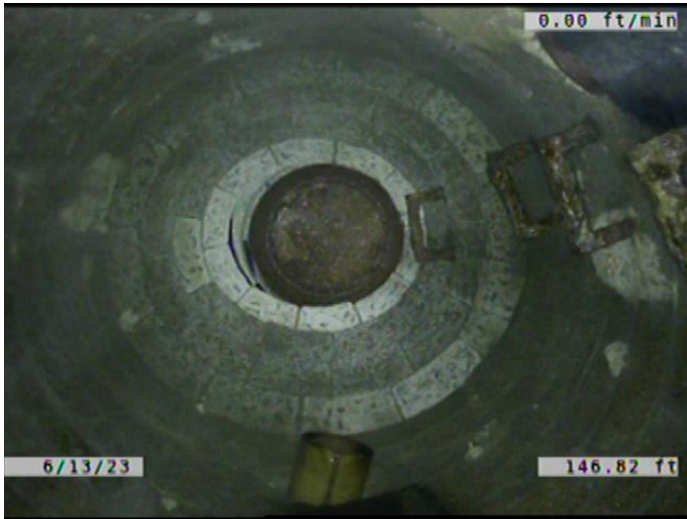
Code:	AMH
Description:	Manhole
Distance (ft):	146.8
Structural Grade:	0
O&M Grade:	0
Clock Start/From:	
Clock To:	
1st Value:	
2nd Value:	
Value Percent:	
Continuous Index:	
Within 8" of Joint:	NO
Remarks:	M-902-039
